I.FAST task 7.5: CompactLight Prototype Accelerating Structure

3rd I.FAST Annual Meeting - 18/04/24

CompactLight Prototype Accelerating Structures

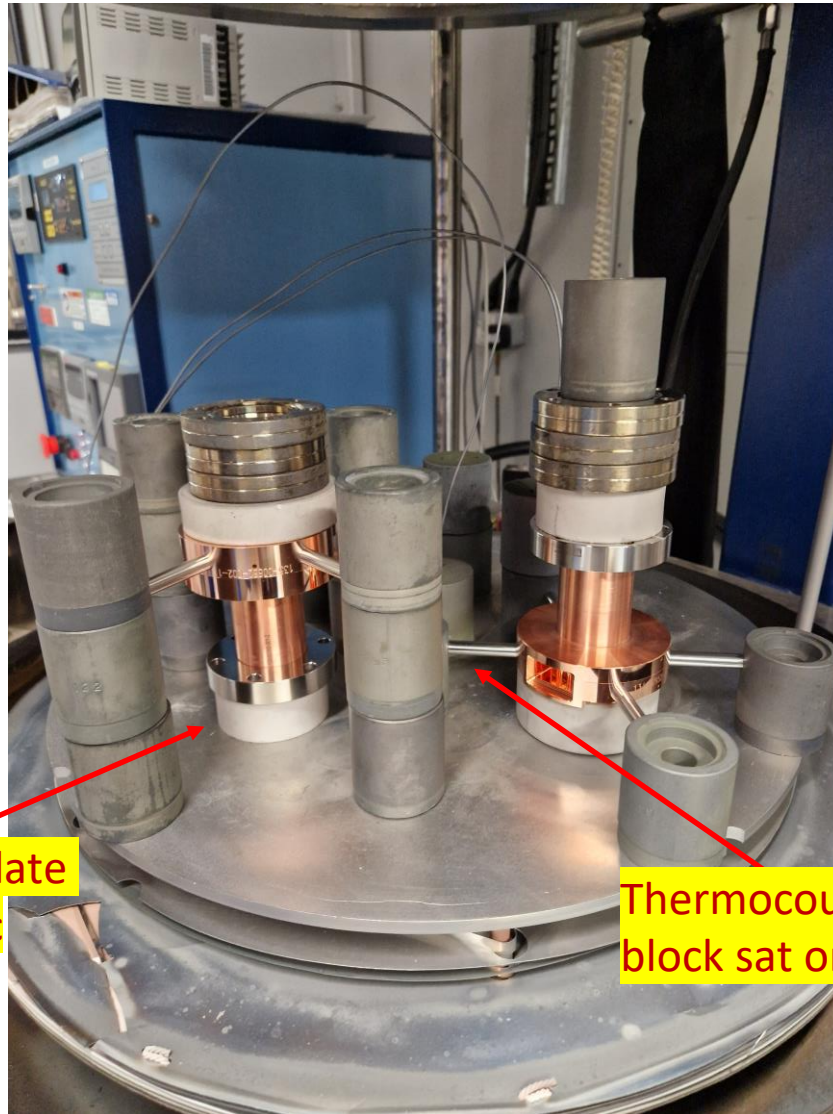
Lifted off baseplate
with ceramic

Thermocouple in steel
block sat on baseplate

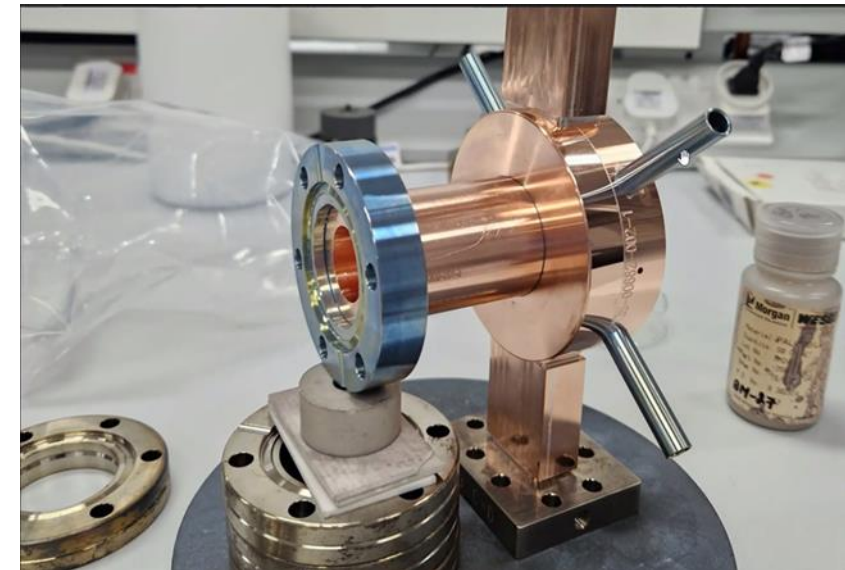
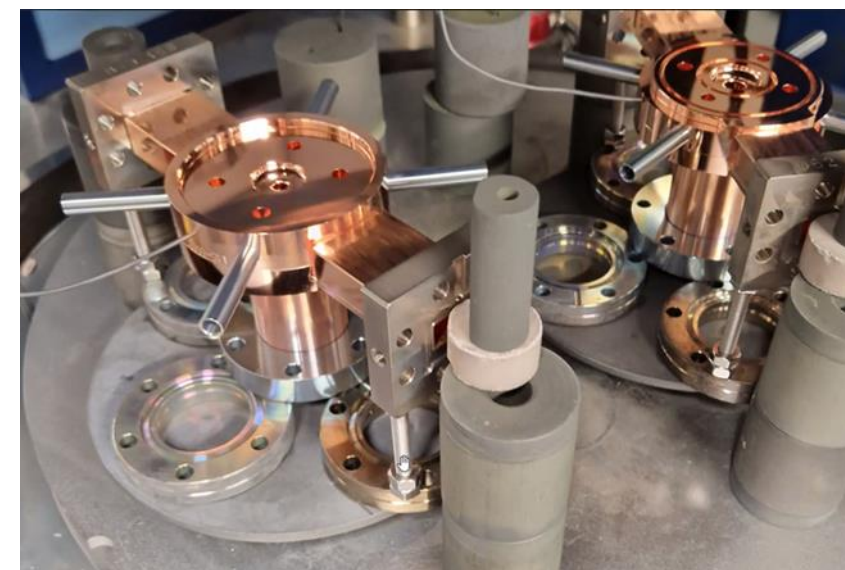
End stack brazes II

- One end stack brazed well, and both stacks had visible evidence of the braze flowing.
- Clear evidence however of the braze eating into the copper in second end stack.
- Visible hole in cavity wall in 2 places, not present in other side of disk.

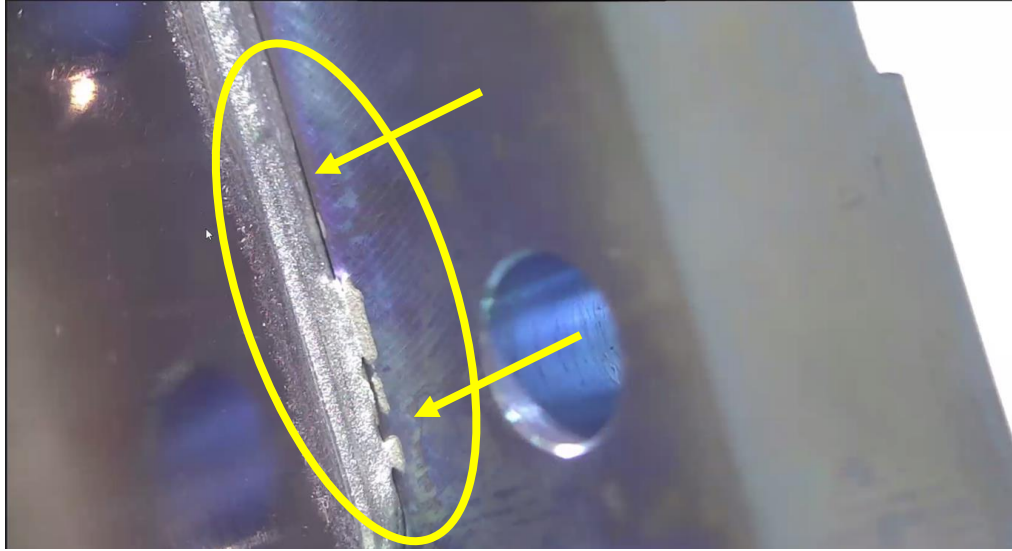
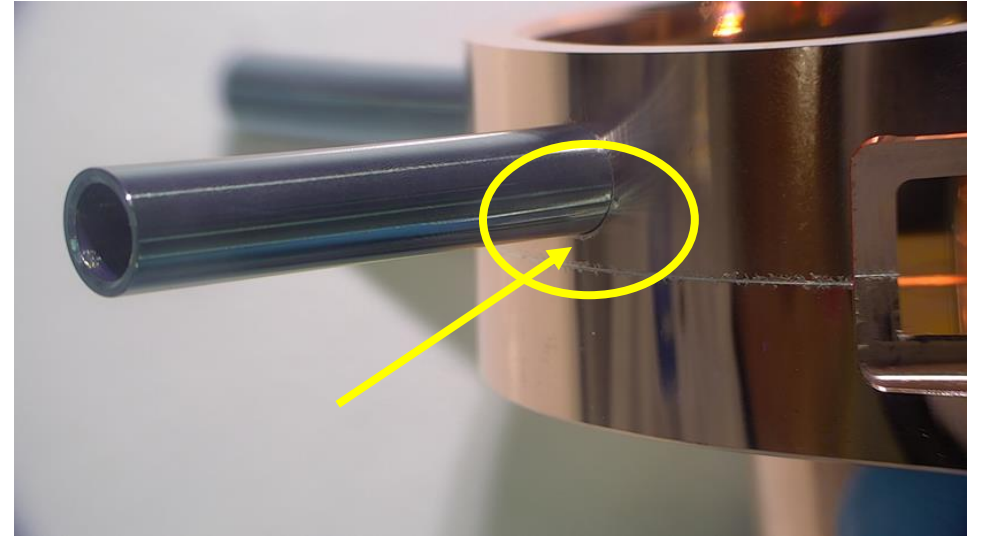
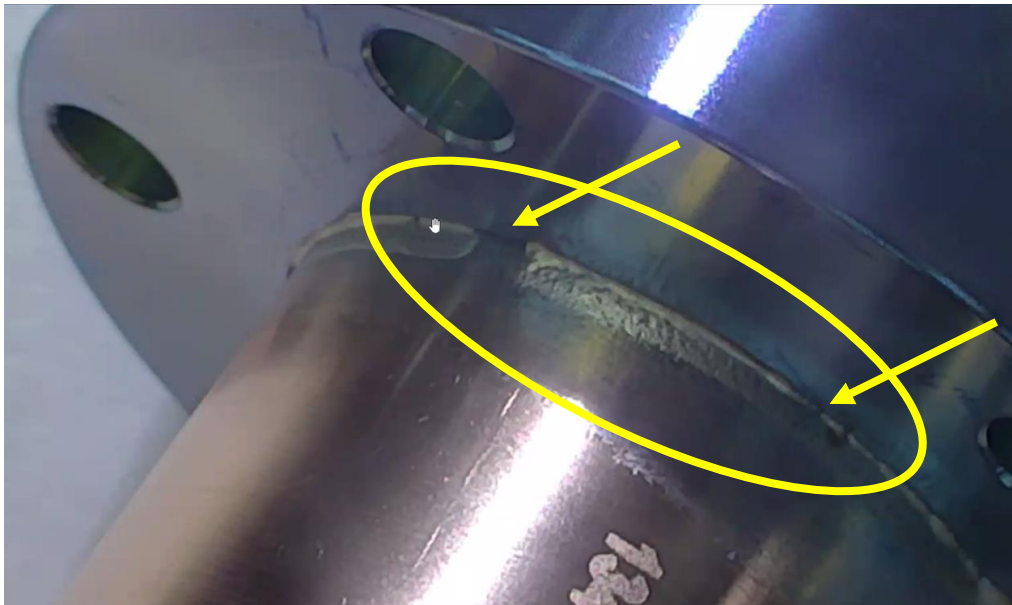
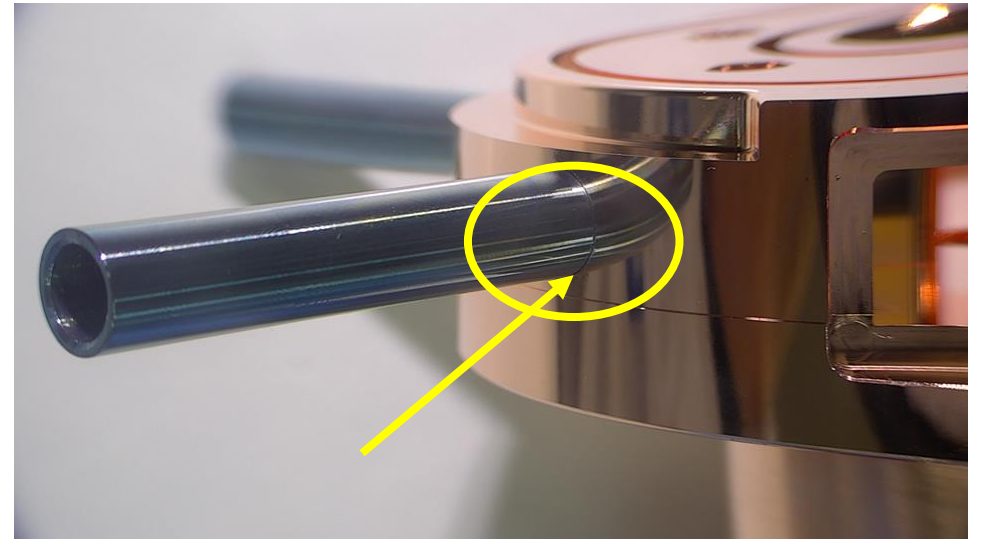
End stack brazes IV

- Unsure exactly why the braze ate into the copper
- Concern however that braze channel appears to touch inner cavity wall
