Updates from Japan group

On behalf of the ATLAS ITk Japan group
Studies mainly by K. Imamura (Kyushu U.), K. Itabashi (KEK),
H. Nose (U. Tsukuba), T. Ogawa (Waseda U.), K. Sugawara (U. Tsukuba)

2024/02/02 at ITk Pixel module QAQC Japan-LBNL discussion

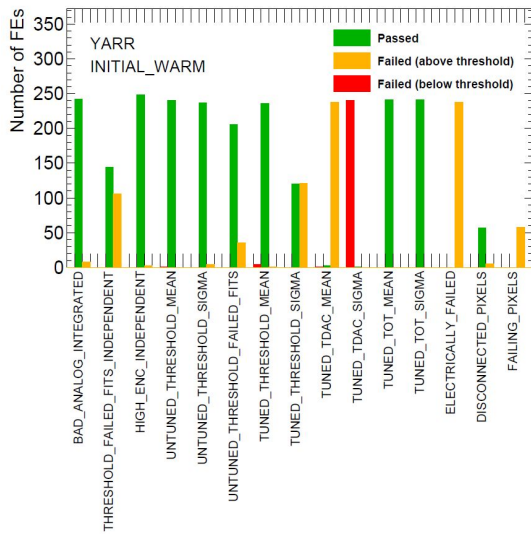
- Many failures in tuning (as discussed on December) and PFA
 - As already discussed at the last meeting

INITIAL_WARM	INITIAL_COLD
Total # of FEs analysed	237	224
DEAD_DIGITAL	17	4
BAD_DIGITAL	1	7
DEAD_ANALOG	17	10
BAD_ANALOG	12	10
HIGH_ENC	0	0
HIGH_NOISE	0	1
MARGED_BUMPS	0	1

Detailed statistical analysis is underway to better identify origins of the failed pixels

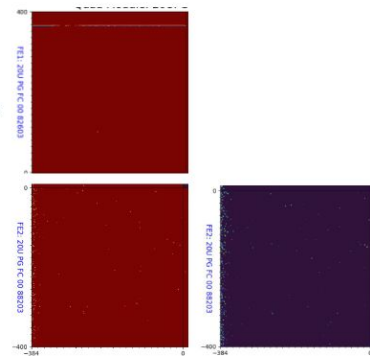
Core column masks

Bad analog FEs on a line

Many noisy pixels

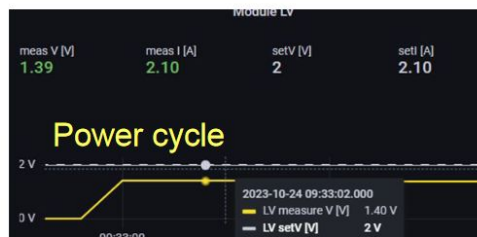
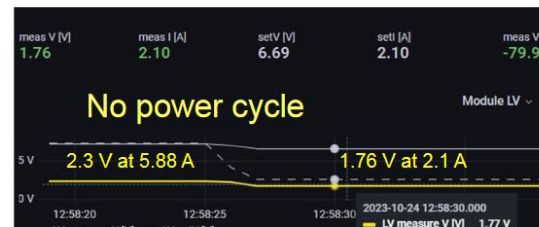
- After power cycle, there are some cases that a healthy module (i.e. which has good communication in the normal power mode) cannot be configured
- Investigated relation w.r.t. slew rate of the power supply

LP_MODE for 0x157b5			
Parameter	Analysis result	QC criteria	Pass
LP_VINA	1.802	[1.468, 1.518]	False
LP_VIND	1.811	[1.468, 1.518]	False
LP_VOFFS	1.308	[1.304, 1.354]	True
LP_IINA	0.61	[0.18, 0.22]	False
LP_IIND	0.87	[0.28, 0.32]	False
LP_ISHUNTA	0.44	[0.0001, 0.1]	False
LP_ISHUNTD	0.632	[0.0001, 0.1]	False

LP_MODE for 0x157bc			
Parameter	Analysis result	QC criteria	Pass
LP_VINA	1.46	[1.468, 1.518]	False
LP_VIND	1.466	[1.468, 1.518]	False
LP_VOFFS	1.299	[1.304, 1.354]	False
LP_IINA	0.21	[0.18, 0.22]	True
LP_IIND	0.3	[0.28, 0.32]	True
LP_ISHUNTA	0.072	[0.0001, 0.1]	True
LP_ISHUNTD	0.071	[0.0001, 0.1]	True

- Previously we used Mpod with slower slew rate
 - Decided to change it from 500 V/s to 3000 V/s
 - Early tests were done with 500 V/s
- First check: testing communication with power cycle at the firster slew rate
 - Chose a module with a good condition
 - Wasn't able to establish communication in LP mode after power cycle, while successful without power cycle

- Would like to test the LP mode with a faster PS
 - A good candidate is RIGOL DP821A
 - Need arrangement to bring modules to KEK...
- Weird behaviour in Vin (as discussed on email) was due to a locally implemented switching to LP mode
 - Seems implemented just as a test mode; removed it and the behaviour has been fixed

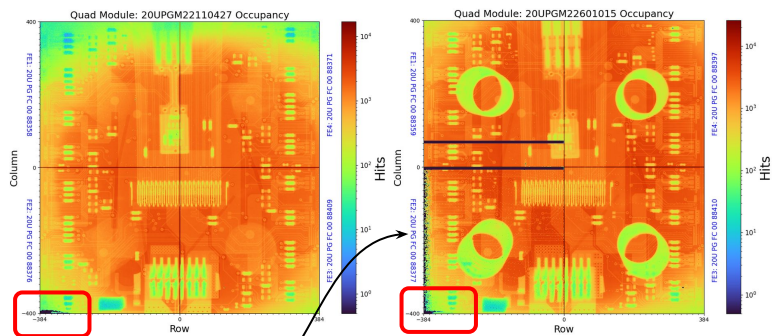
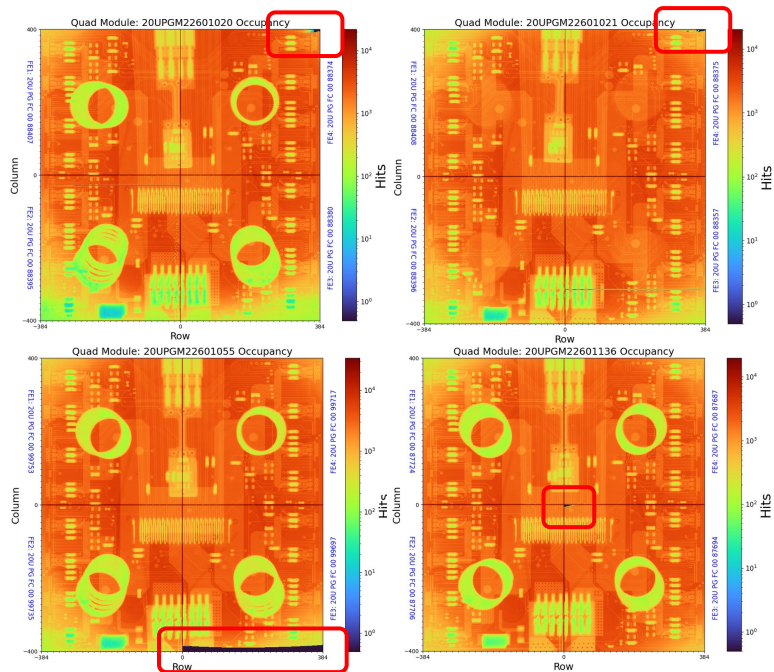
Bump disconnection

- AND of all the three types of scans
 - Observed 6 modules with some disconnection (out of them, 1 failed the threshold)

- Observed 6 modules partly with disconnected bumps
 - 0427 FE2, 1015 FE2, 1020 FE4, 1021 FE4; these share the same dicing line → Potential cause in the dicing process identified, and confirmed that will not happen in the production
 - 1055 FE3, 1136 FE4: these chips are from the wafer edge → Known that bump formation is incomplete for these chips (so should not have been used...)
- All 6 cases have been understood, and feedback given to the manufacturers

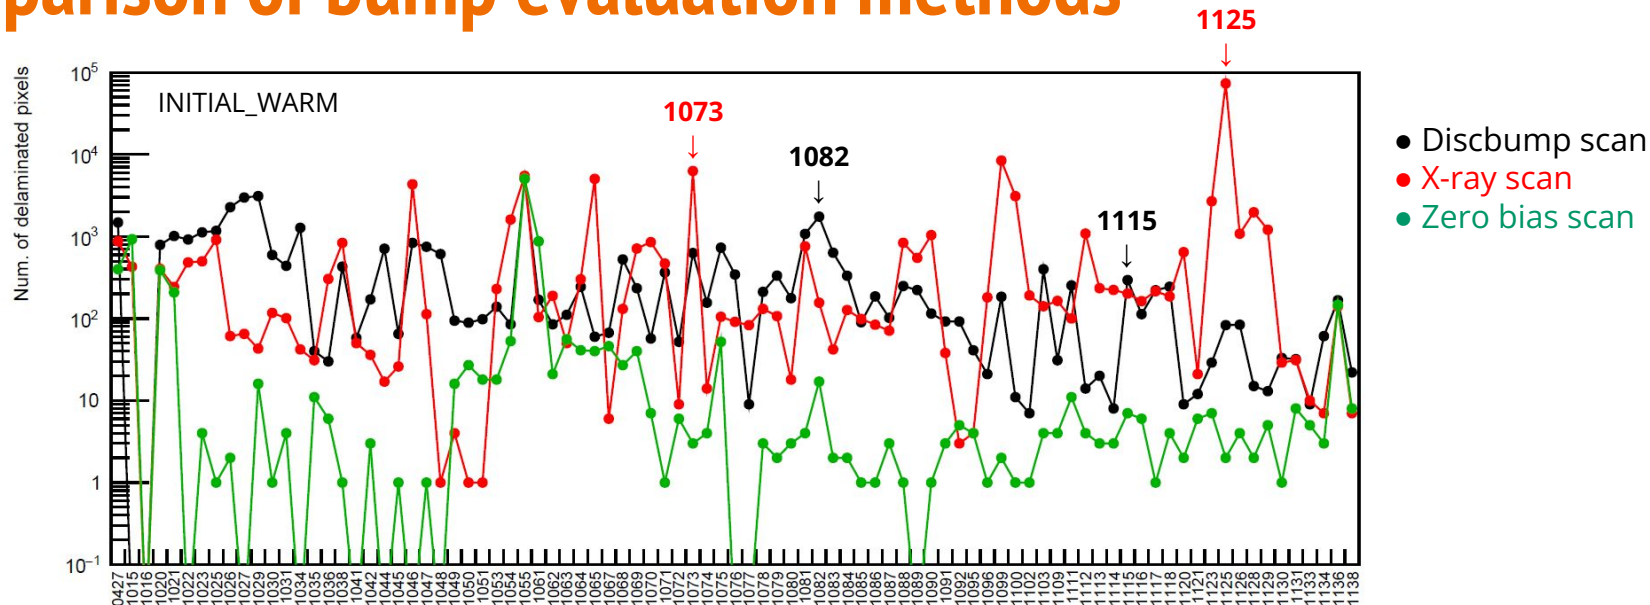
Comparison of bump evaluation methods

- Disconnected bump scan and X-ray scan show many 'disconnected' bumps
 - But probably that's not true, as the results from noise in zero bias scan are low
 - ...and we didn't see any delamination-like cluster of disconnected bumps in any of the 2D maps during elec. QC

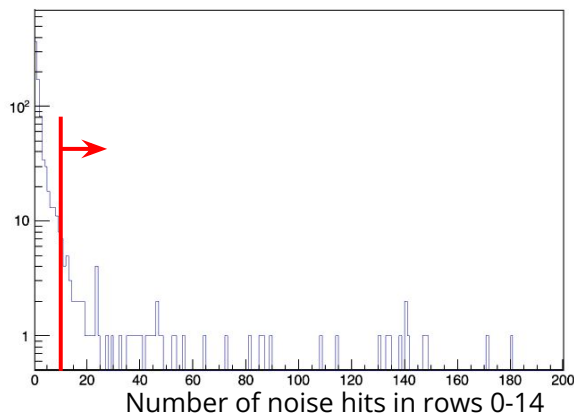
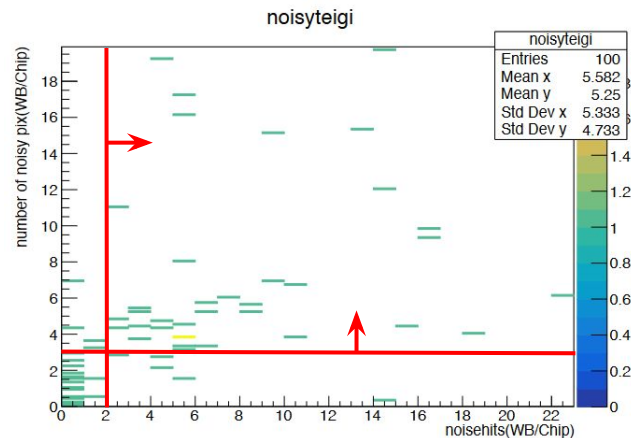
Noise around WB pads (chip bottom)

- Some modules show high noise near the chip bottom
 - They are concentrated on around rows 0-14
- This feature may be correlated to mis-measurements in disconnected bump scan?
- Investigated effects of enabling LCC

- Define 'module with high noise around WB pads'
 - Consider rows 0-14 as 'around WB pads'
 - Number of noisy pixels ($N_{hit}(\text{rows } 0-14) > 0$ in noise scan) to be greater than 10
 - Fraction of noisy pixels in rows 0-14 to that in rows 15-383 to be greater than 4
 - Fraction of N_{hit} in rows 0-14 to that in rows 15-383 to be greater than 2
- Very preliminary selection, but seems not so bad...

(INITIAL_WARM)	LCC off	LCC on
Num. of chips tested	310	60
Num. of noisy chips	17	0
Fraction	5.5%	0.0%

- So far we observed no 'noisy' module after enabling LCC by default
 - Good indication of effectiveness of the LCC
- Will check also results from the cold tests too

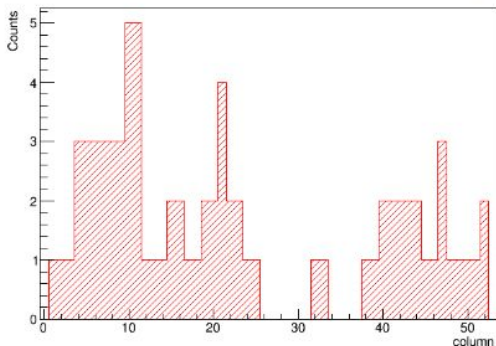
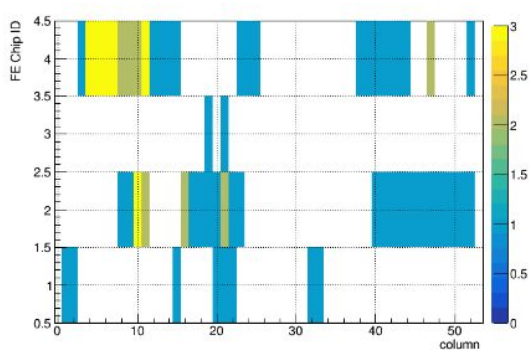
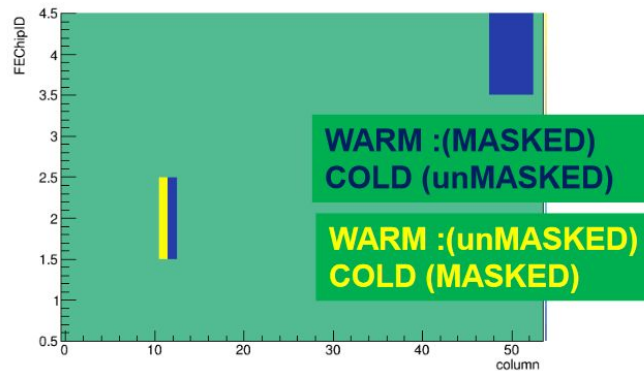
CoreColumn mask

- Some problematic FEs disturb communication
 - Communication can be established by masking a (few) core column(s)
- 40 out of 744 [FEs*(initial_warm or initial_cold)] have at least one core columns masked
 - Slightly high in FE2 and FE4?
