PRE-RUN PREPARATIONS 2024

S.HAIDER

-
- Upgrades and repairs
 - Cooling down
 - First observations

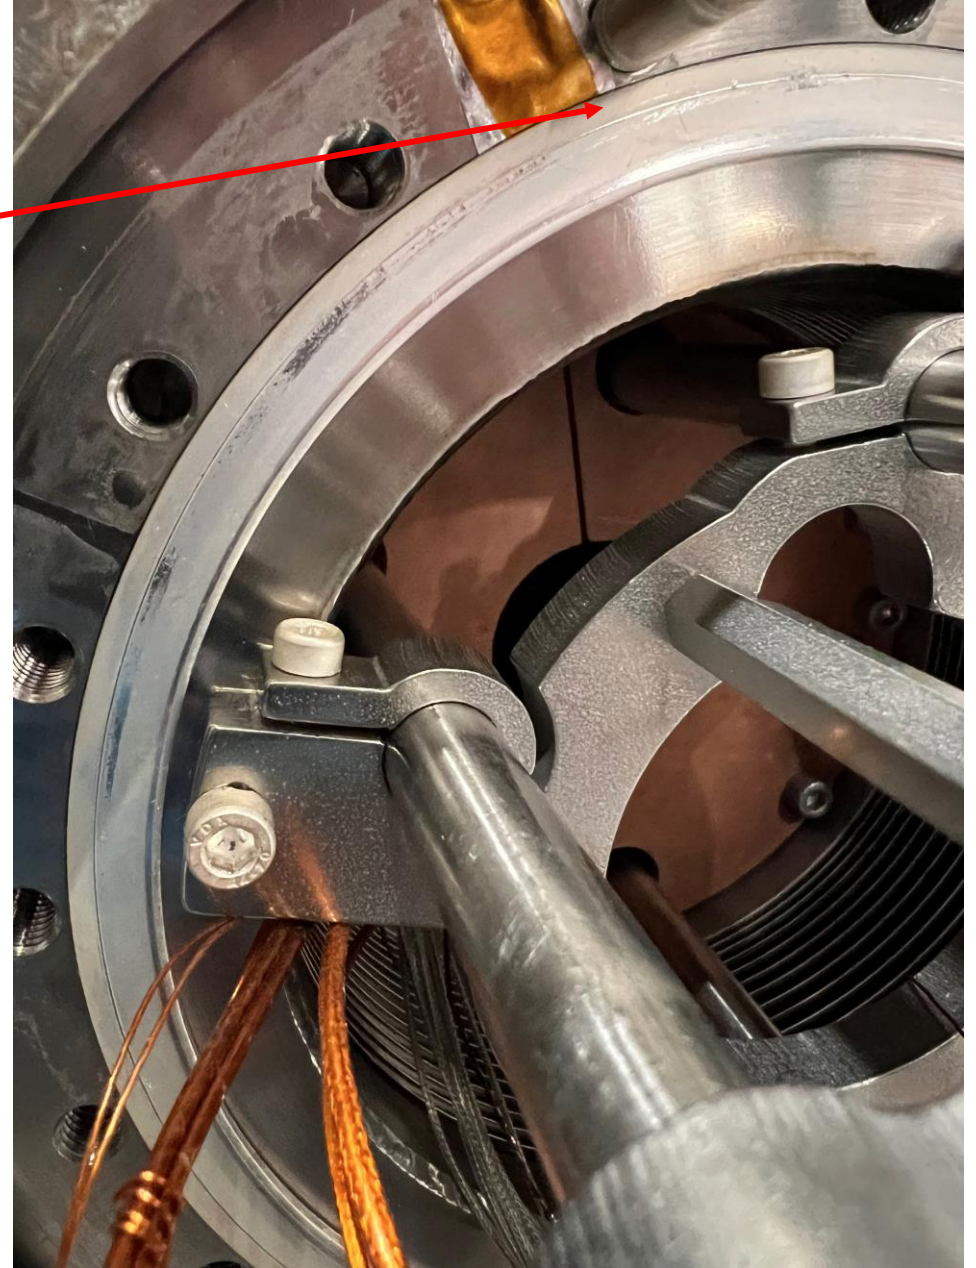
The gasket was distorted because the knife-edge on the SUN did not have anything to press against.

Both flanges were “steel-on-steel” due to the enormous pressure of the screws

Only the lower knife edge was pressed into the gasket

The copper gasket
was deformed into a
“Cone” !

We fill the gap between flange and copper gasket, in order to keep the form of the gasket intact.
Such both knife-edges can cut into the copper.

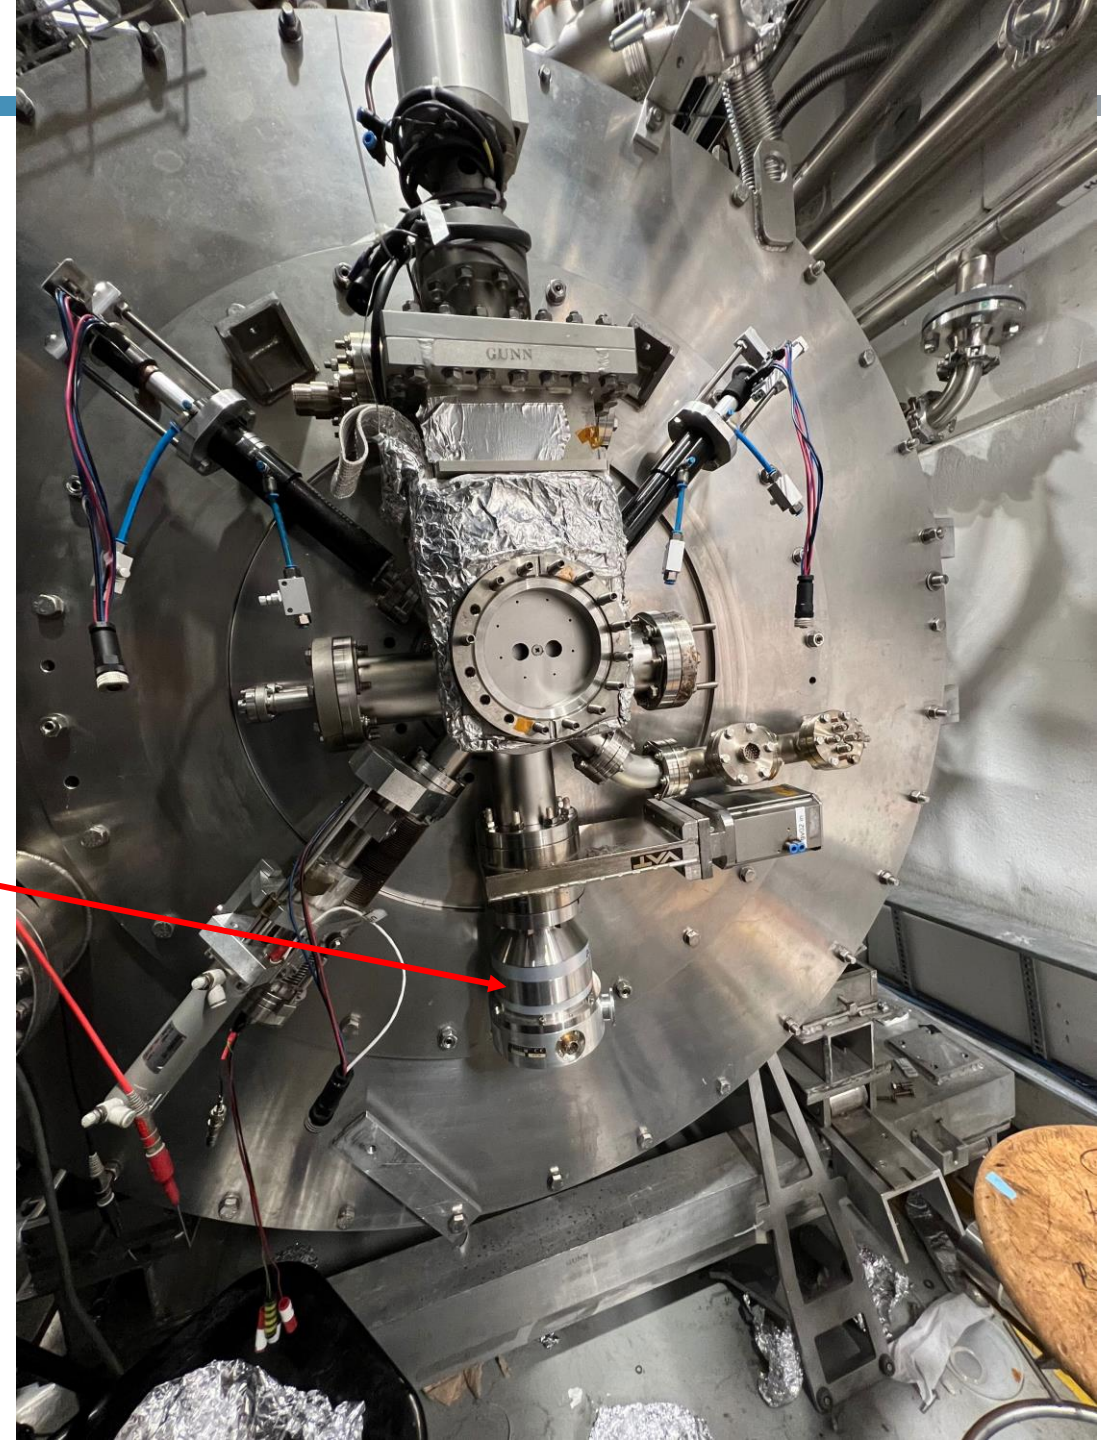
End January vacuum test with the new SUN in place. All actuators Adjusted and verified.

No leaks found with the Helium leak detector

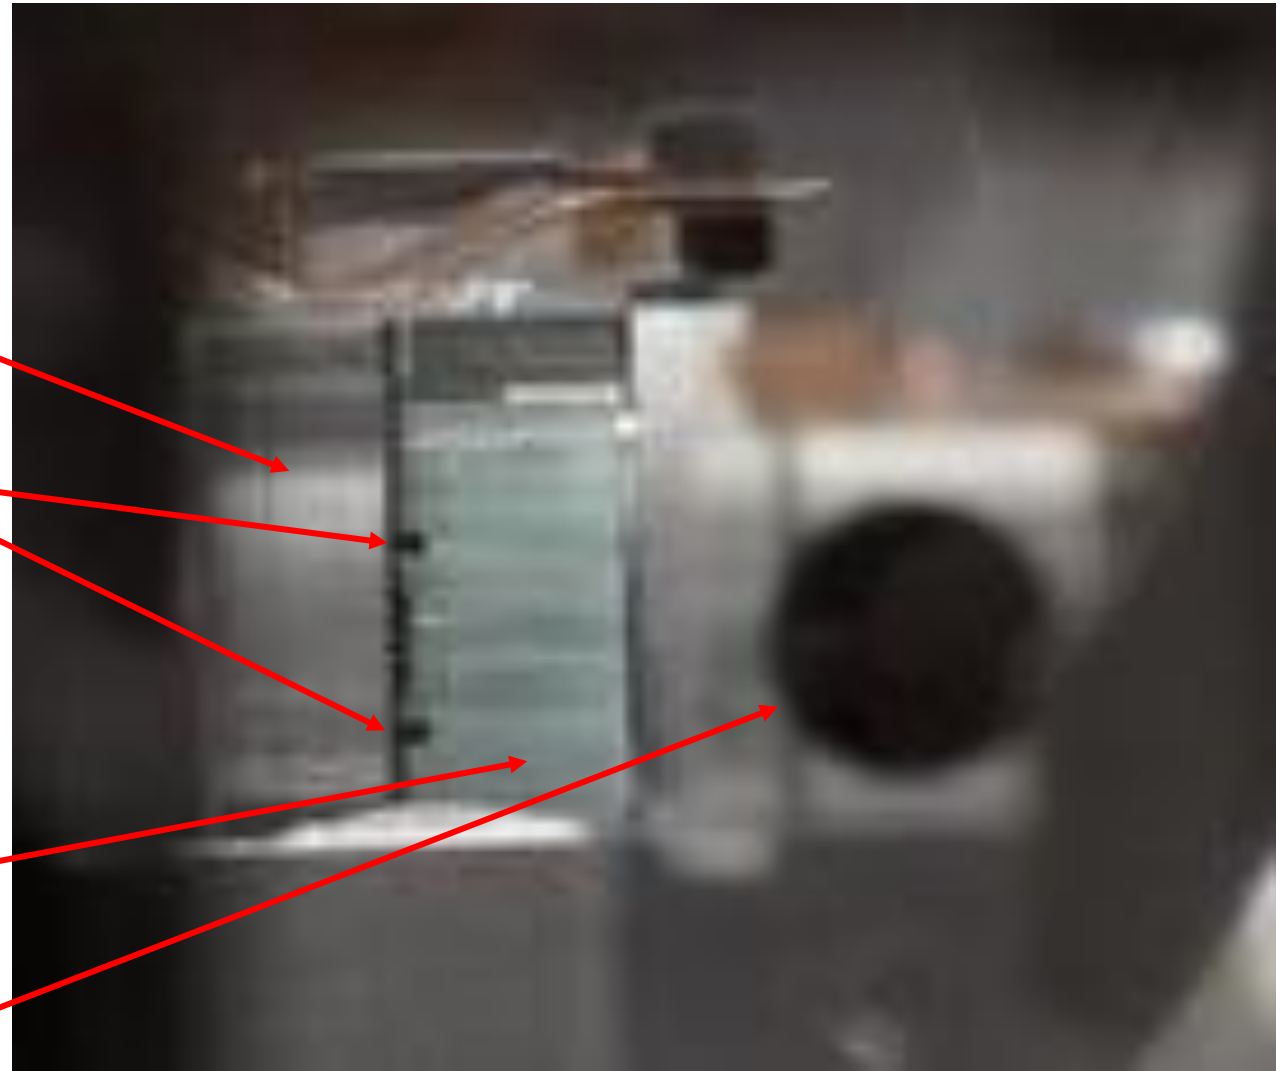
View from the air flange
(focus target):

- Target electrode A0
- Target holder brackets (no target installed)
- Fiber bundle, illuminated from outside
- Hole for electrode B9

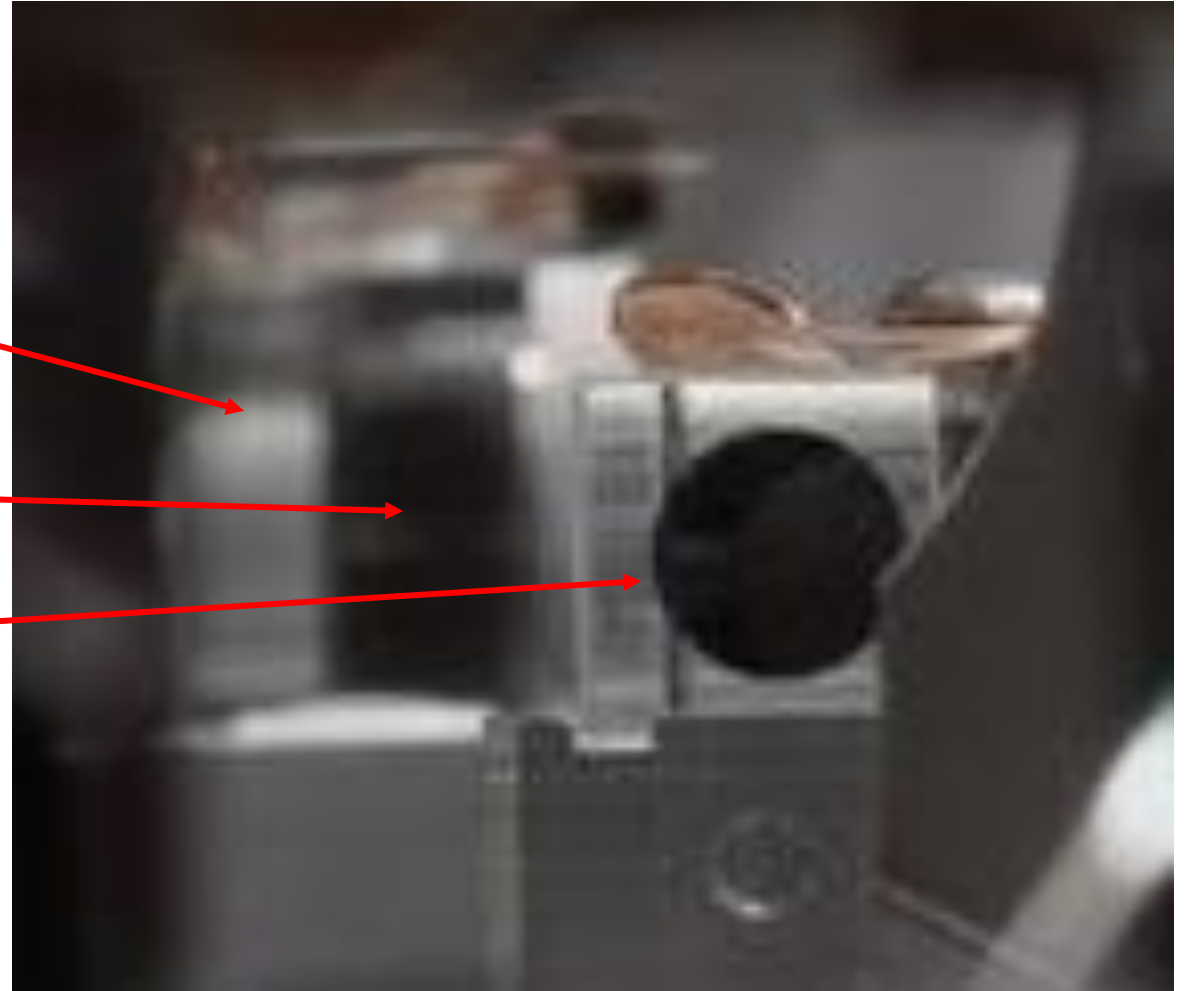
View from the air flange
(focus B9):

Target electrode A0

Fiber bundle, NOT illuminated
from outside

Hole for electrode B9
