Recent Experience with Testing and Operating RF Couplers at SNS

John Mammosser

July 2nd, 2024

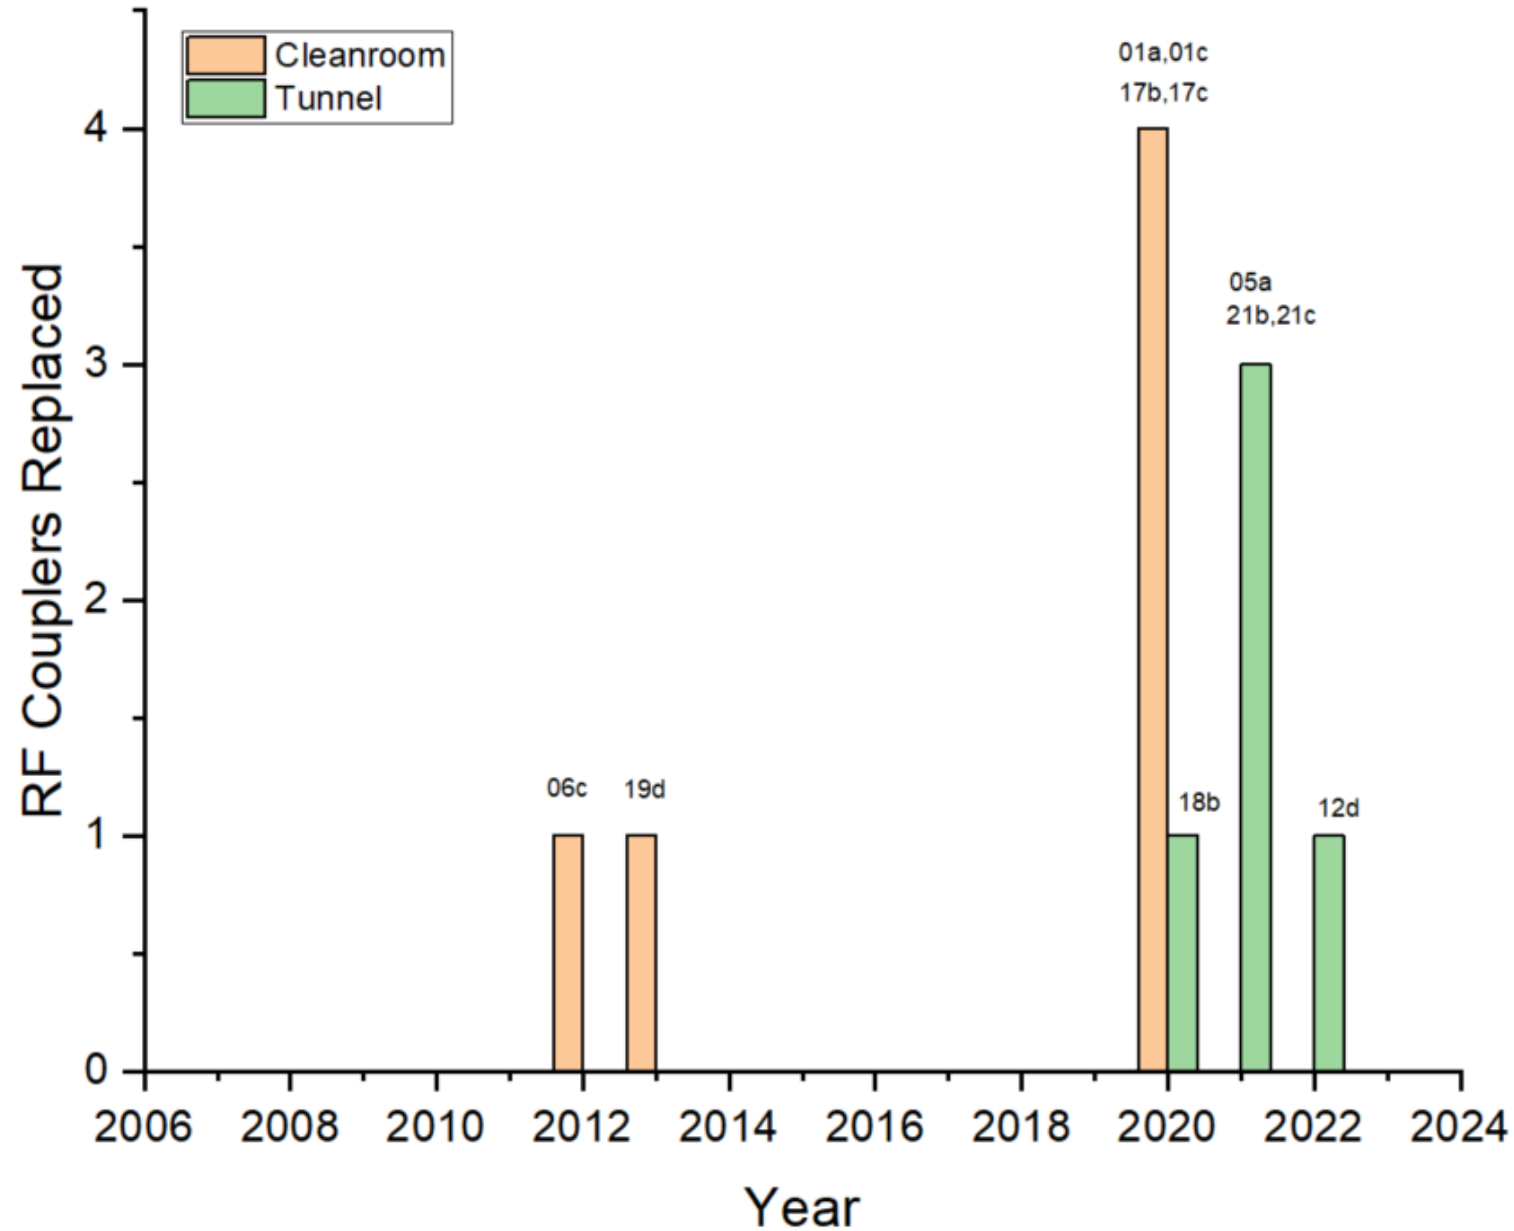
RF Couplers Replaced

A total of 11 RF couplers have been replaced due to performance since 2006

Symptom: In most cases ceramic window vacuum leak occurs which leads to repetitive RF tripping which increases in frequency over time

After removal most had $\sim e^{-7}$ Torr L/s

8 had Leak locations identified, all were under outer diameter choke joint at or near the braze joint

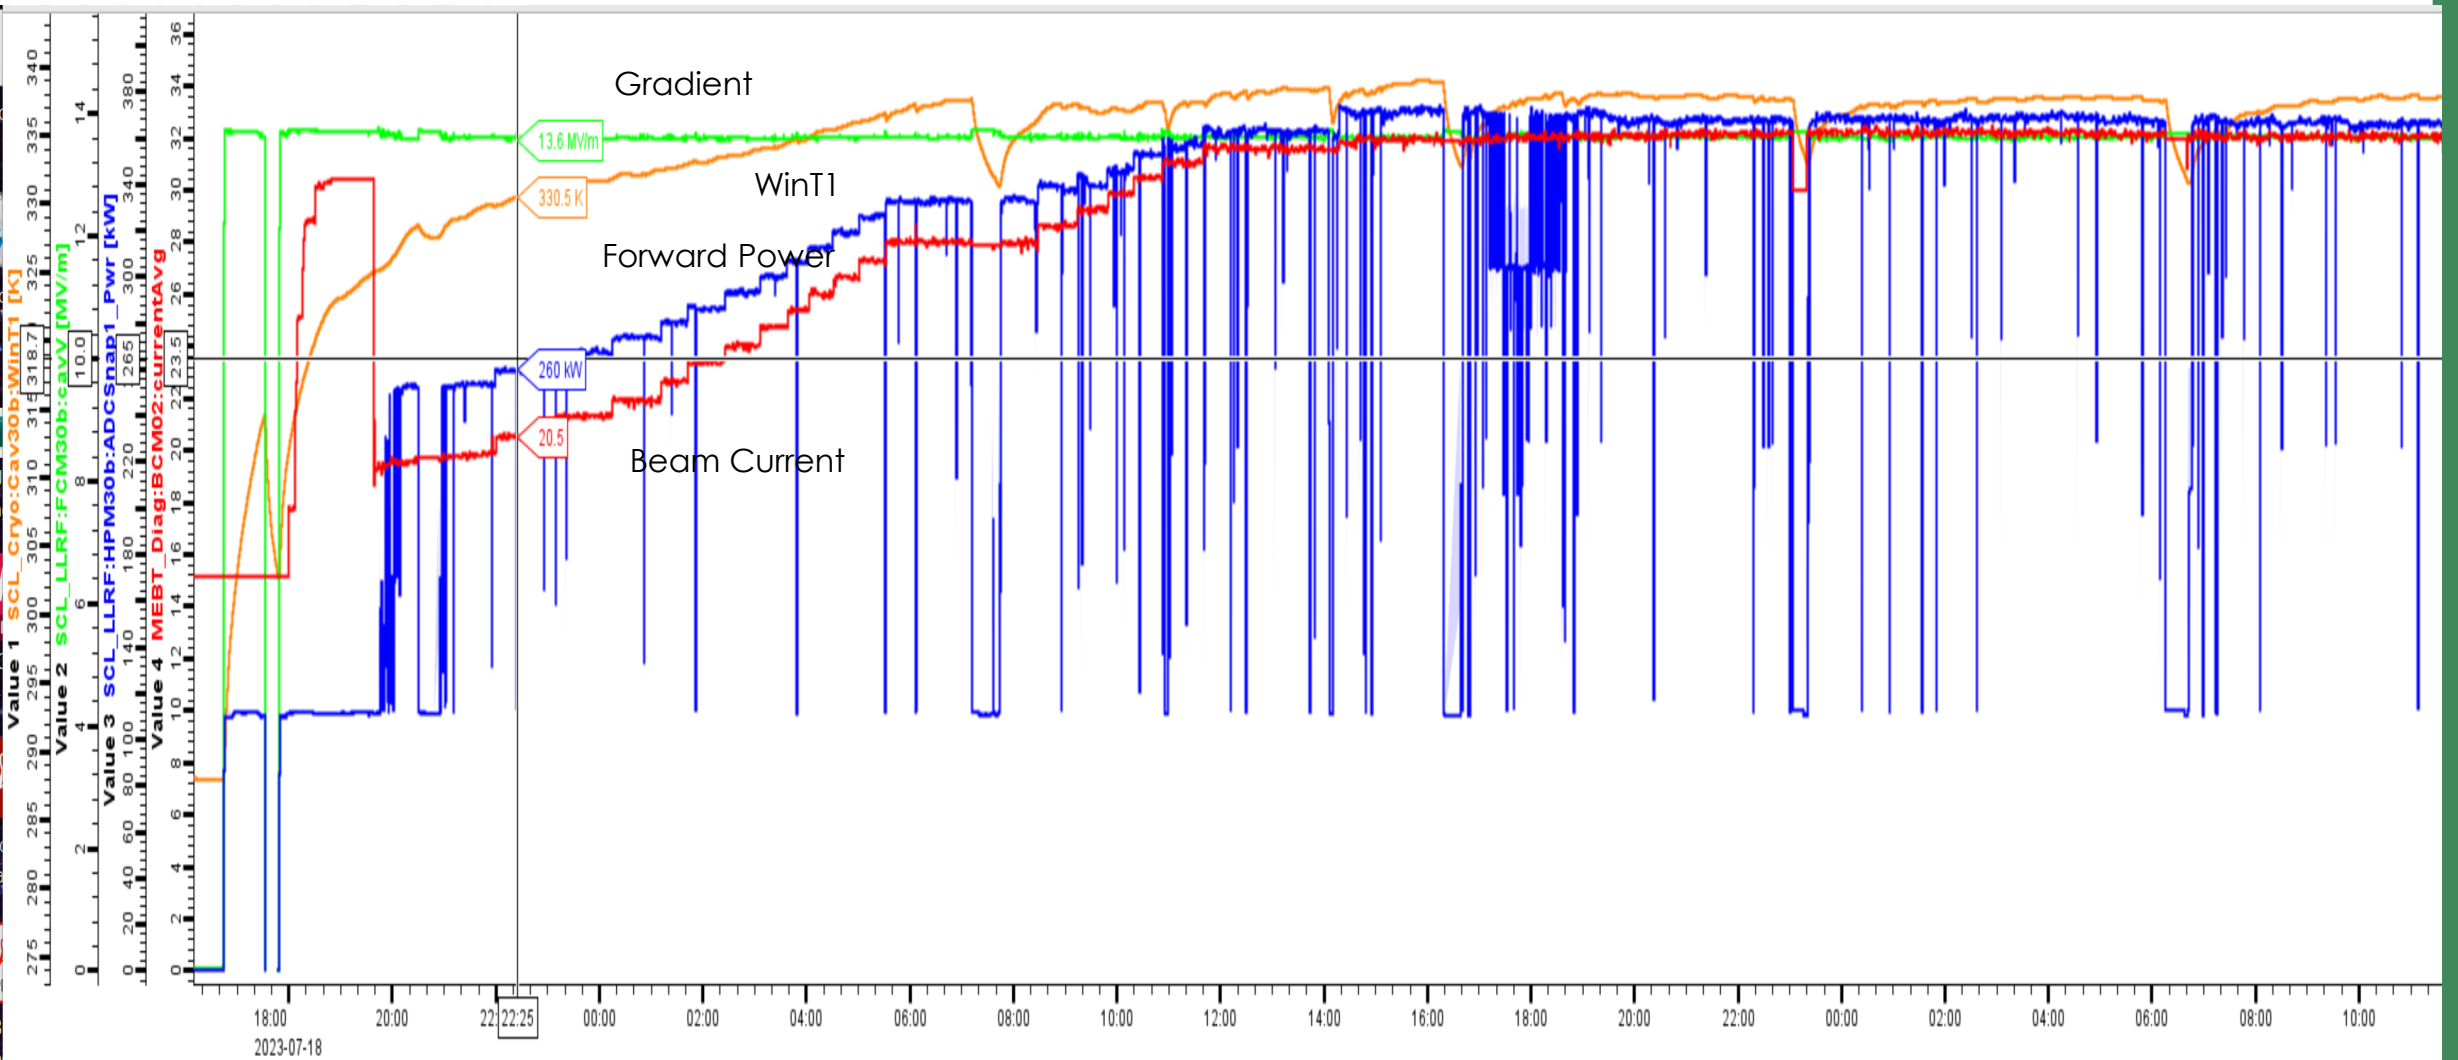
30b beam current ramp

- During RF Conditioning of the RF couplers ceramic temperatures would depend on the position standing wave
- Once installed in the tunnel several cavities became limited by the RF coupler ceramic temperature 30b and 32b were the highest
- Since installation and two run periods CM32 was warmed up to repair a tuner and after that the RF coupler temperature has seemed to recover to a much lower value
