WP4-RFD/SPS– NCR and repair action for FPC 1 & FPC 2

18th of June 2024

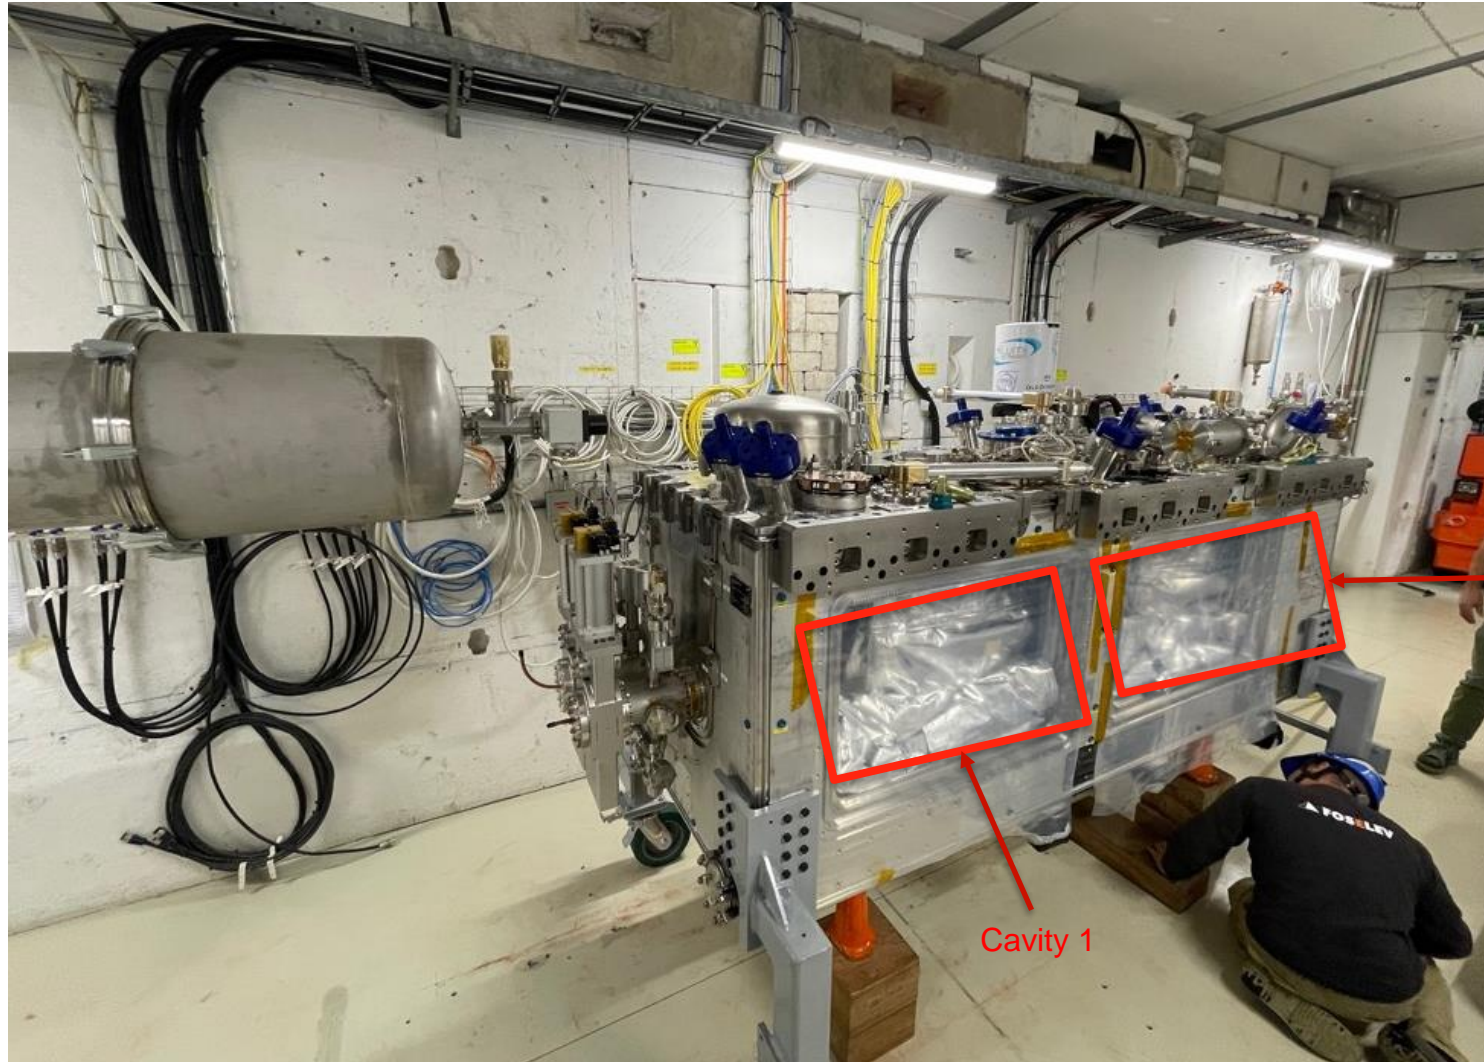
Cryomodule overview in SM18

Cavity 2

Cavity 1

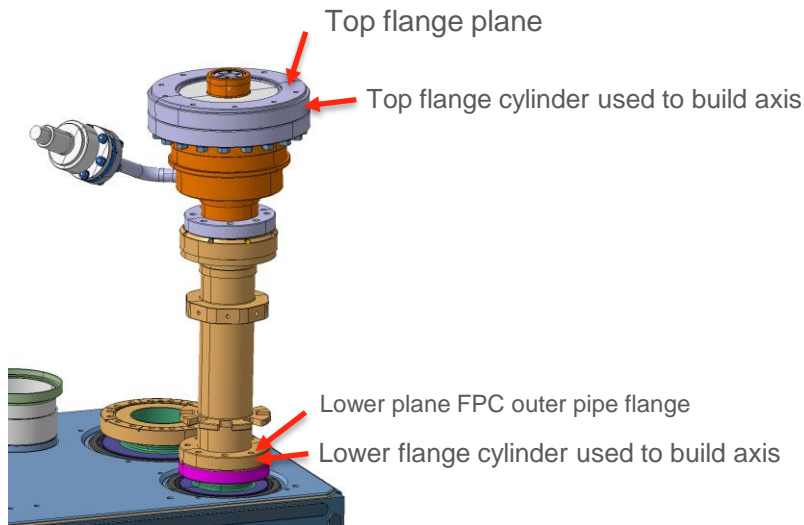
Fig .5 Measured using laser tracker – V.Rude

- A measure of both the top FPC flange and the lower FPC outer pipe flange (Plane + axis for both) show a deviation as described on the sketches below :

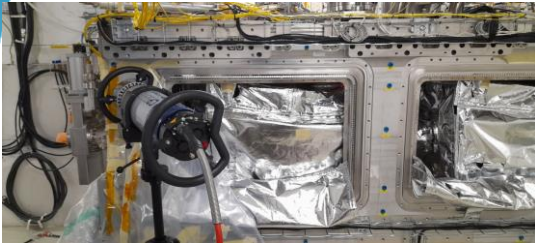
Set up preview - courtesy A.Porret

- X-ray confirms our preliminary observations :
 - The hook isn't bended
 - The deviation starts from the top

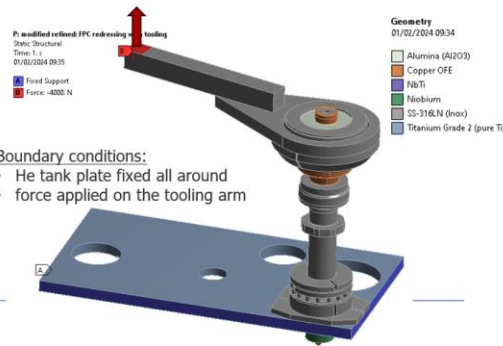
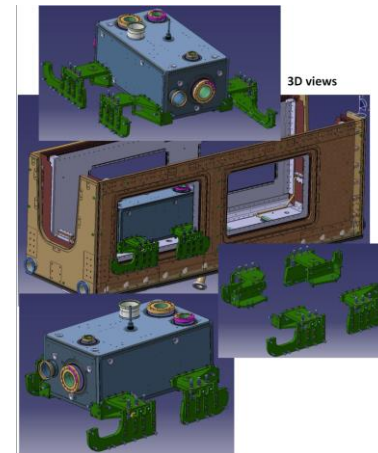
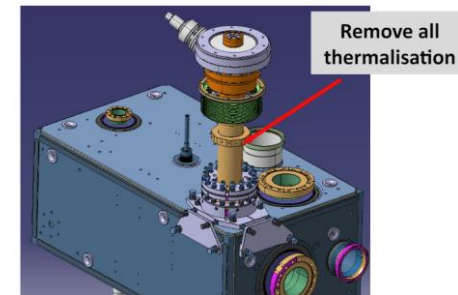
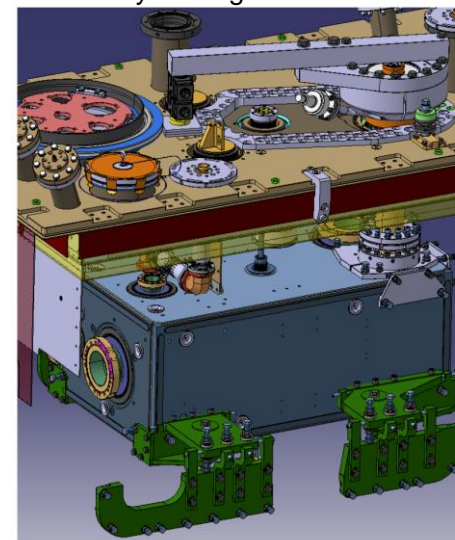
courtesy P.Mingnette

- Applying the redressing force
- Deforming copper body
- Rotating around the weakest point leading to rigid body motion of the antenna

The calculation and the design were iterative and includes the inputs from S.Barrière, Prever Loiri and SY/RF (S.Calvo, E.Montesinos)

- Following discussion and recommendations from all the experts involved (RF, manufacturing, vacuum & AI.) and considering that redressing FPC body represent a risk of critical damage that could jeopardize cryomodule and cavities cold test K.Turaj and N.Valverde presented the following plan :
 - **1** : Cavity 2 leak repair (see details in [EDMS 3120529](#) - S.Barrière) – **EN/MME – SY/RF**
 - **2** : Cold test of the cryomodule (results presented by K.Tujaj on 12/06)
 - **3** : Cavity 1 redressing (see [EDMS 3120529](#) - S.Barrière) – **EN/MME – SY/RF**
 - **4** : Cold test of the cryomodule
- Leak closure on FPC cavity #2 was performed successfully and cold test were possible operating only cavity #2
- FPC Cavity #1 repair started on Monday 17th of june and is expected to be finished by the end of the summer for cold test in spetember
