UiO ITK Status: Assembly of R0 Triplets

ATLAS Upgrade meeting in Oslo

25th June, 2024

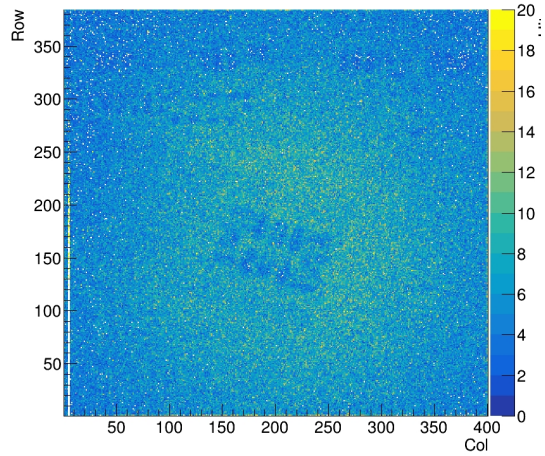
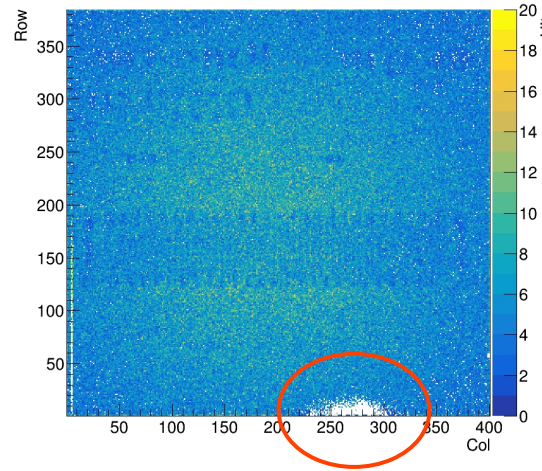
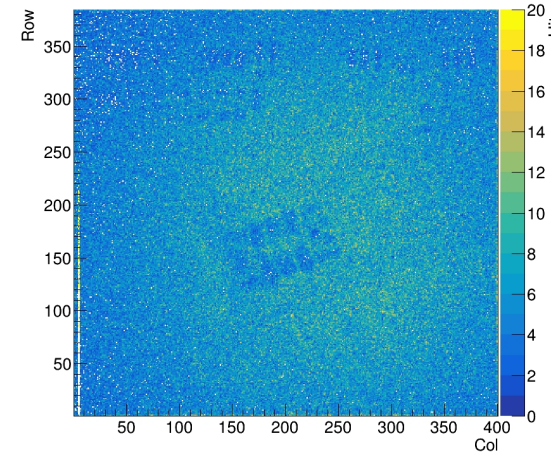
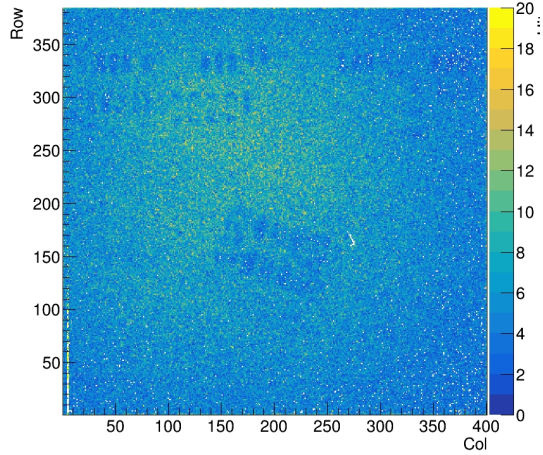
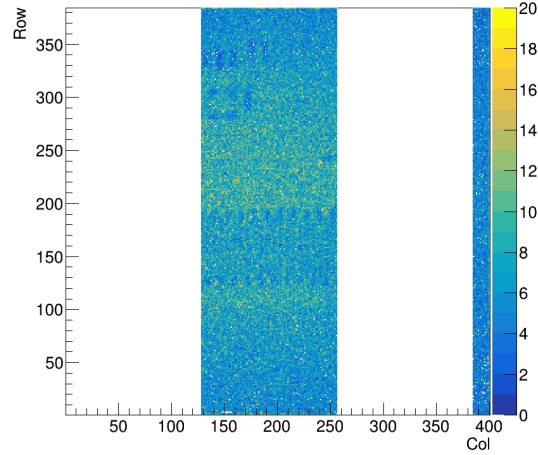
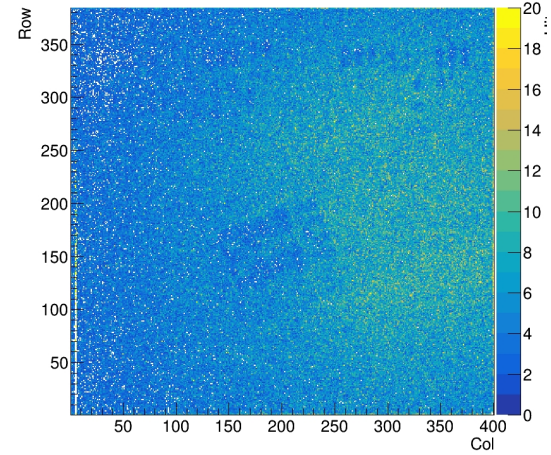
Had to run YARR scans and tunes for chips 1 and 3 separately from 2.
Still have errors if run all three chips enabled even after tuning (scans work, if disable chip 2 or enable only chip 2).

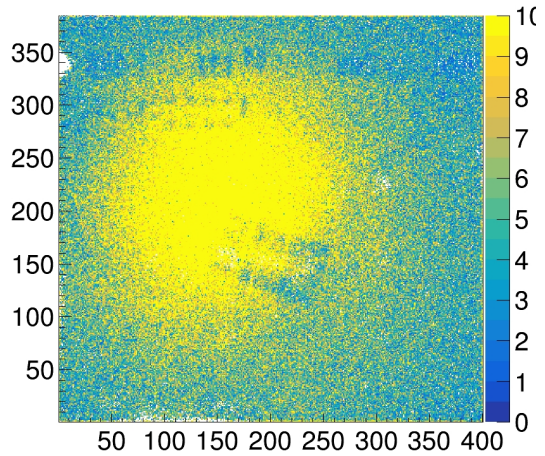
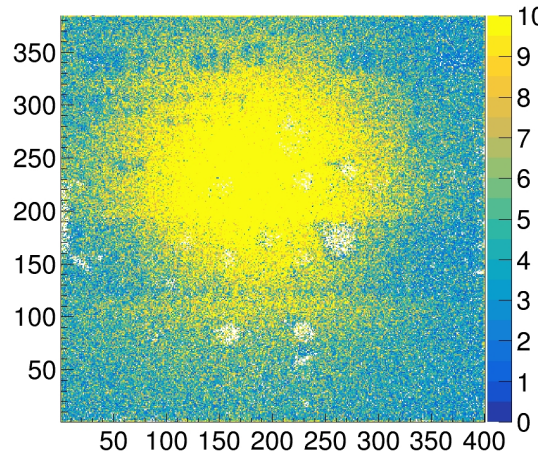
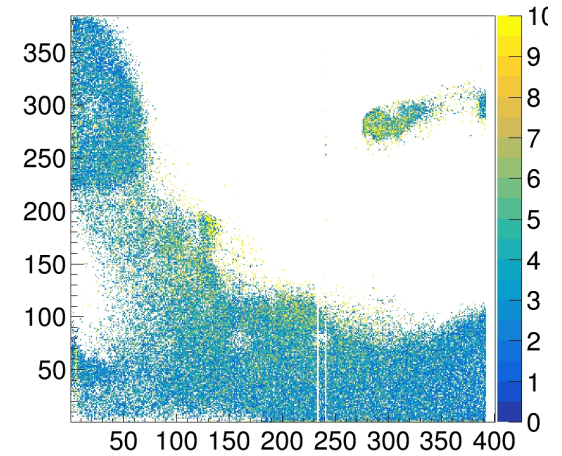
Chips 1 started coming apart during wire bonding, had to use some glue.

Could not run source scan for long due to errors.
