Status of MBRD series production

S. Farinon INFN - Genova

Zoom Meeting – May 22nd, 2024

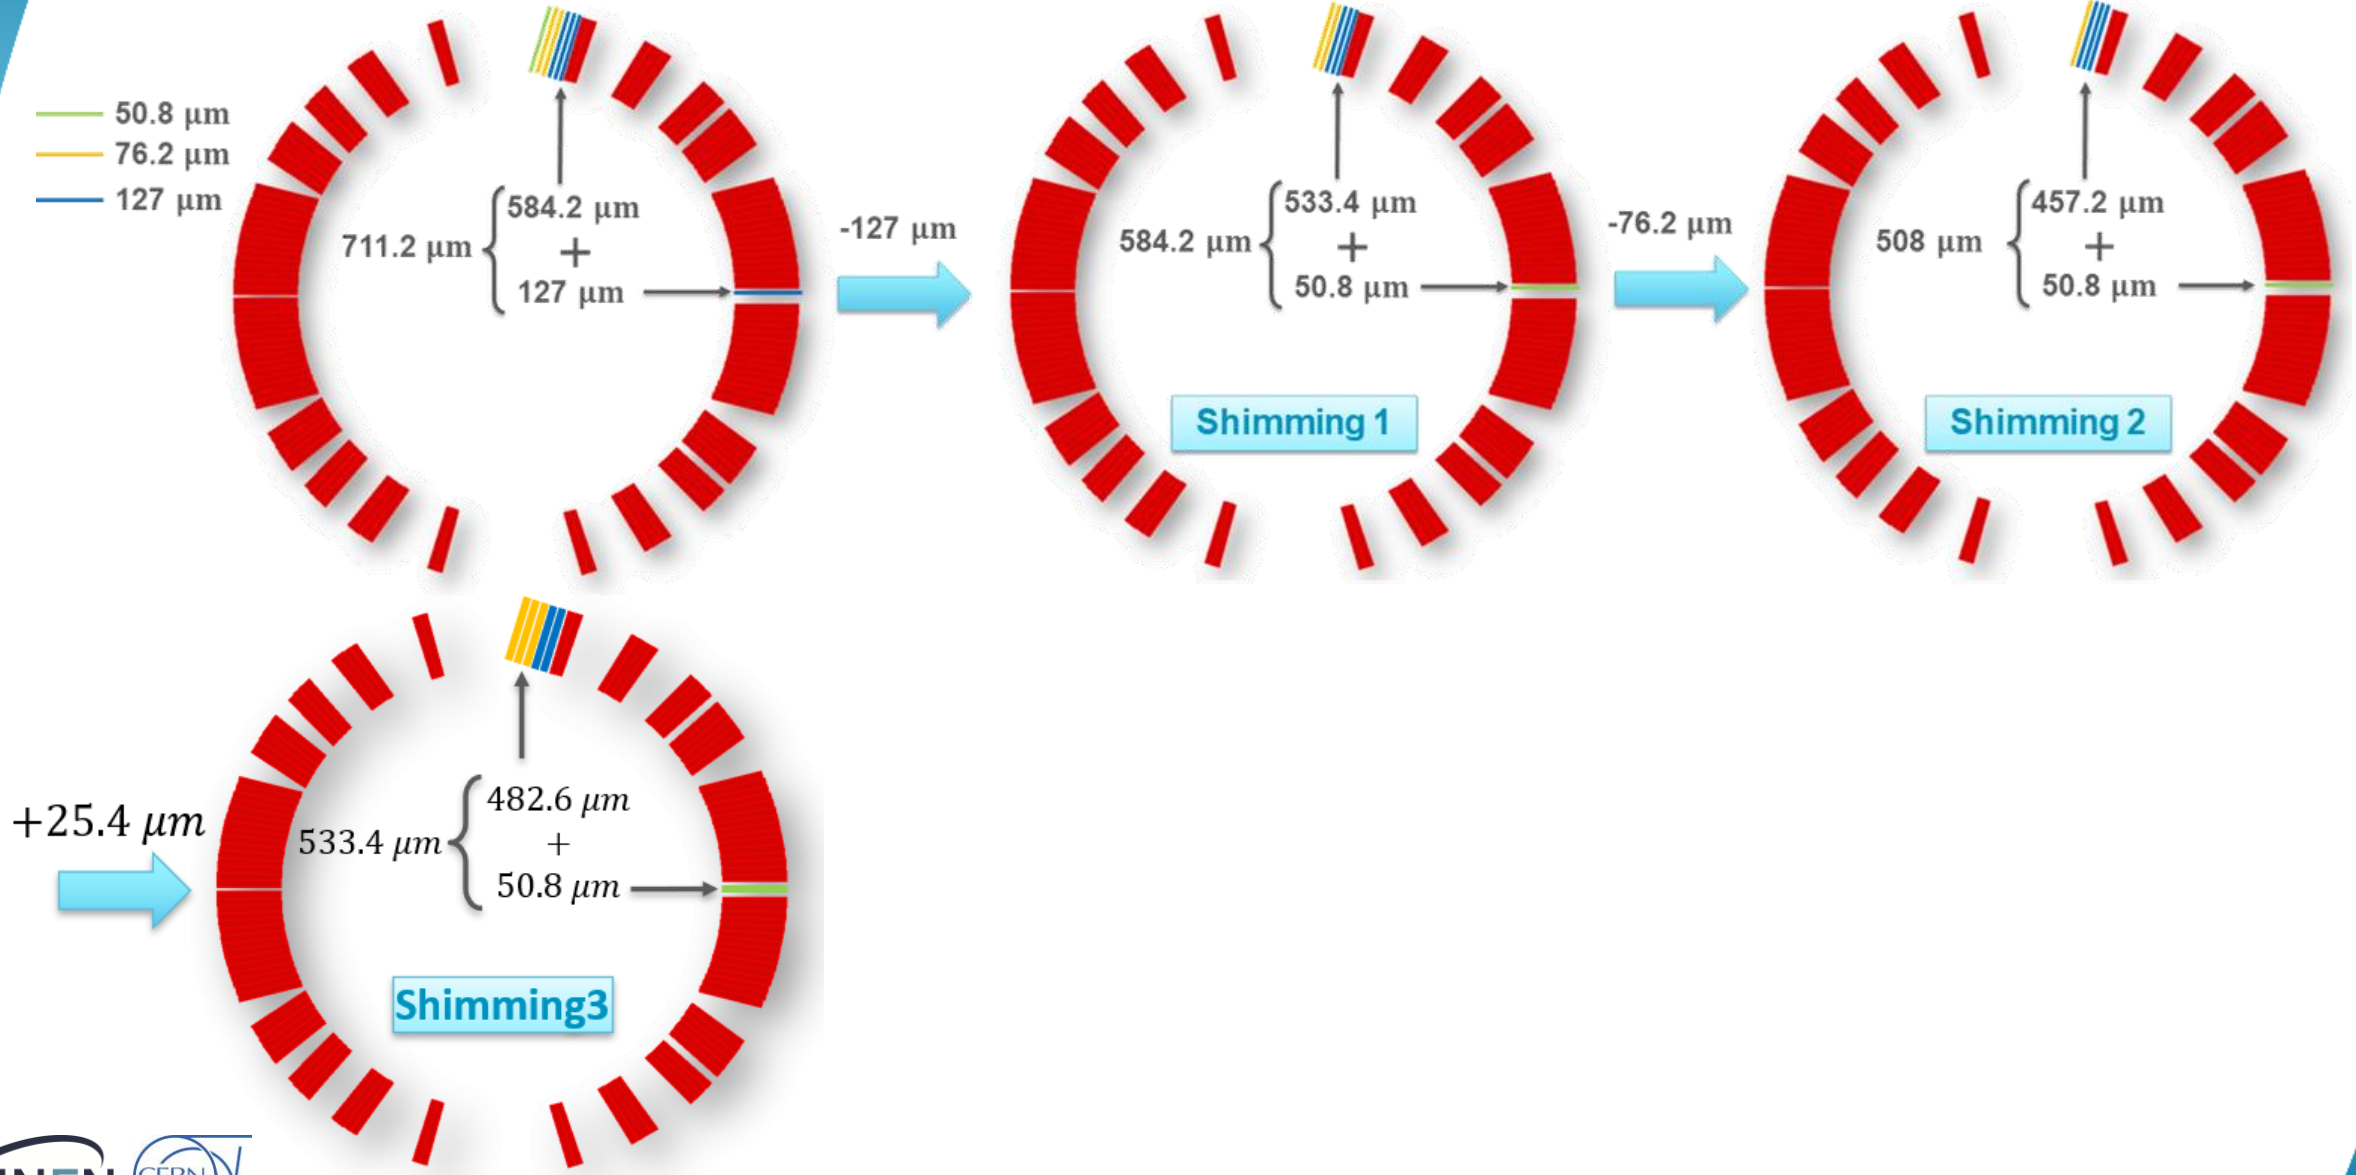
SHIMMING SCHEMES

- The winding and curing of all the 24 coils has been completed.
- There are 2 issues:
 - Insulation damage in the coil ends
 - Excess coil dimension in 4 coils
 - The issue is that we do not have the necessary margin with the available shimming sheets to accommodate the largest coils while maintaining the nominal field quality.
 - Our initial proposal to the beam dynamics team was to couple the coils in such a way that all issues would be confined to the last magnet, which would be tagged as a spare.
 - However, this proposal was not accepted. We are now developing a new proposal that distributes the issues among the magnets to ensure they are as similar as possible. It will be ready in 2 weeks from now.
