MQXFB coil fabrication

for the MQXFB coil production & QA team

14th HL-LHC Collaboration Meeting
07 - 10 October 2024

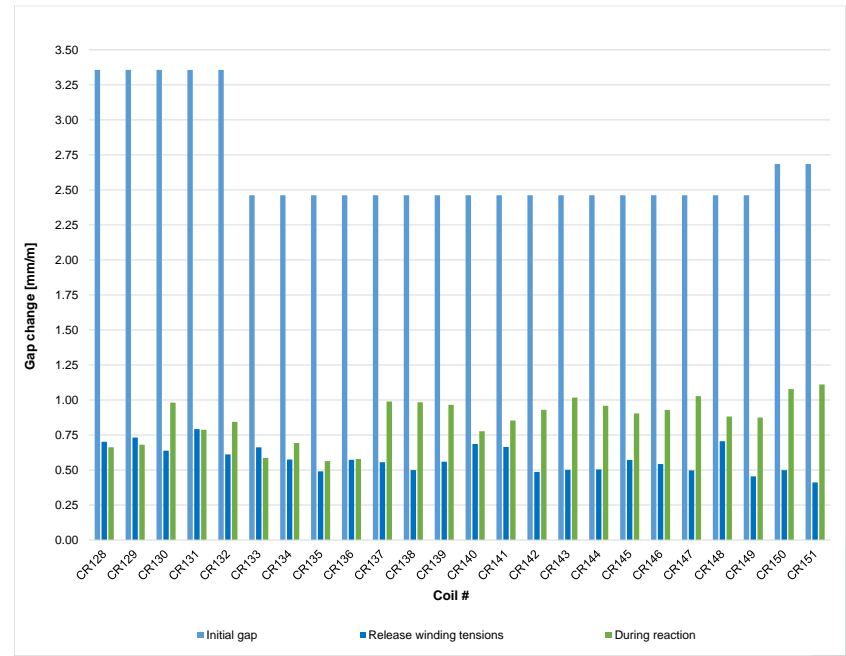
Measurables: pole gap

- Pole gaps are set to avoid tensioning the Nb₃Sn sub-elements during the coil fabrication process
- Since new generation coils
 - Pole gap was modified: 3.4 mm/m → 2.5 mm/m → 2.7 mm/m
 - Different pole gap change along the process
 - At CERN the winding tension is lower w.r.t. MQXFA coils
 - 19 kg in the straight part and 7 kg in the ends (MQXFB coils with binder on both layers)
 - New generation MQXFB coils:
 - IL → 19 kg in the straight part and 7 kg in the ends
 - OL → 14 kg in the straight part and 7 kg in the ends

Pole gap change [mm/m]	Release of the winding tension		Reaction heat treatment	
	avg	σ	avg	σ
MQXFA coils	1.39	/	1.14	/
MQXFB coils w/ binder (20 coils)	0.68	0.13	1.00	0.15
MQXFB coils new generation (25 coils)	0.59	0.11	0.84	0.18

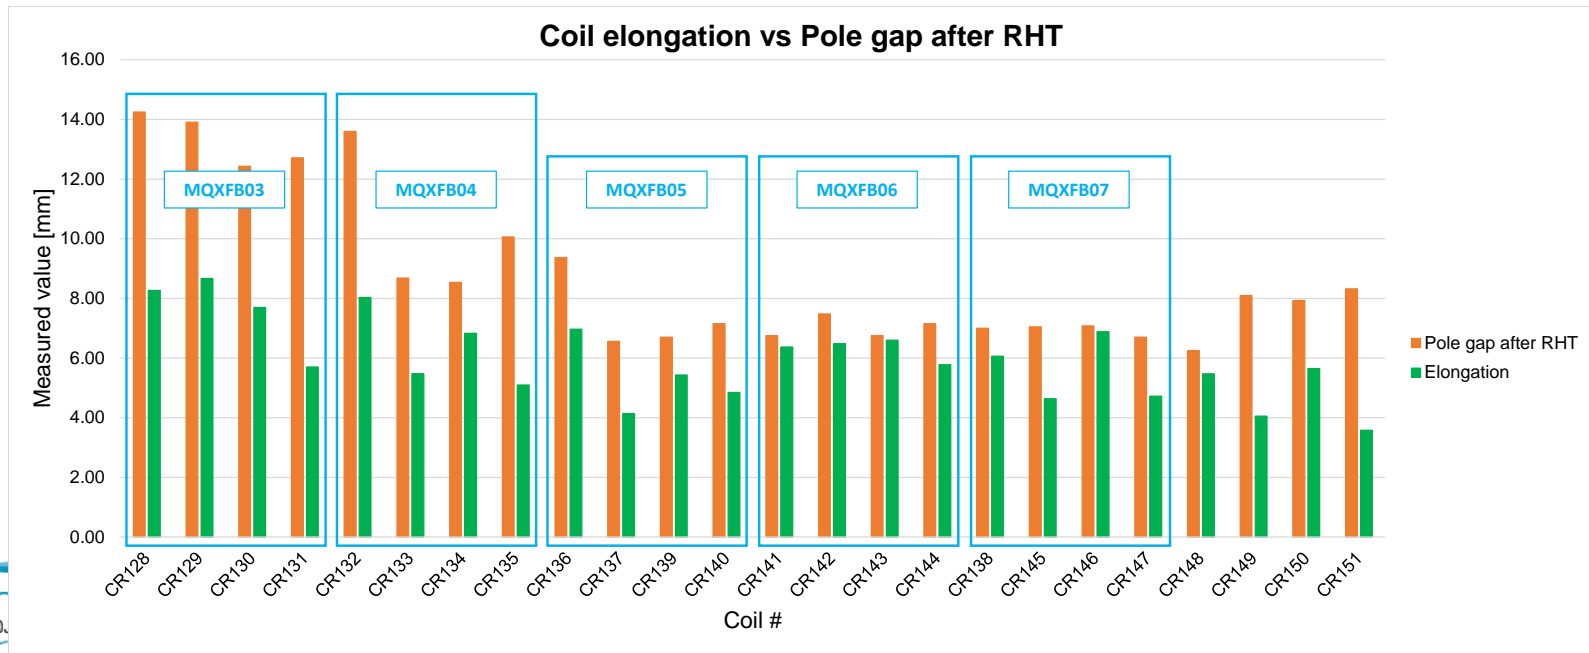
Measurables: coil elongation after RHT

- The reacted coil gradually elongates on both ends during the mold opening
- Pole gap increases during the opening ([indico 1220226](#))

Coil #	Total /L _m [%]	Manufacturing line
CR127	1.50	CERN w/ binder
CR128 – CR151	0.83	CERN new gen. coils
AUP 146 – 147	0.89	FNAL
AUP 237 – 238	0.88	BNL

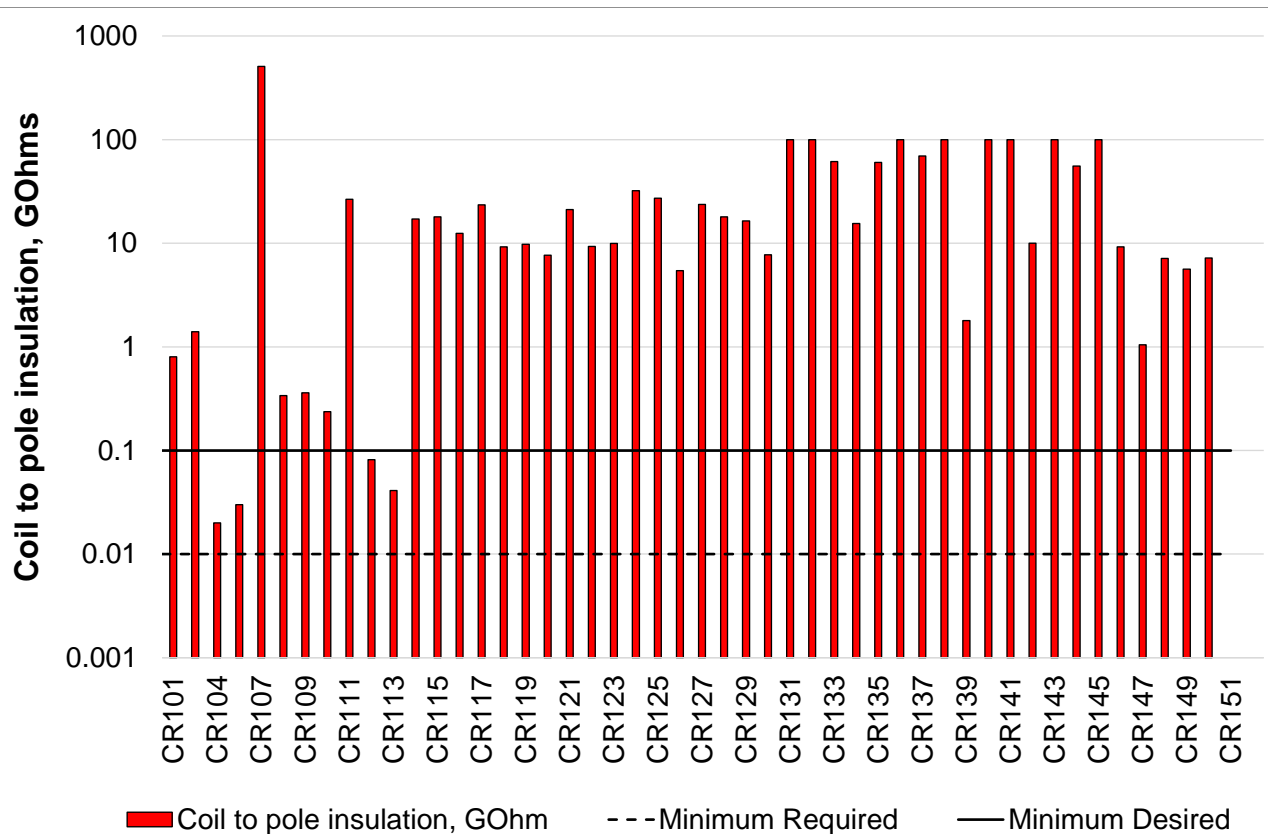
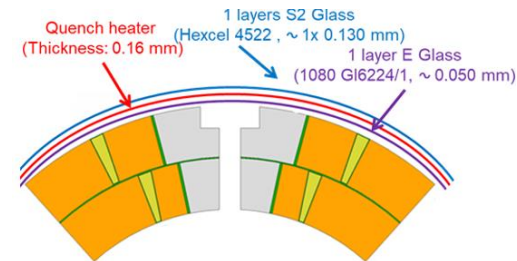
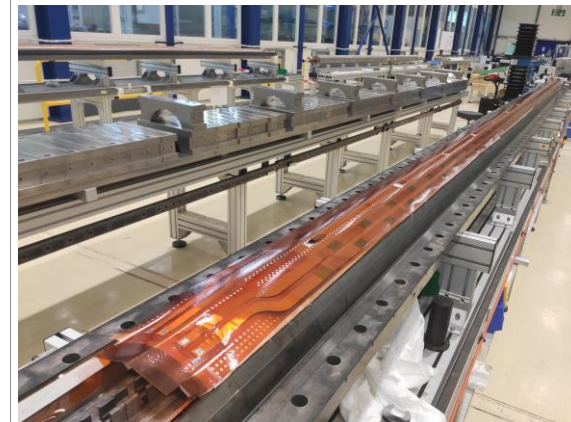
Measurables: electrical robustness

- Since coil CR114, coil to pole insulation always above the minimum desired
 - Use of heat cleaned S2 glass around poles
 - Reduction of ceramic binder amount close to the poles

- QH mini-swap configuration since CR126 with higher voltage qualification test ([EDMS 2646046](#))

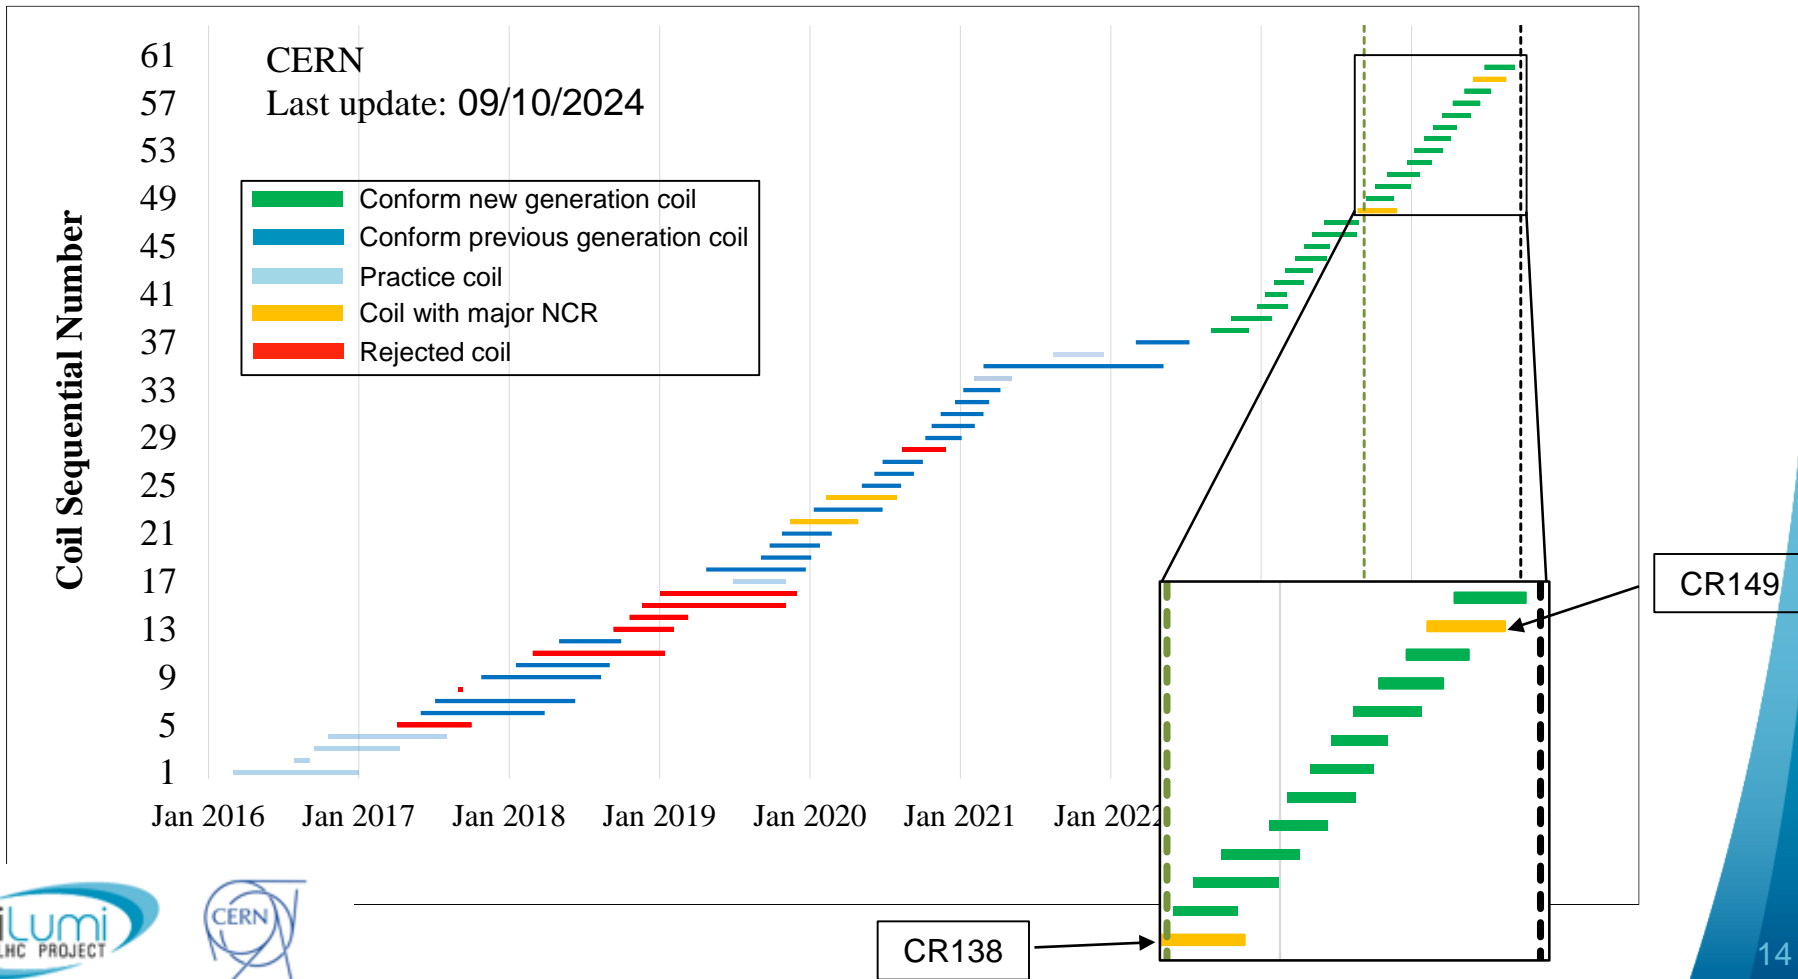
Statistic

- Over the last year of coil production, we faced two major NCRs (more details in the following slides)
 - Coil CR138, happened during the impregnation process (27/10/2023)
 - Coil CR149, discovered during the demolding post-impregnation (21/08/2024)

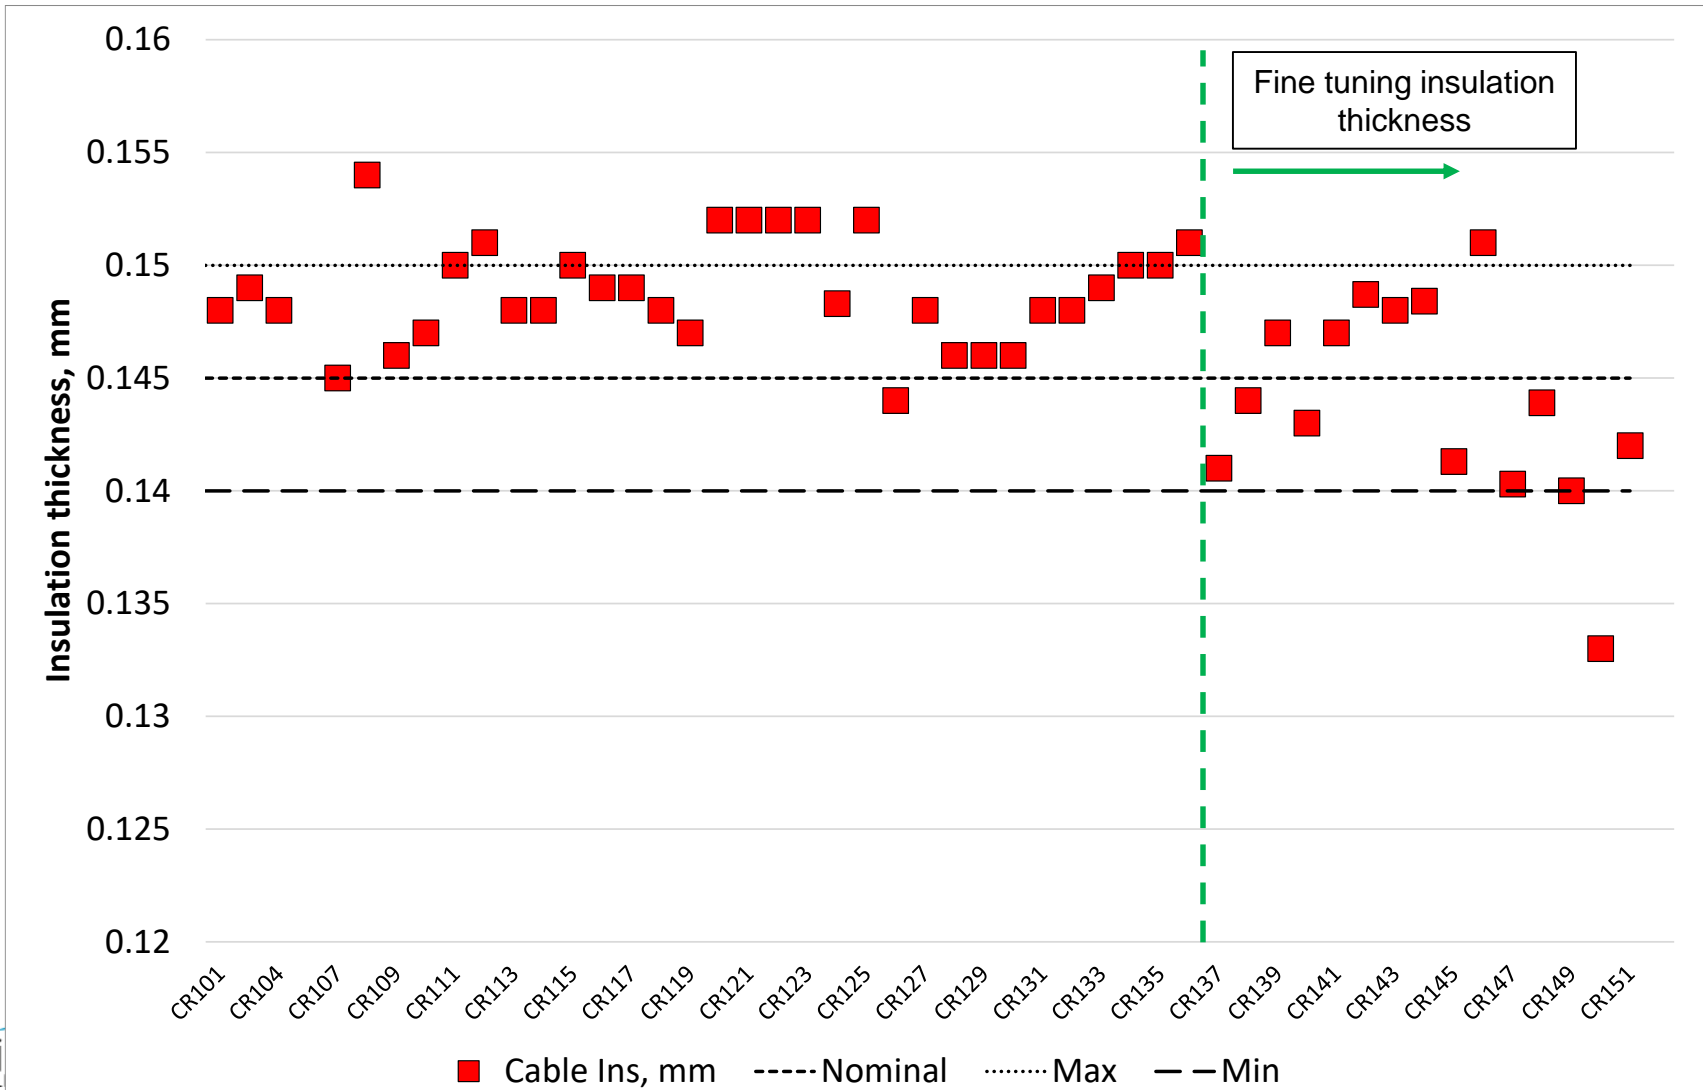
Cable insulation thickness

- Target insulation thickness is $145 \pm 5 \mu\text{m}$
 - Measured insulation systematically above target
 - Fine tuning of the insulation parameters in 2023 → well centered around $145 \mu\text{m}$
- Since then, recurrent mechanical instability → popped strands detected during the cable insulation inspection
 - Insulated cable [HCMQXFBC09-4200419A](#) (used in coil CR143)
 - Insulated cable [HCMQXFBC09-4200454A](#) (used in coil CR145)
 - Insulated cable [HCMQXFBC09-4200455A](#) (used in coil CR148)
 - Insulated cable [HCMQXFBC09-4200409A](#) (used in coil CR149)
 - Insulated cable [HCMQXFBC09-4200412A](#) (used in coil CR150)

- Target insulation thickness is $145 \pm 5 \mu\text{m}$
