RFD-SPS UK Assembly Lessons learnt & improvements

UK Contribution to WP4

*14th HL-LHC Collaboration Meeting
8th October 2024
Genoa*

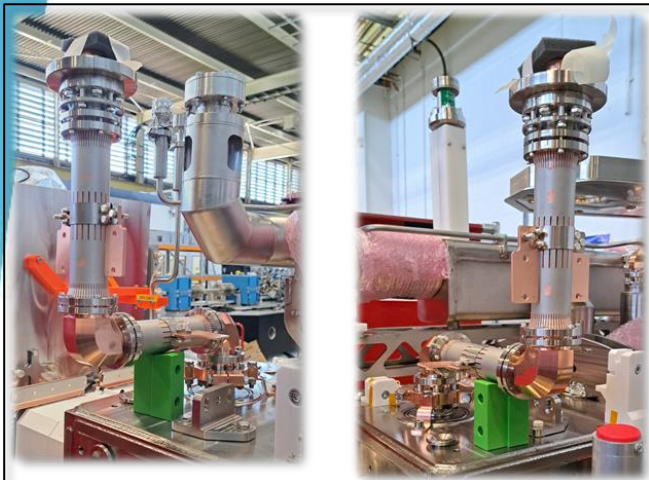
Co-axials (Step 5) installed before 50k line (Step 4) – had to be removed and reinstalled

- Back Loaded and compressed schedule – less buffer time to reflect and review
- Not following procedure led to steps backwards
- Hard Deadline for RFD-SPS to reach SM18 before Nov 2023

- DQW Series scheduled adequately for tasks to be performed

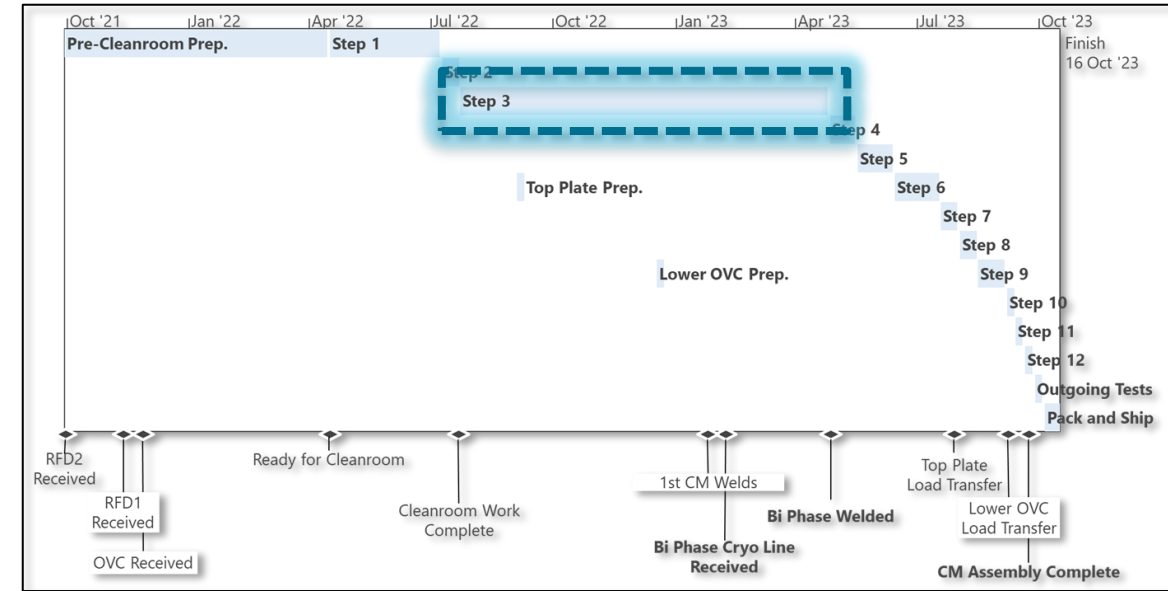
- RFD SPS Bi-phase line delivered ~12mo late
- Further delay to re-work & qualify at STFC
- Considerable effort spent to monitor & manage supplier quality

Only 1 bidder - challenging specs & requirements

- DQW Series approach involves greater engagement with suppliers earlier in the manufacturing stage.
- Maintaining strong dialogue to ensure MIPS are followed, and manufacturing issues are approached correctly and timely.
- Managing raw material procurement and free-issuing to suppliers

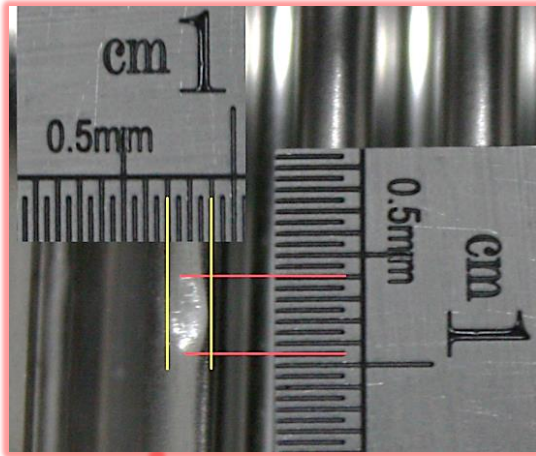
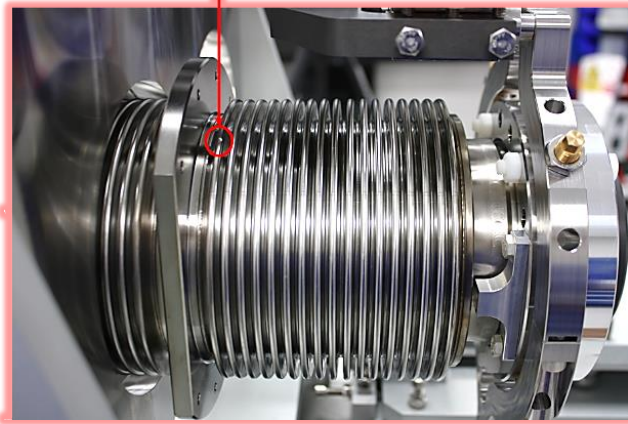
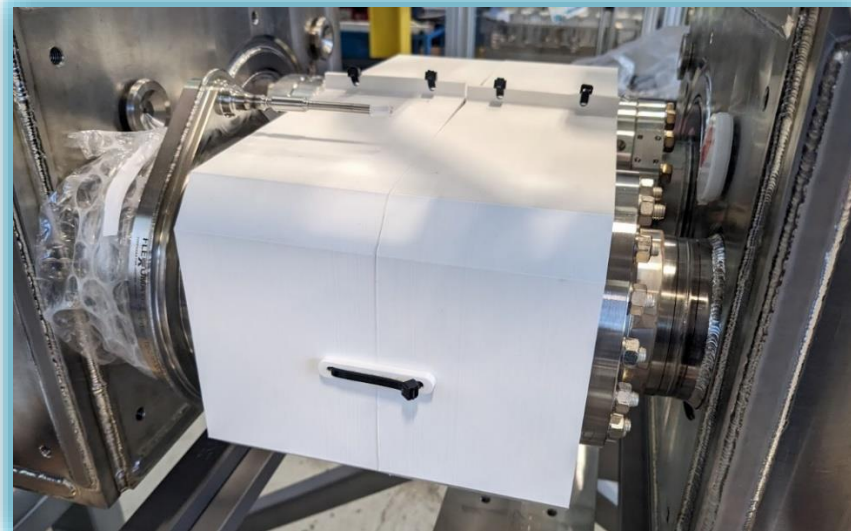
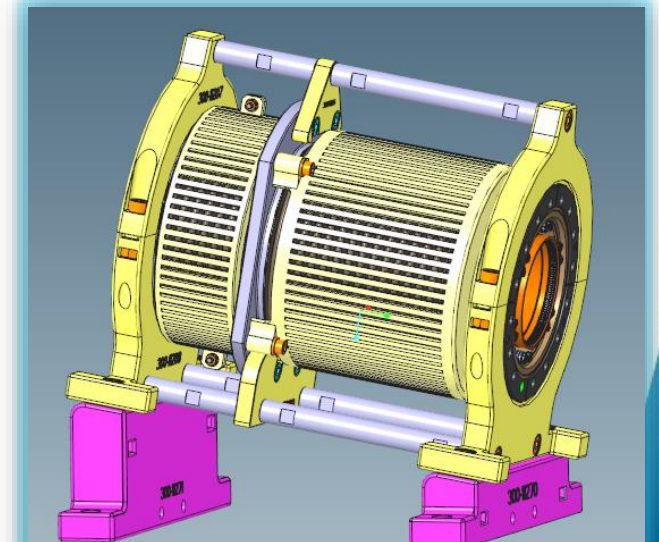
- Handling errors experienced during RFD SPS build
- Some imperfections are the result of not following procedure correctly, some from suppliers, others unknown.
- Difficult to categorically conclude when damages occurred as travellers were quite lightweight

- Bespoke covers design for DQW build for various processing and assembly steps with bellow components

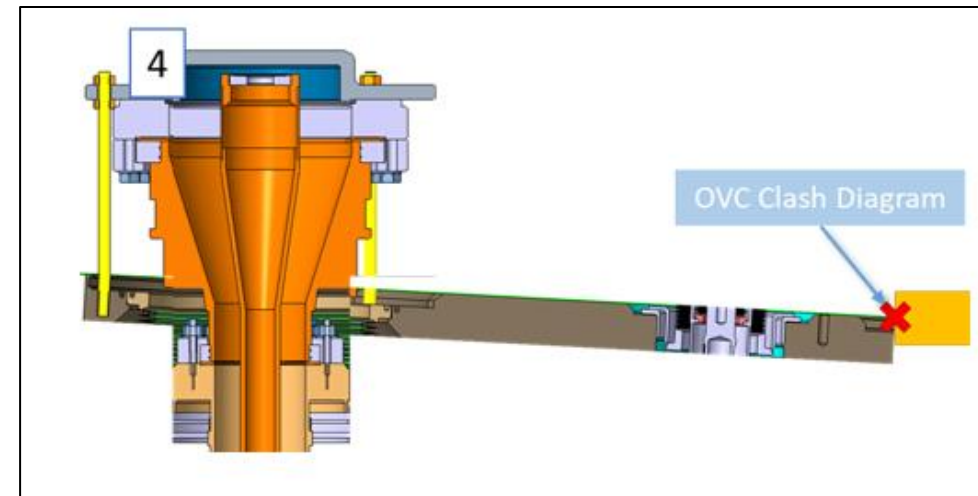
3. Correcting the plate pitch was challenging with the FPC-Plate tooling. Due to nut clash on tooling
4. Suspected OVC clash location

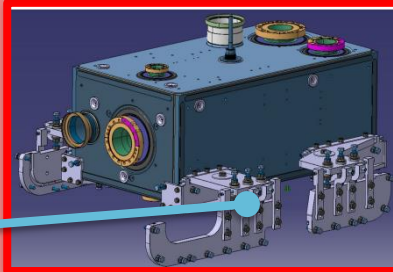
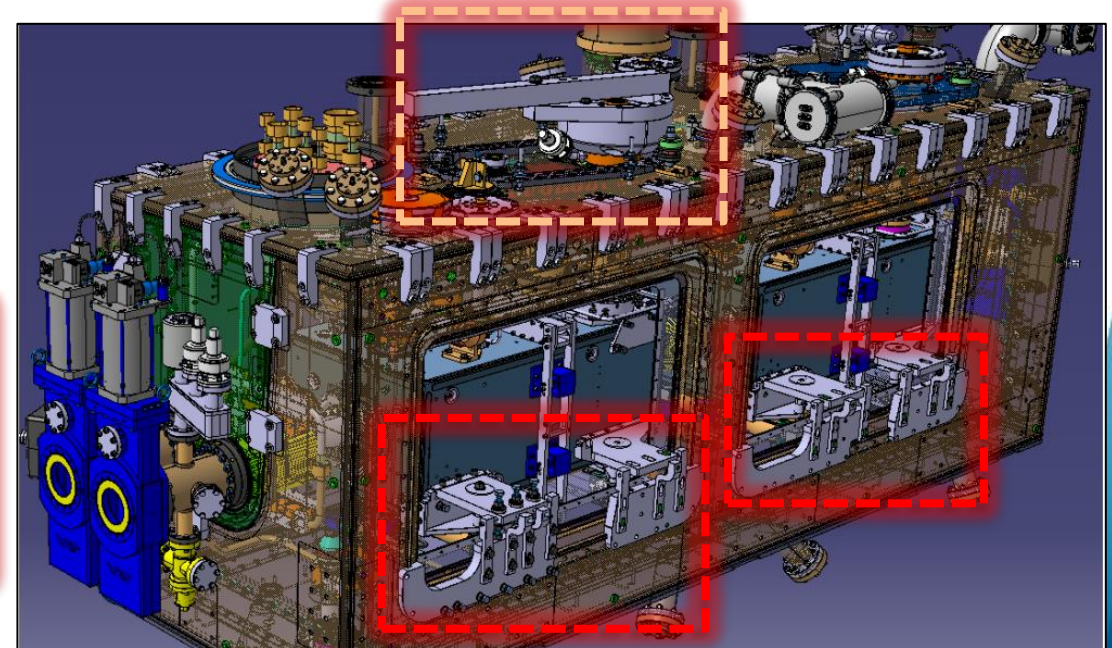
Support tooling to keep cavity in correct global position and prevent further damage

Repair solution designed & developed & implemented by CERN Team.
Challenging to design for all forces involved and account for all mechanical behaviour

Lever mechanism developed to correct hook angle
