AUP Cold Mass & Cryostat Assembly Production Challenges

HL-LHC AUP Cold Mass & Cryostat Assembly, L3/CAM

14th HL-LHC Collaboration Meeting

Genoa, Italy, October 7-10, 2024

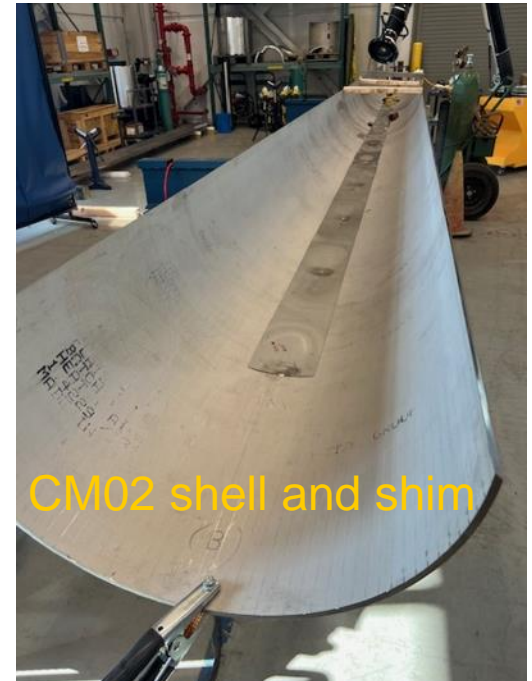
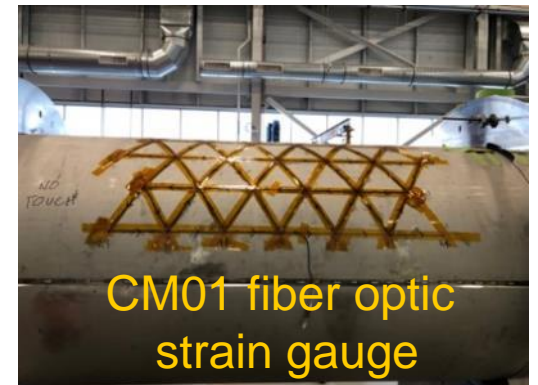
Shell Prestress Achievement

- Shell design revised to add 2 mm SS shim between shell and magnets after CM01.
 - The shim is used to reduce shell and coil pole stress increase during welding.
 - First shims used on CM02 and were flat. Subsequent shims were rolled for ease of welding.
 - Fiber optic strain gauge measurements showed shell stress reduction of 10 Mpa between CM01 and CM02.*
