MQXFB07 Coils: Coil fabrication, manufacturing data and NC

N. Lusa, S. Izquierdo Bermudez, L. Baudin, A. Vieitez Suarez, J. Axensalva,
P. M. Quassolo, L. Grand-Clement, R. Berthet, O. Housiaux,

11/07/2024

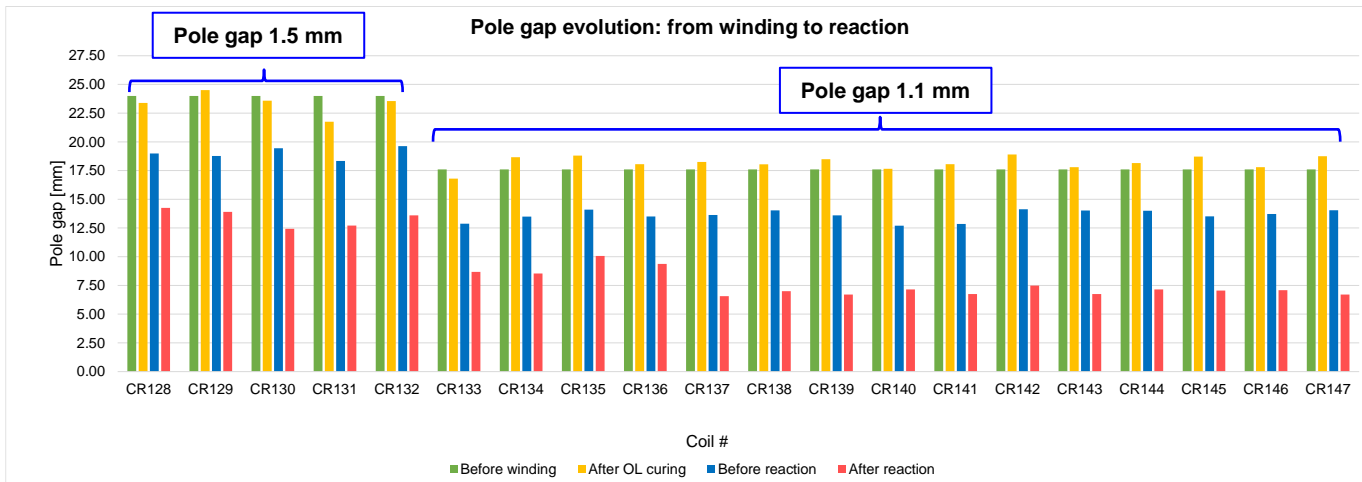
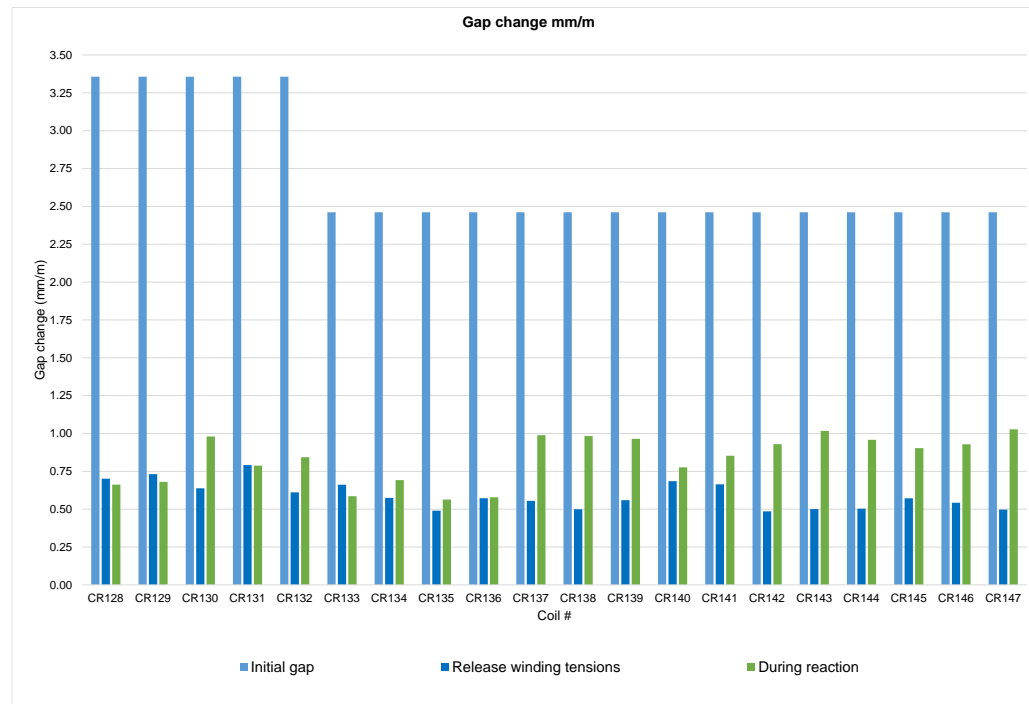
Pole gaps

In the latest coils (CR127-CR144), pole gaps in the middle of the coil are not closed after reaction, as it is the case for AUP coils (see additional slides)

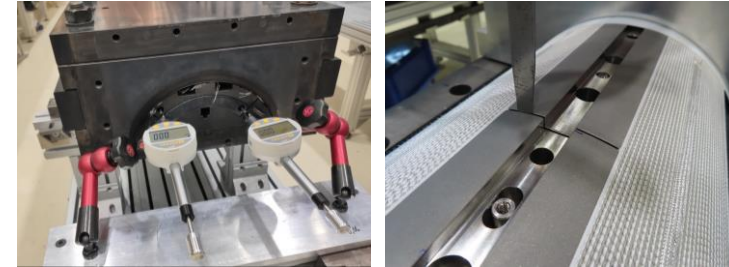
- To avoid tensioning the SC cable, the total pole gap must be higher than the coil elongation
 - The plotted total pole gap correspond to minimum value (feeler gauge measurement, precision 0.05 mm)
 - The coil elongation measurement is done using dial gauges (much more precise, precision 0.01 mm)
- Pole gap will be increased in the next CR150

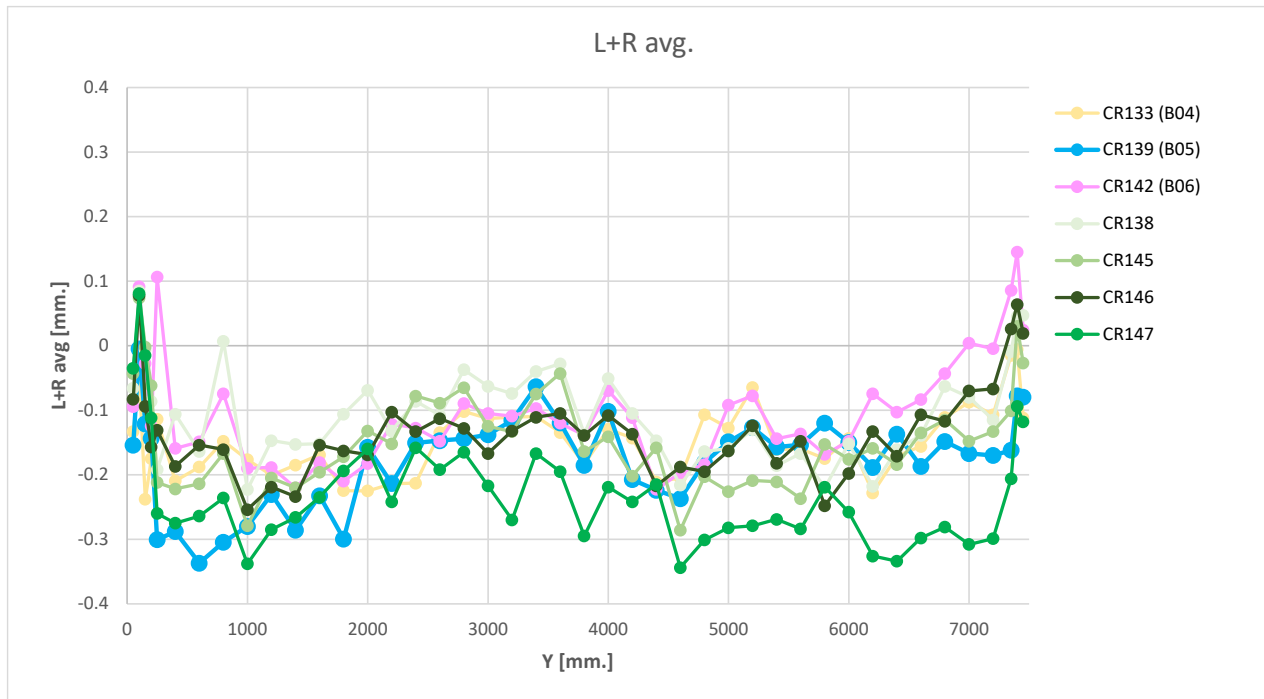
Impregnated coil geometry (Faro arm)

- Systematic behavior in terms of coil shape to previous coils without binder: mid-plane has a little 'wedge' (the coil covers 89.6 degrees instead of 90 degrees)
- Based on FEM we expect ≈ 15 MPa increase in the mid-plane stress (inner edge) under conservative assumptions, confirmed with a mock-up test, see <https://indico.cern.ch/event/1260584/>

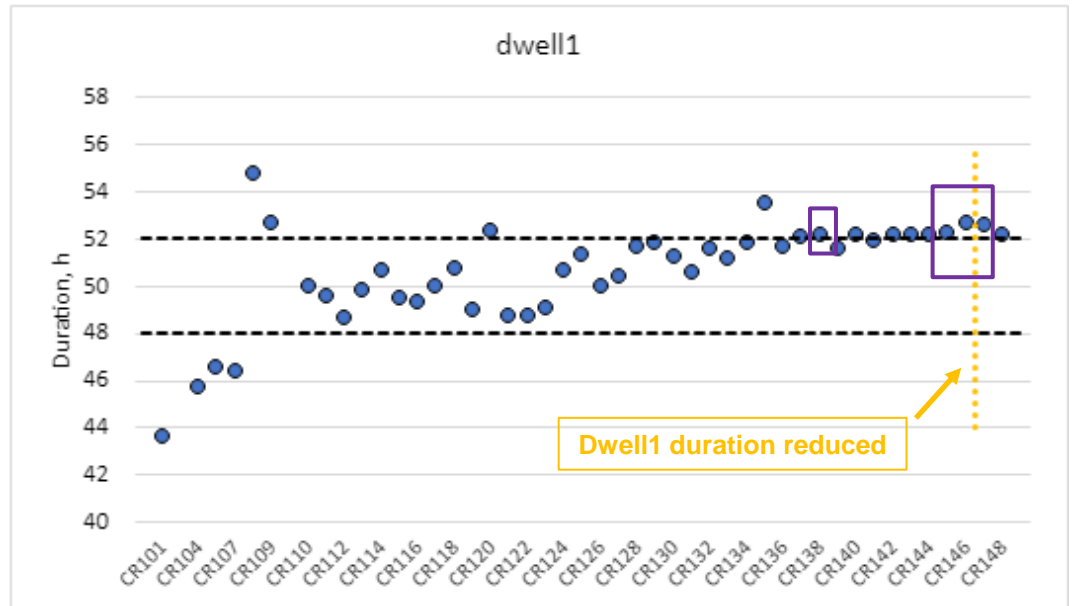
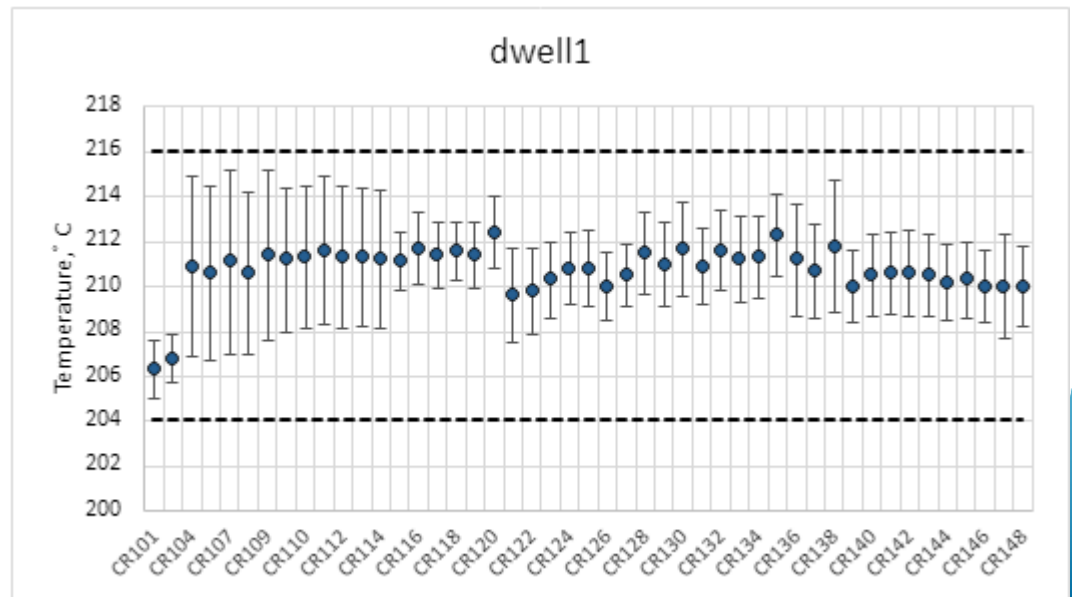
RHT NCR – dwell1

- The duration of dwell1 is out of specification in all the 4 coils:
 - CR138: 52.09 h
 - CR145: 52.17 h
 - CR146: 52.61 h
 - CR147: 52.53 h
 - Spec. 52 h maximum allowed
- Temperature homogeneity within specification

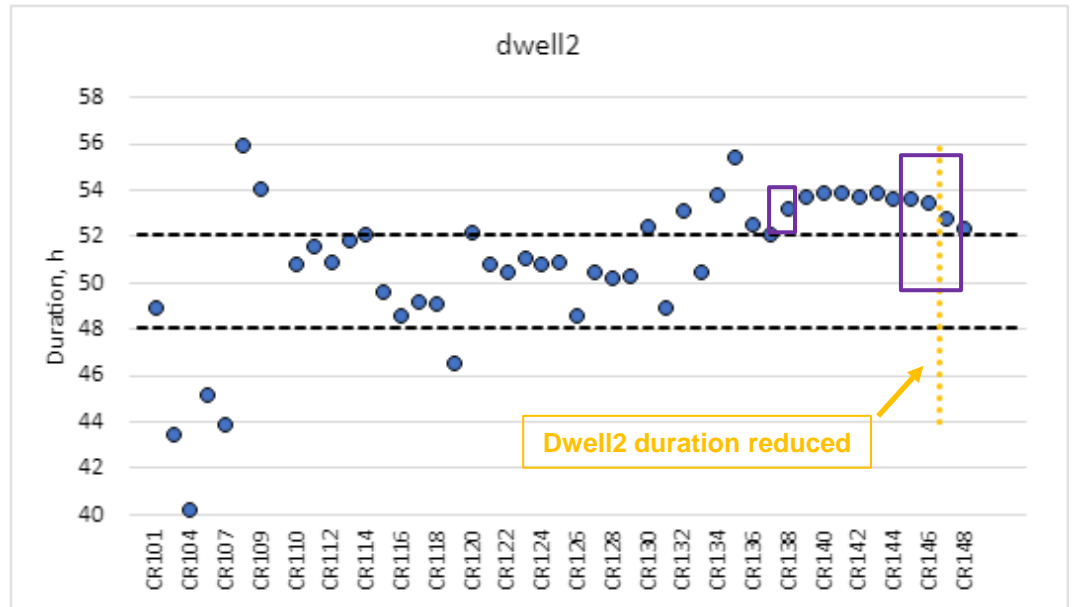
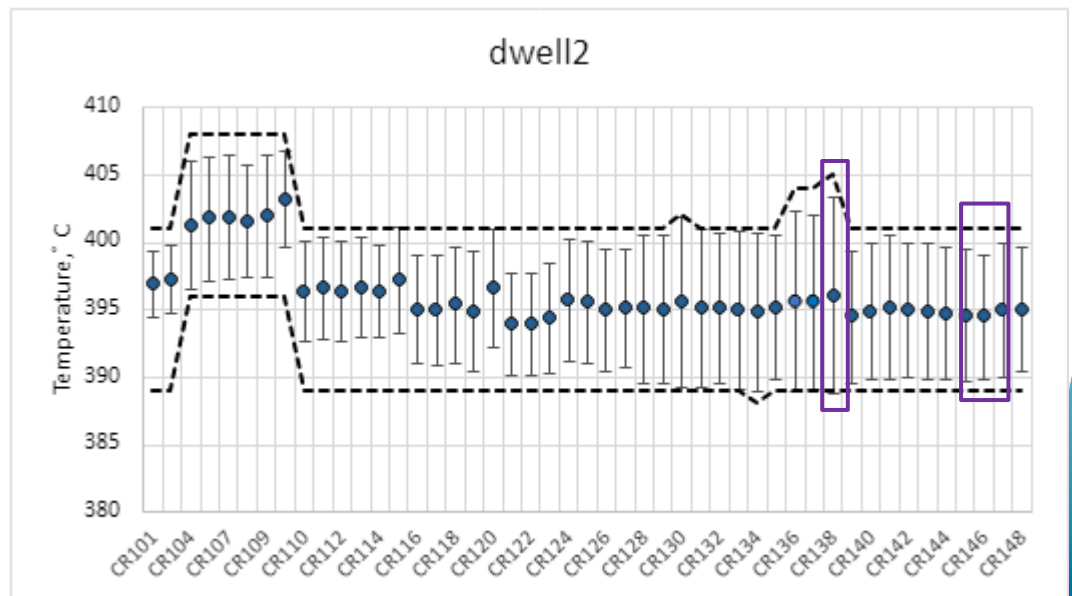
RHT NCR – dwell2

- The duration of dwell2 is out of specification in all the 4 coils:
 - CR138: 53.09 h
 - CR145: 53.54 h
 - CR146: 53.38 h
 - CR147: 52.67 h
 - Spec. 52 h maximum allowed

- In coil CR138 (previously in CR136 and CR137) the upper band of the plateau had to be increased from 401°C to 404°C
 - TCs close to the RE of the mould were warmer
 - Furnace intervention after CR138 RHT (see next slides)

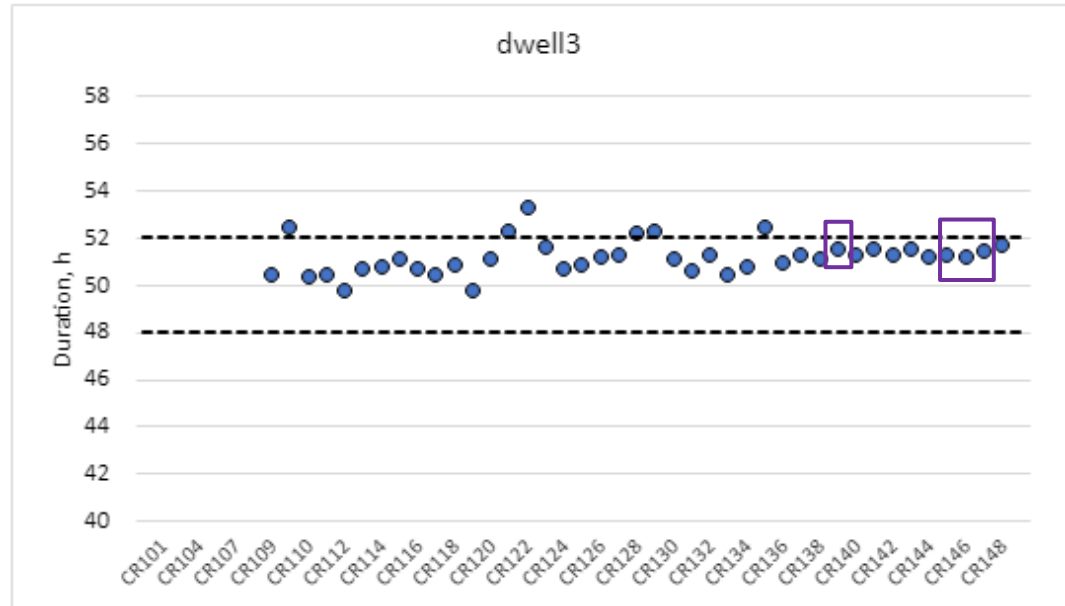
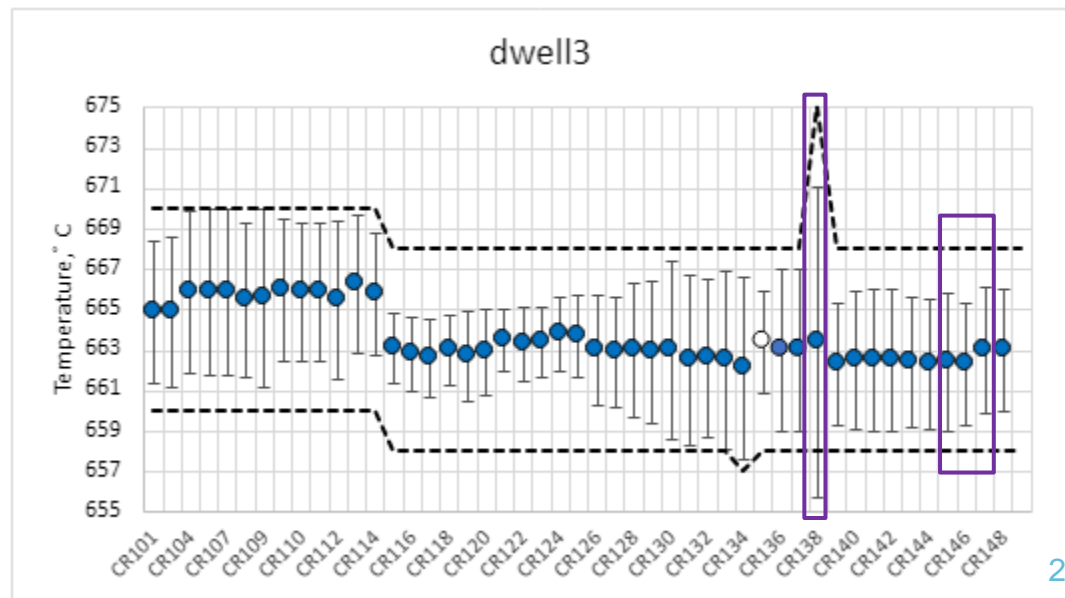
RHT NCR – dwell3

- The duration of dwell3 is within specification for the 4 coils (52 h max. allowed)
- In CR138, 3 TCs were out of range (TT17, TT19 and TT37)
 - Max. temperature measured: 675°C
 - Max. temperature allowed: 668°C
 - Root cause analysis pointed to the melting of the fuse 3F6
 - [NCR 2962606](#) and [NCR 2961736](#)
- Dwell3 mean H/2 out of spec
 - CR138: 7.7°C
 - CR145: 3.4°C
 - CR146: 3°C
 - CR147: 3.1°C
 - Spec. 3°C maximum allowed

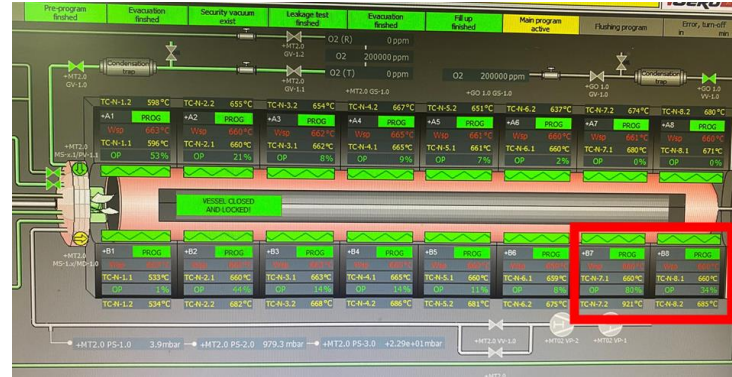
CR138 (NCR 2962606) → Furnace intervention

- The furnace has several heating zones along the length
 - A1-B1: LE of the mould (door)
 - A8-B8: RE of the mould

- During the 3rd plateau, issue in B7 zone which was not regulating correctly the temperature
 - Adjacent heating zones B6 and B8 provide more heat flow so the temperature increased above the target
- Root cause analysis showed a B7 zone fuse heavily damaged which was then replaced
 - Electrical check of the heating resistances of the furnace and of the electrical circuit → ok

- Check of the fuses every 3 months in the preventive maintenance planning
- Implementation of phase controller on each of the static relays to monitor any missing phase

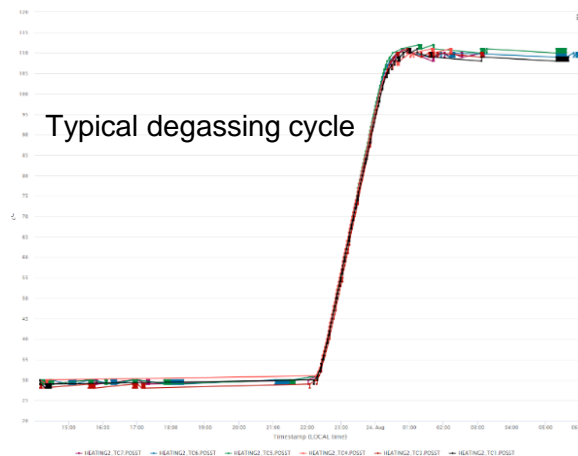
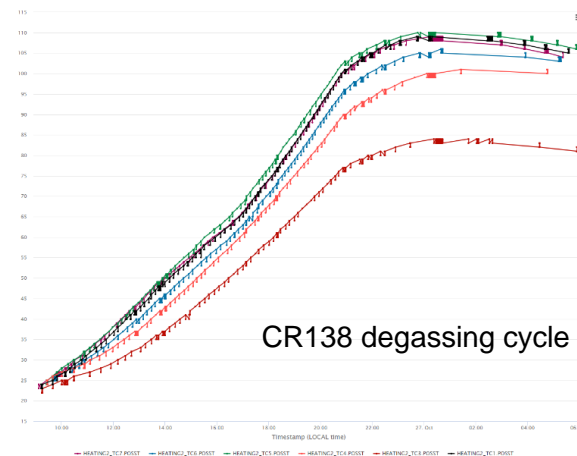
Why did it happen? → Human errors

1. The wrong connector was plugged by the operator (procedure not followed)

2. Parallel activities on another mould were 11T TCs were installed during the days preceding the MQXFB coil
 - Reason why the 11T TCs and plug were not hidden as usual
3. Direct monitoring of the degassing cycle not done
 - Unusual behavior could have been detected

- Consolidation of the impregnation machine, replace the wiring and implementation of plugs with oriented slots to avoid any connection error
- **Preventive action:**

- Regular reminders to the impregnation machine operators to strictly follow the procedures and check lists

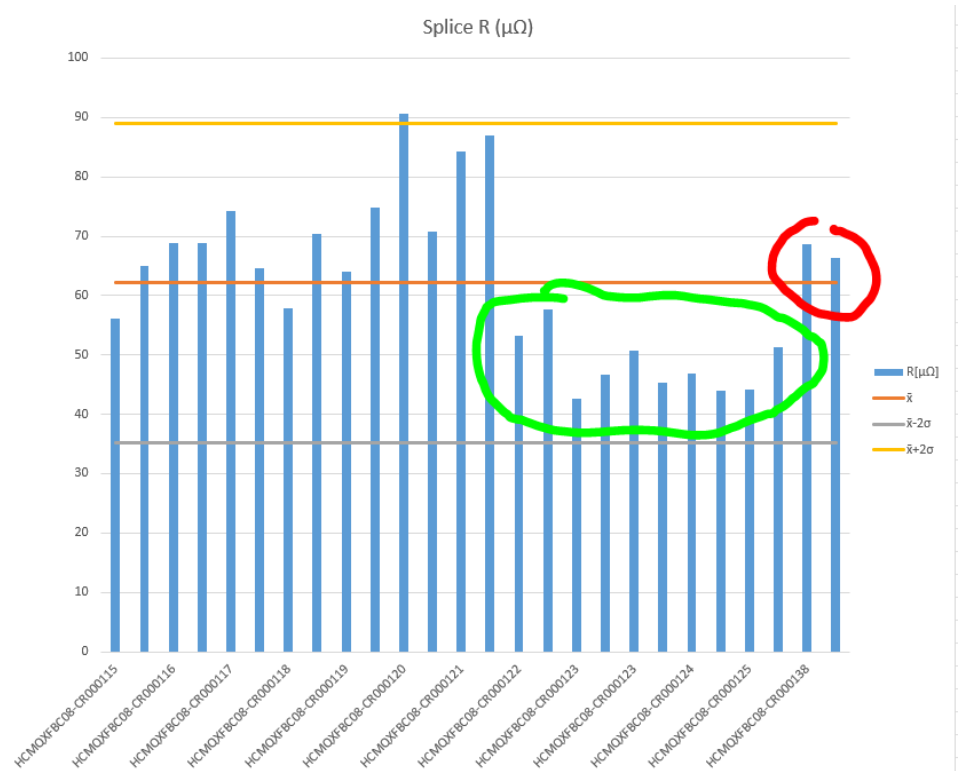
Splice analyses

- Acceptance range: 15 – 100 $\mu\Omega$
- Measured range: 66 – 69 $\mu\Omega$

This result does not tell us the splice is good but at least it tells it is not bad

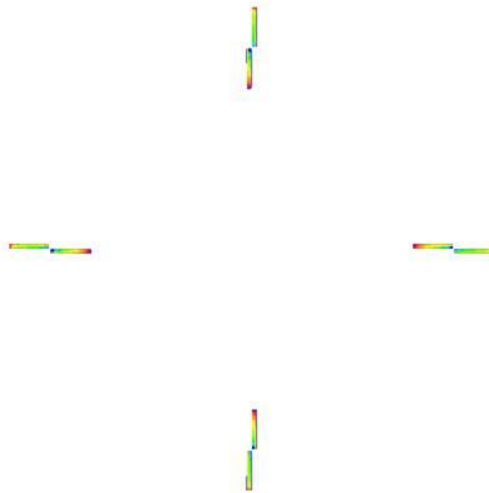
NbTi performance degradation

- TE-MS-C-LSC team carried out I_c measurements on NbTi wires heated at 300°C for 24 hours
 - NbTi strands showed a degradation of the I_c of 27% at 8T and 1.8K (I_c measurements)
 - From magnetization measurements, the treatment: magnetization ratio suggests a J_c degradation of around 31% at 8T (comparable to the value from transport measurements) and around 6% at 0.5-2T
- Susana computed the magnetic field in the splice region for assessment of the NbTi:
 - At nominal operation conditions, it is less than 1T
 - If we assume that current goes through the 2 leads homogeneously, the current density is 1400A/mm²

Based on those results, we have margin for operation
