Experience with SPS RF and outlook

Sam Pitman, Eric Montesinos, Gino Cipolla, Sebastien Calvo, Flory Matthia Ten Broeke, Fred Killing, Christophe Renaud, Joan Revoltos, Calum Sharp, Christian Schachtner, Francesco Repola, Luciano Ciampo, Odin Ervik, Kim Wagener, Alessandro Cazzaniga, Giulia Papotti, Ivan Karpov, Bartek Bielawski, Rama Calaga 10/12/2024

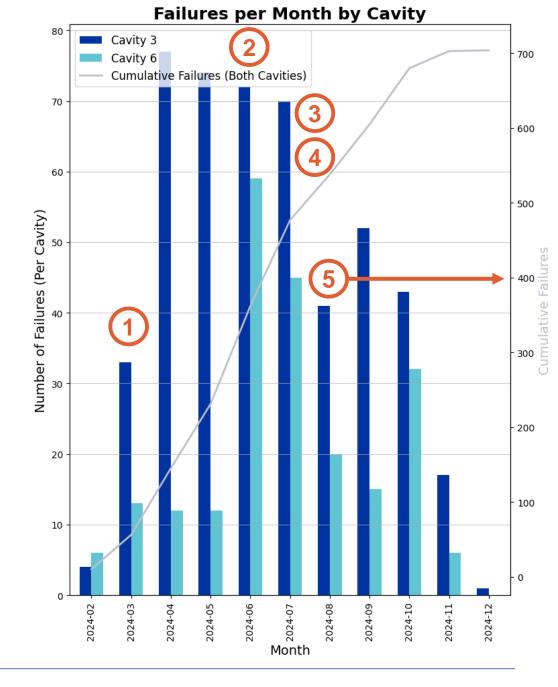
SSPA exceptional failures

Large vacuum spike on cavity 3, 14 modules broken within 30 minutes, around 30 in total.

LLRF signal cable disconnected from half towers, around 100 modules lost (over around 3 months)

2 x high power loads broken

Towers are thought to have been overdriven

AM turned off in HIRADMAT cycle - 14 modules lost at once

HOM coupler burned

10 modules lost in 30 mins prior to HOM burning Same coupler in Cav 6 to be inspected in YETS

Loads on isolated port of combiners have been broken

Not clear what impact this had on failure rate

Interlocks have since been connected to prevent this happening again

All loads to be replaced in YETS (14/30 replaced during the run)
