P42 XTAX Issue

Initial Assessment / Post-Mortem

EATM 13.08.2024

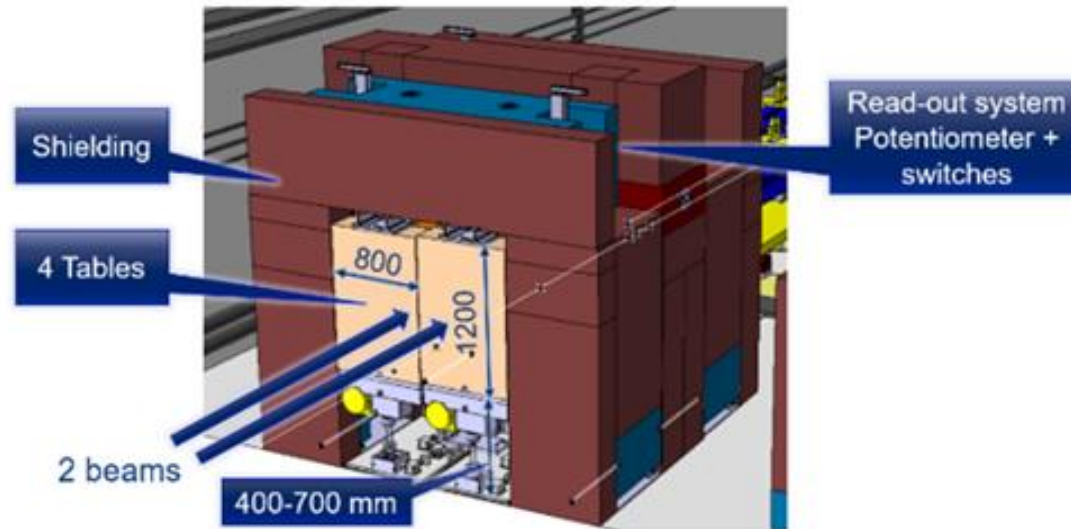
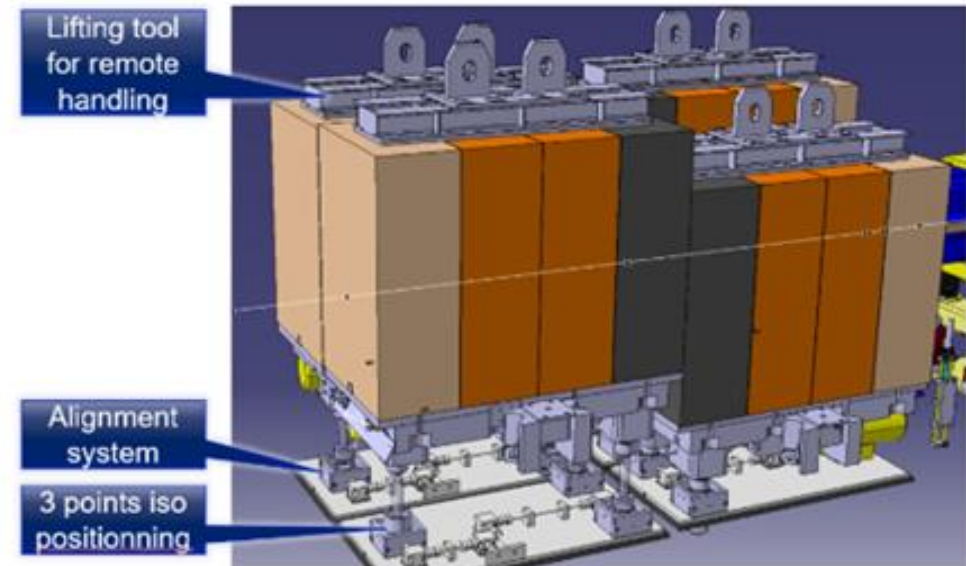
- Alignment and position measurement of the XTAXs is critical for operation. Suspecting at some point misalignment between the holes, several endoscopic checks were performed, showing no blocking material or melted material in the apertures, however some offsets, but nothing to fully explain the situation.
