Planned adjustment of the temperature interlock of the BBCW

Adriana Rossi @ 253rd MPP meeting – 13 Sept. 2024

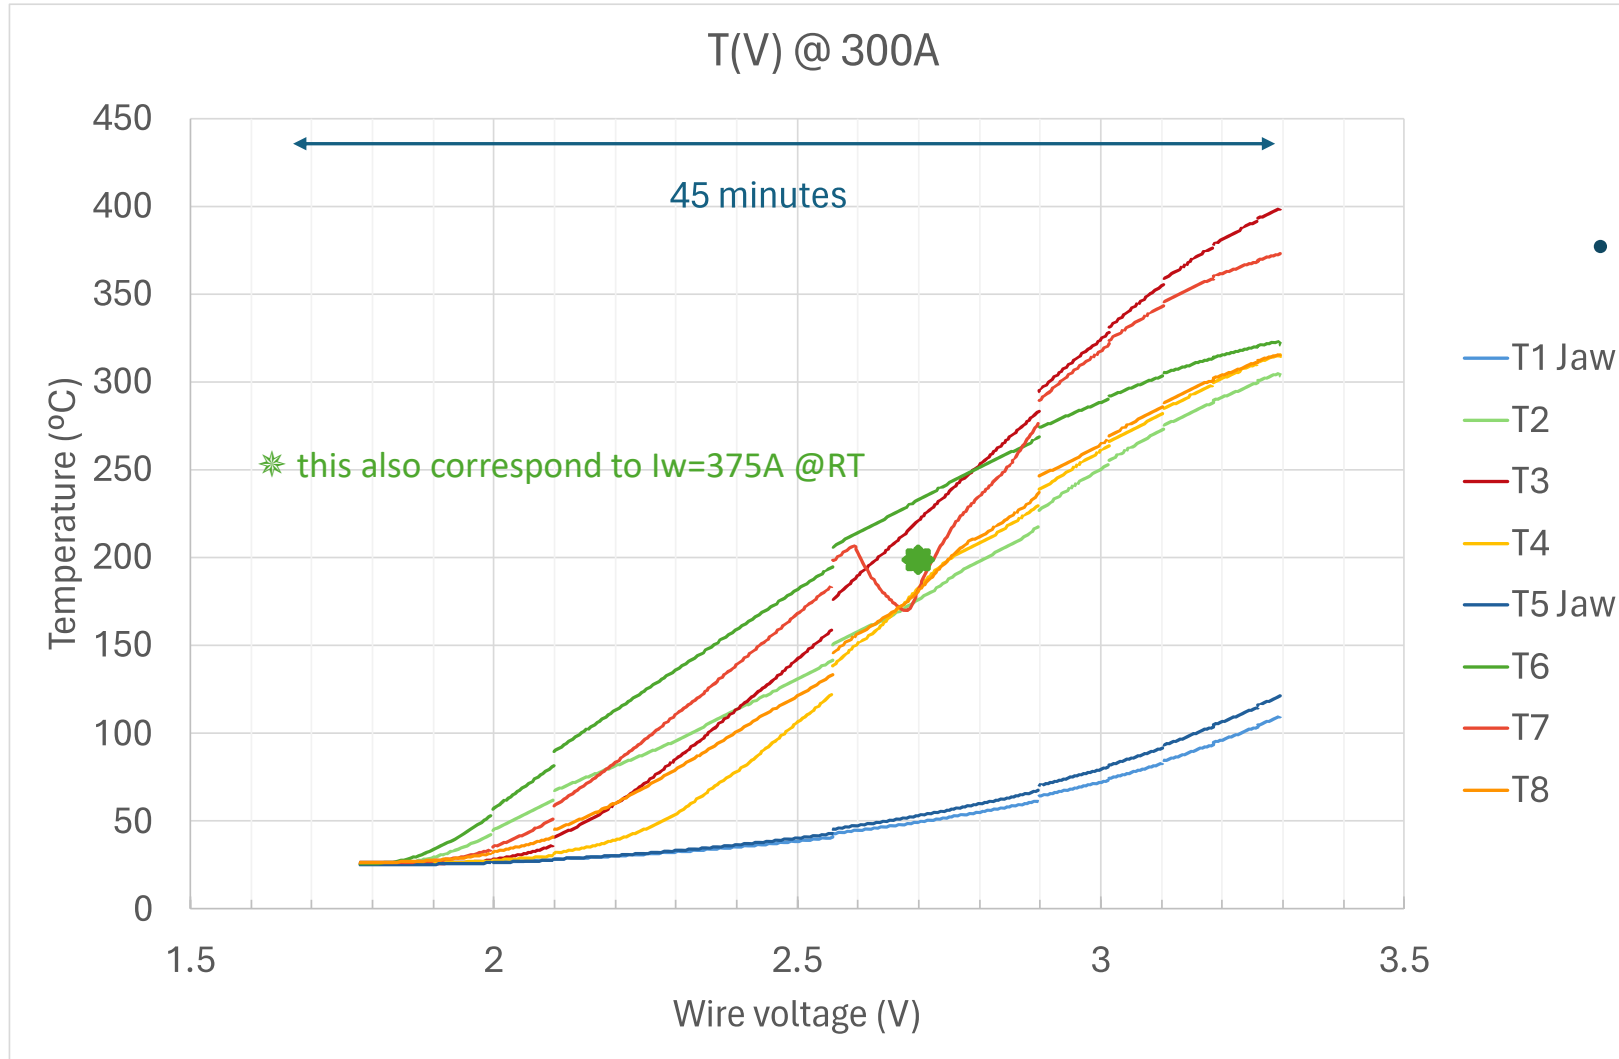
Wire interlock threshold

- Wire resistivity $f(T)$
- If wire voltage $> 2.7V^*$
 - if hottest point @ 300A inside vacuum $\sim 200^\circ C$
 - beam dump + WIC cuts the PC
- **Long time constant of system, no constraints on collimator HW**

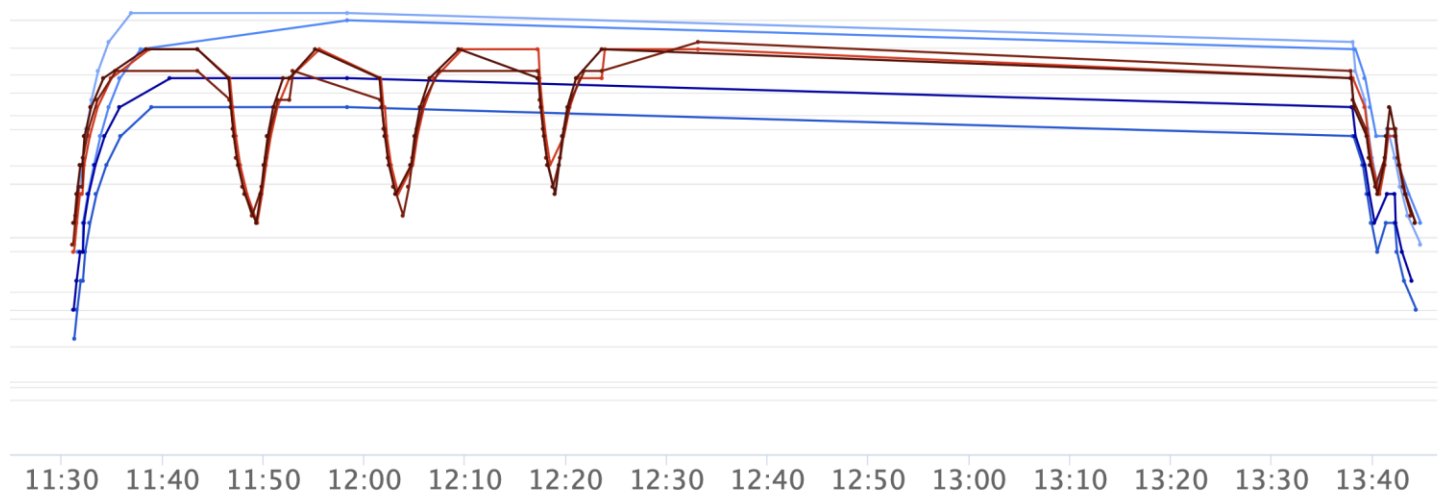
T interlock triggered on TCTPH.4L5.B1 (24 April 2024)

- Interlock tested @ 375A
- Wire temperature measured in situ for 20-25 min @ 350A
- Around Easter, interlock triggered after ~ 40 min @ 350A only on this collimator
- Operation resumed after rMPP @ 315A

interlock triggered by moving cables

Interlock while modifying the threshold value

Interlock while just touching the voltmeter cable to thd lvl 1-1
