# MQXFA13 – AUP227 metallographical inspection

# Metallographical analysis of MQXFA13 – AUP227 coil

## **metallographical inspection – pole turn**

## **Extended inspection of pole turn region by deep copper etching and CT analysis**

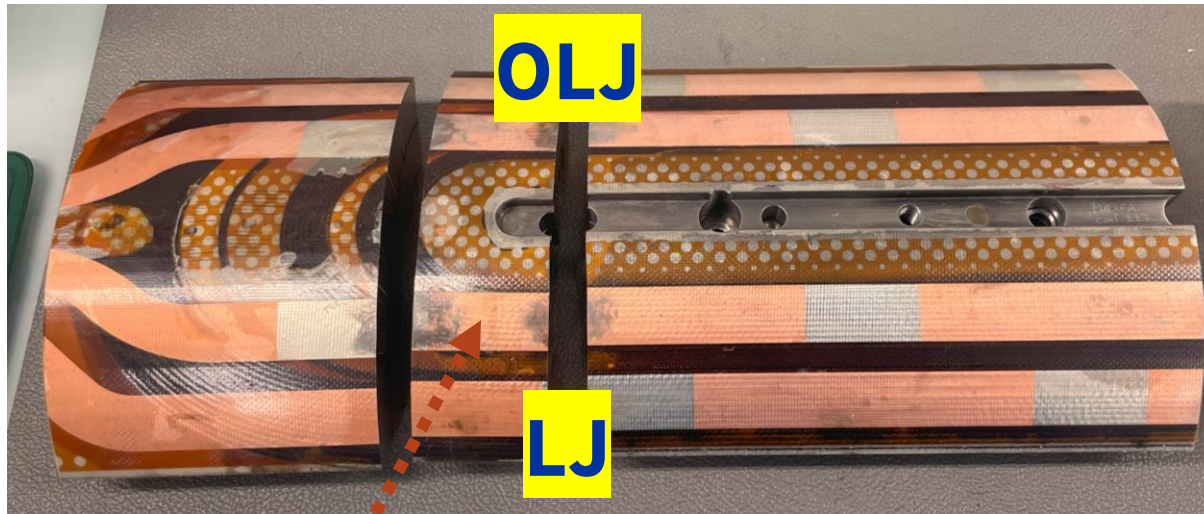
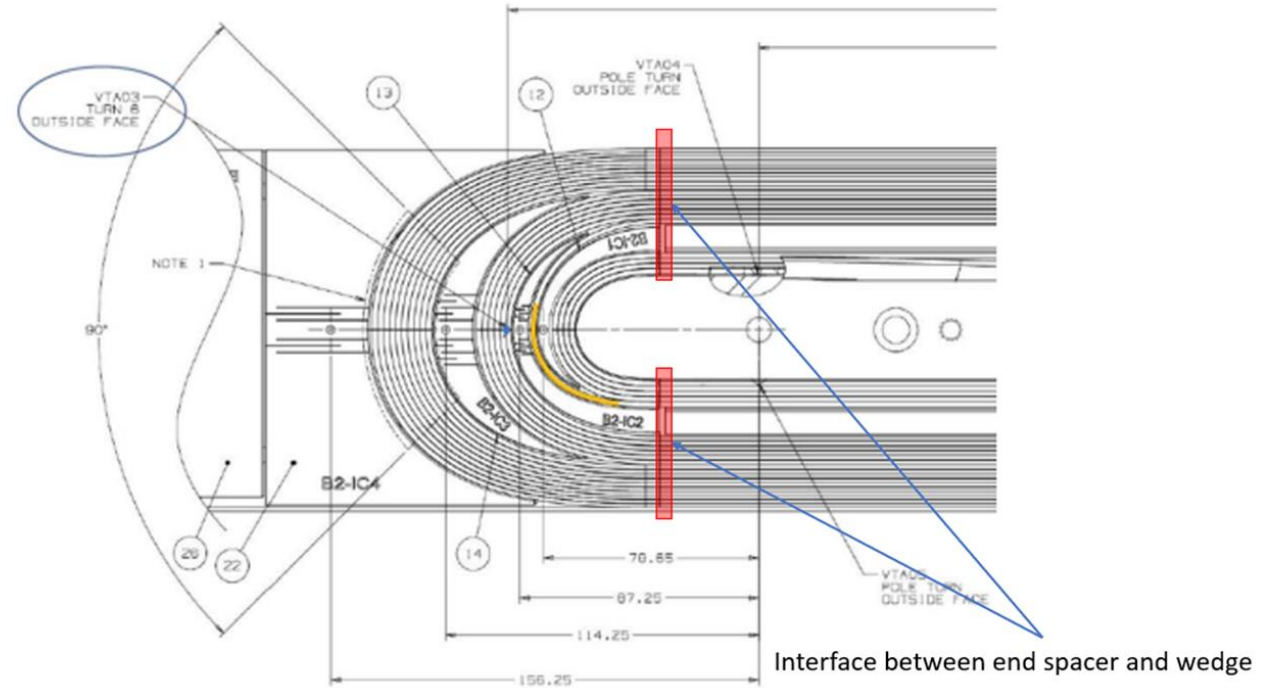
Transition between end spacer and wedge

43 mm thick slice including the transition between end spacer and wedge was extracted as illustrated below.

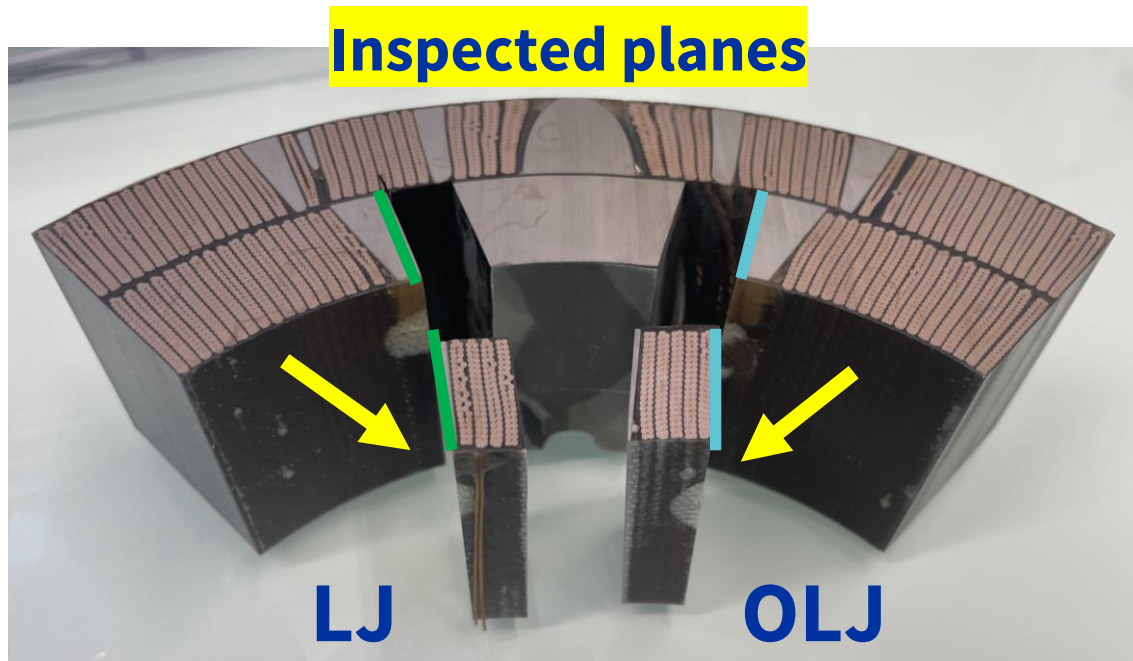
**Pole blocks**

VOIs have been then extracted from the slice accordingly to schema below.

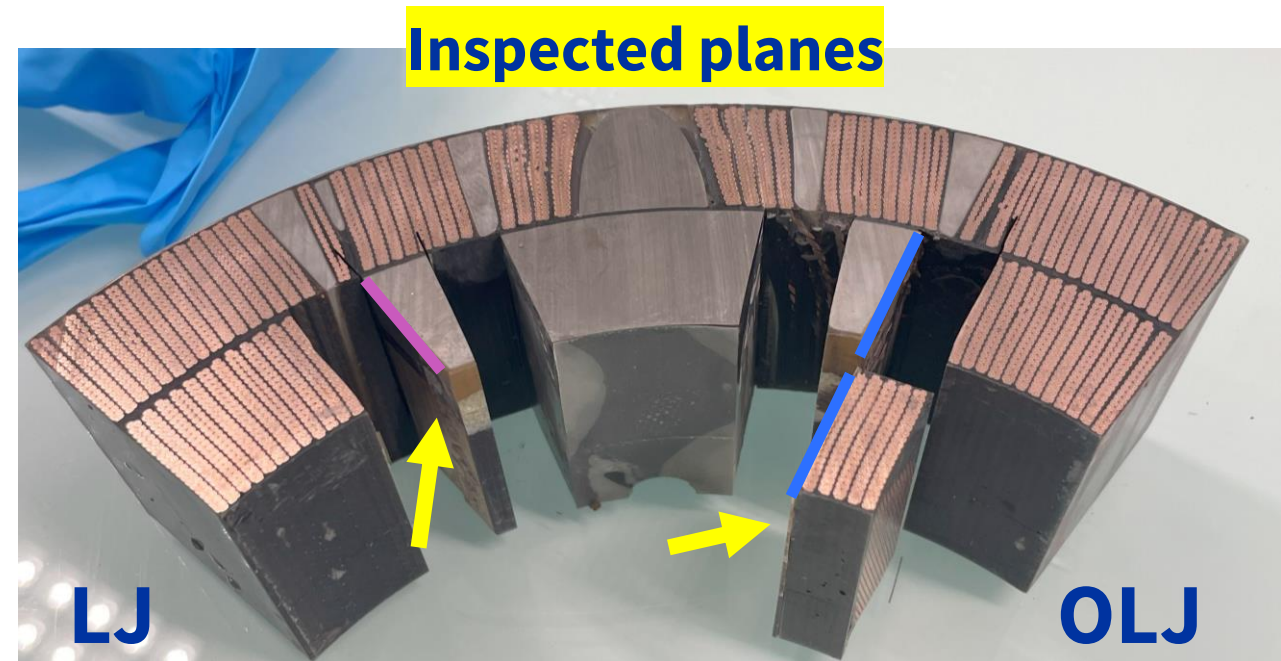
**Midplane blocks**

All 4 blocks were analysed from the connection side plane

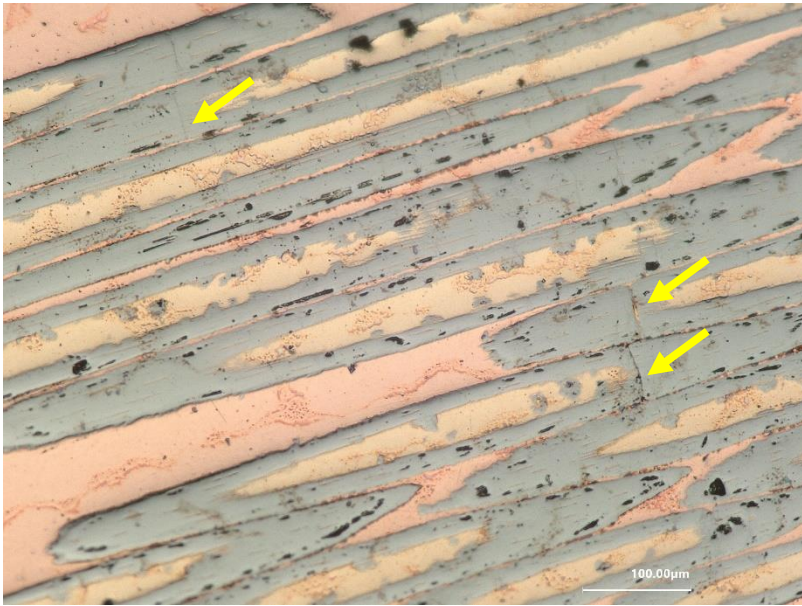
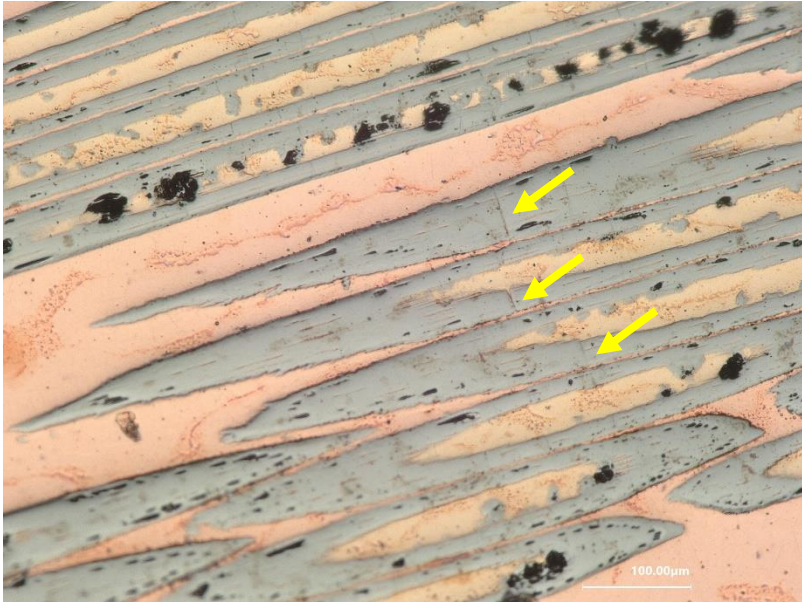
- Transversal microcracks seem to follow the end spacer – wedge transition.
- The thickness of a resin is higher than in the previously analysed samples (AUP coils #213 and #214) – 3.6 mm compared to approx. 1.5 mm in AUP214

Calculated number of cracks - 180

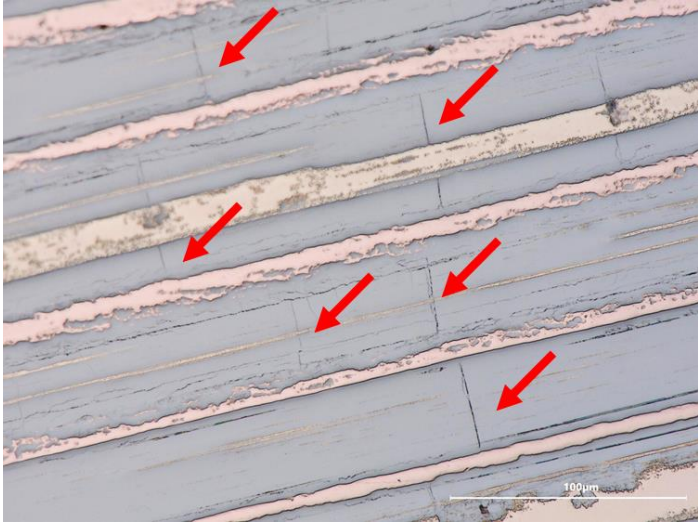
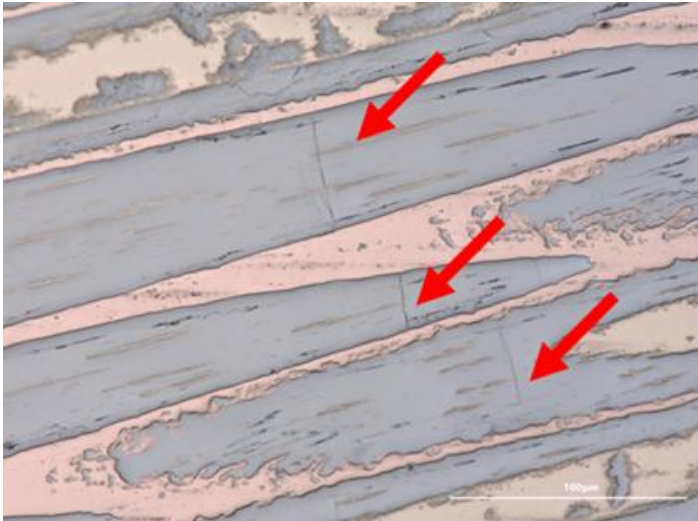
- Microcracks seem to follow the end spacer – wedge transition.
- The thickness of a resin is higher than in the previously analysed samples – 2.8 mm compared to approx. 2 mm in AUP214

Calculated number of cracks - 210

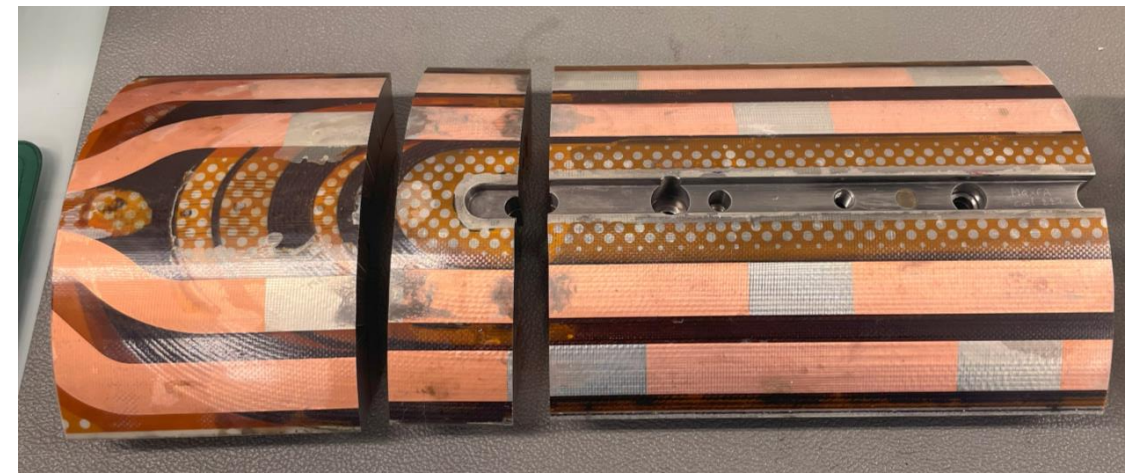
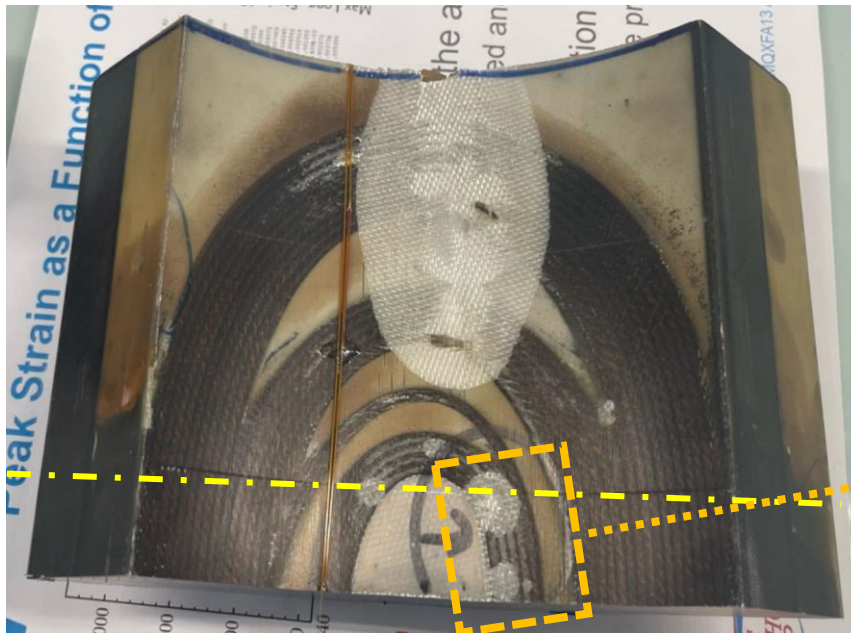
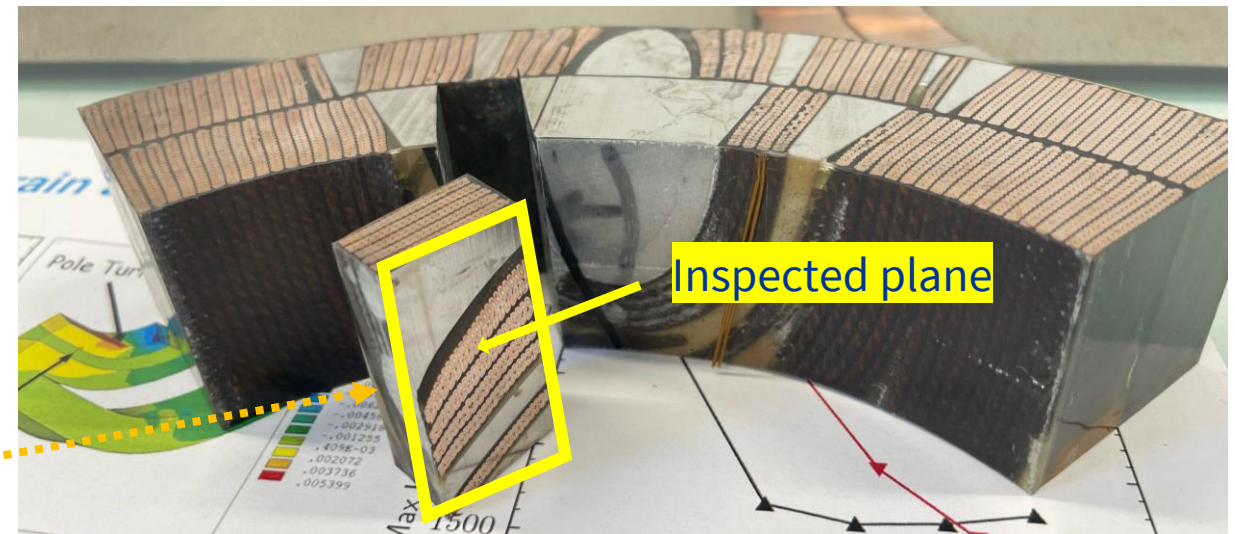
VOI have been then extracted from the slice accordingly to schema below.

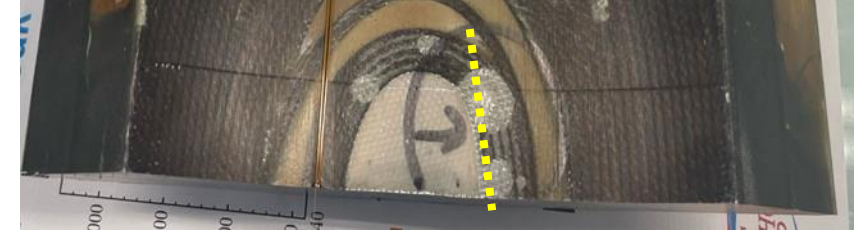
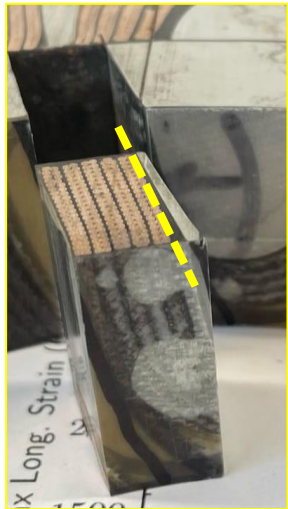
Numerous transversal cracks present, up to  $10^3$  cracks in the highlighted region – high resolution images can be found in the EDMS report.

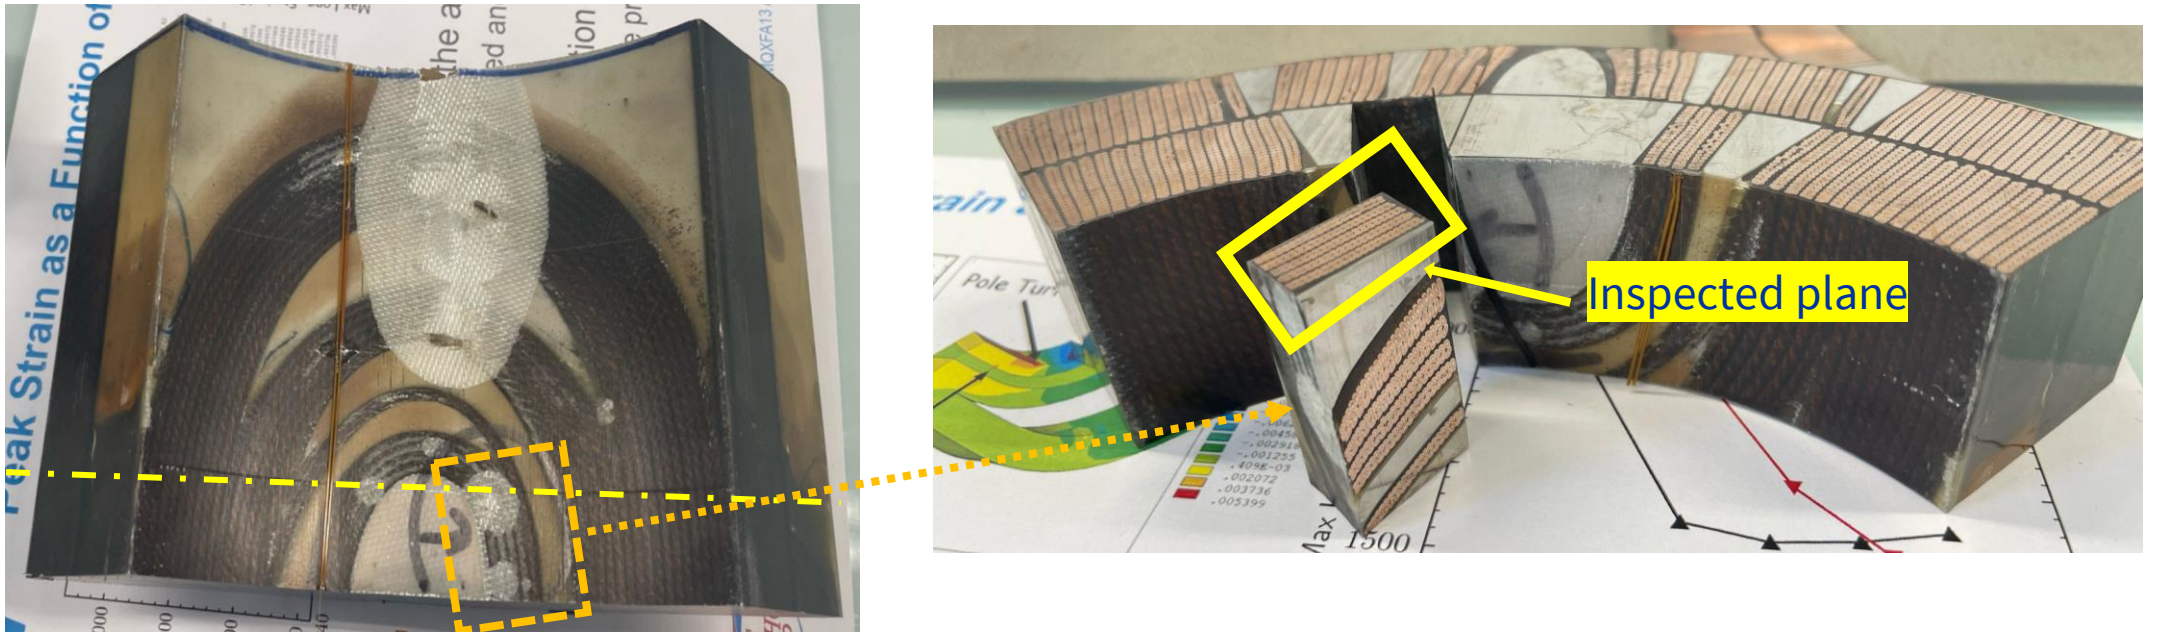
VOI have been then extracted from the slice accordingly to schema below.

PLEASE NOTE that two lines of the cables were partially removed during the previous polishing thus we are only observing the remaining parts.

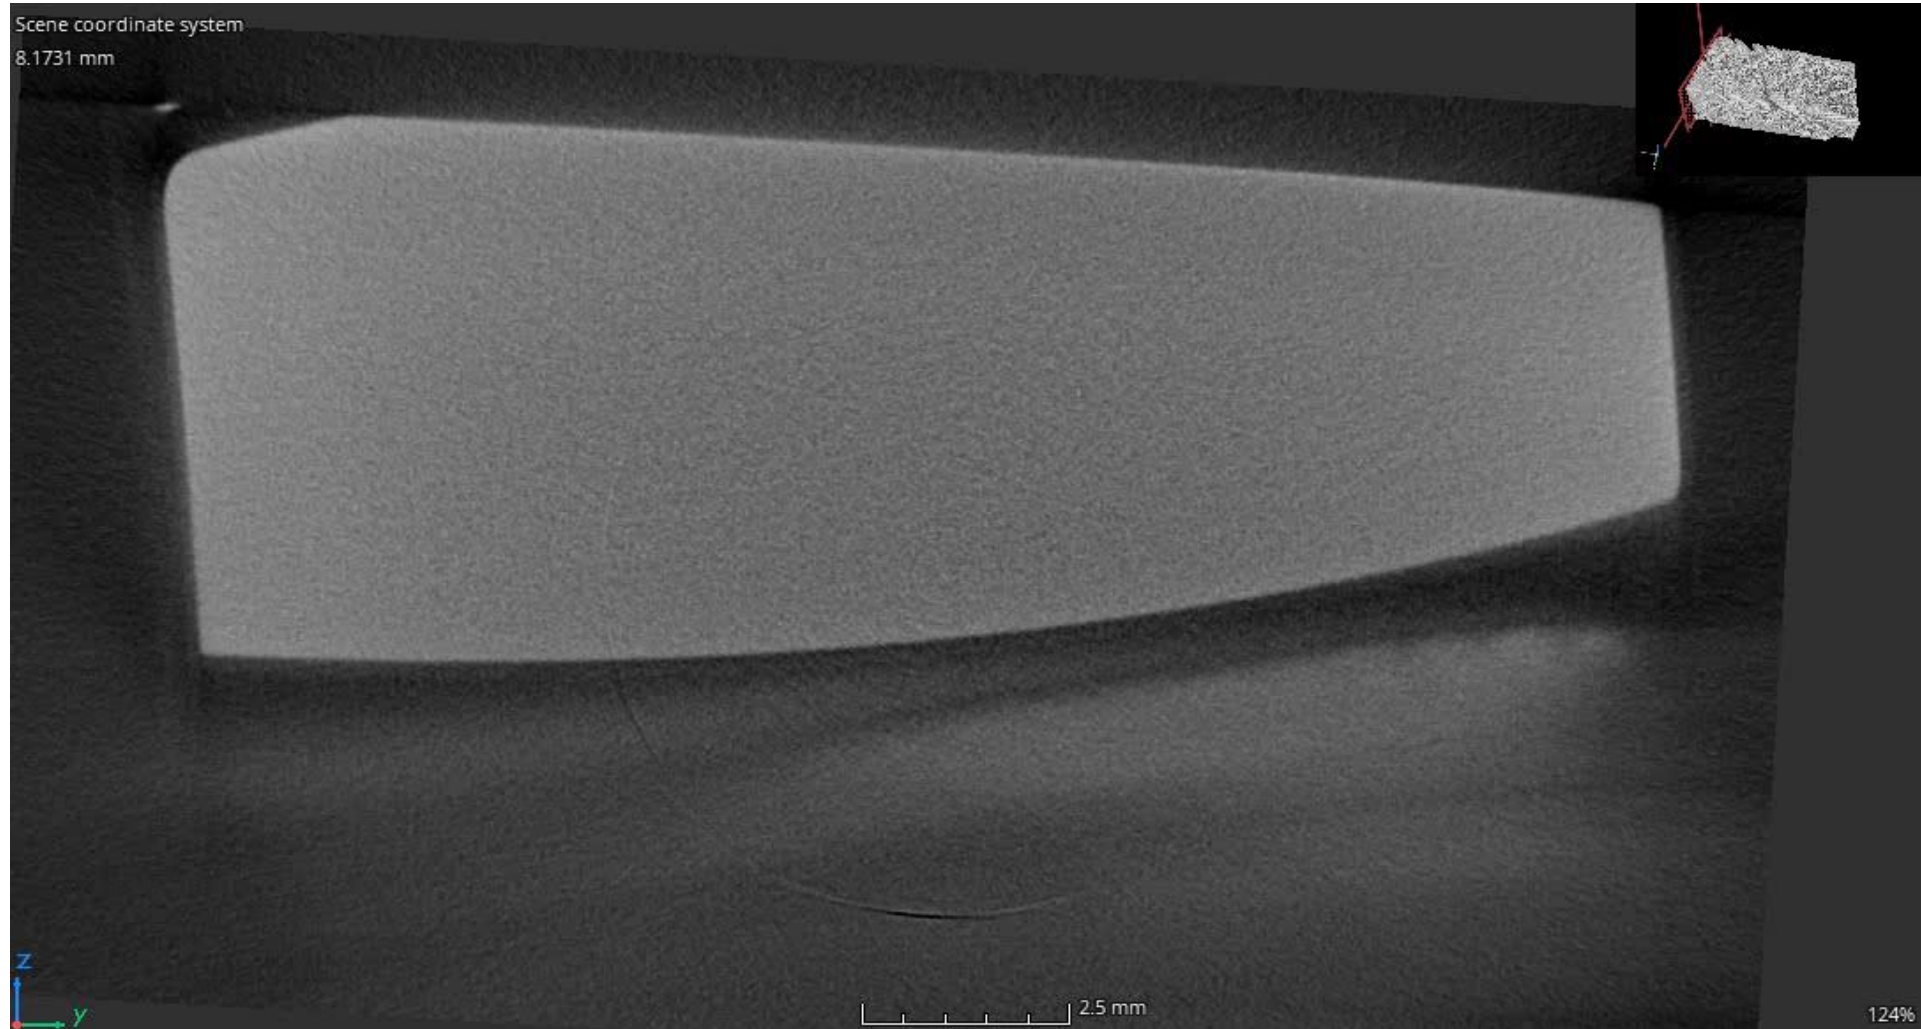
- No events observed during the CT analysis
- Videos in 3 different orientations added to the EDMS document
