MQXFB08 Coils: Coil fabrication, manufacturing data and NC

N. Lusa, S. Izquierdo Bermudez, L. Baudin, A. Vieitez Suarez, P. M. Quassolo,
L. Grand-Clement, R. Berthet

06/11/2024

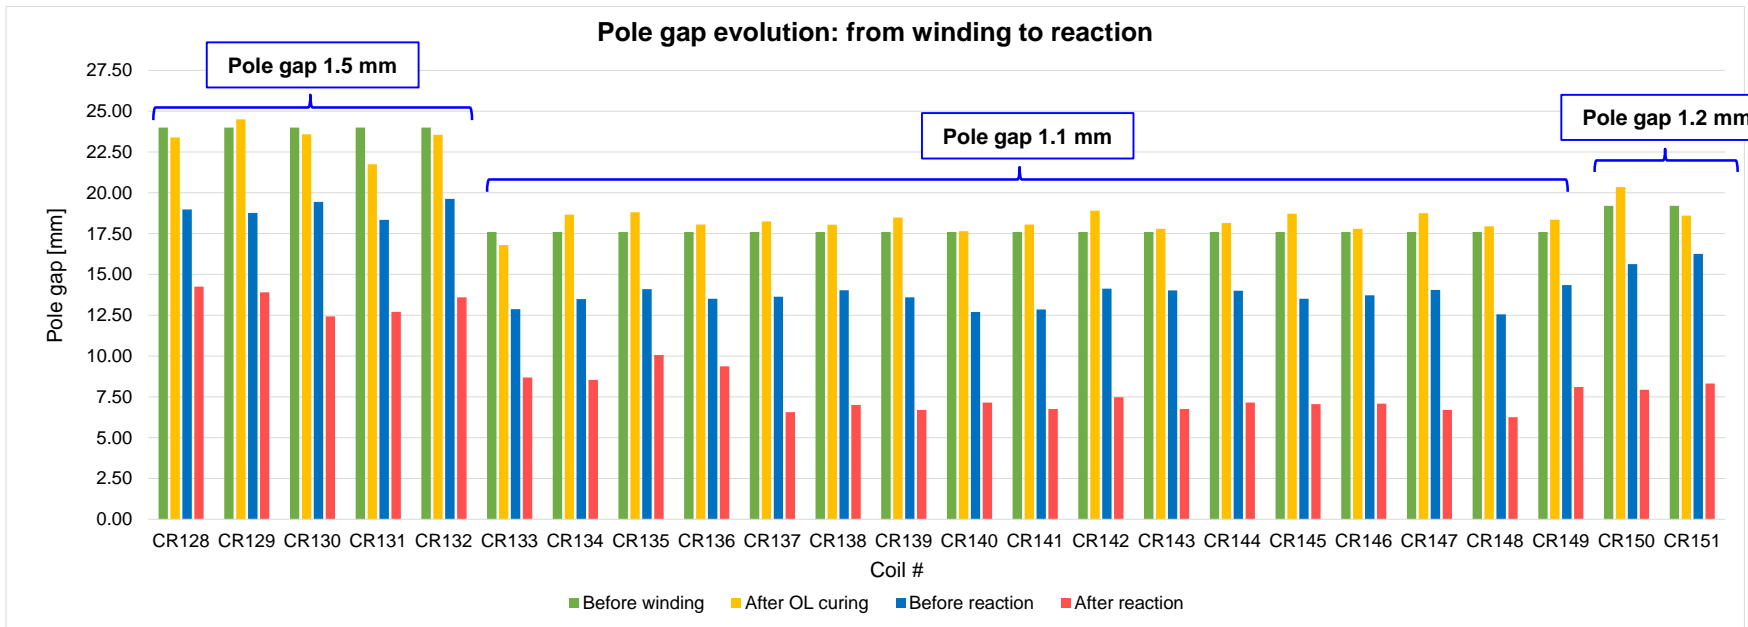
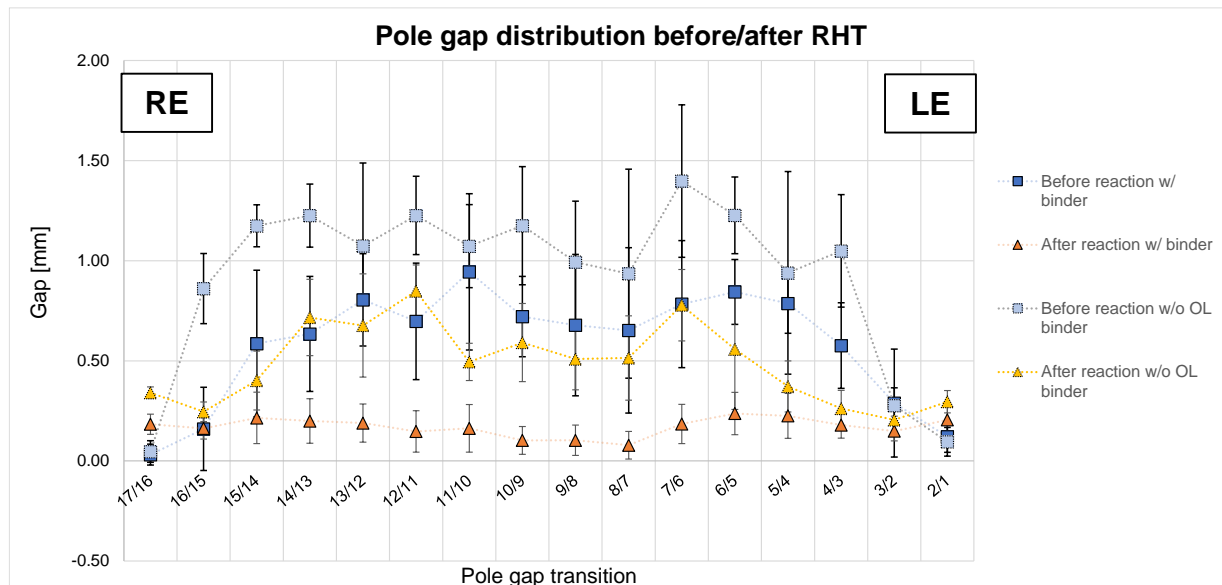
Pole gaps

- In new generation MQXFB coils pole gaps in the middle of the coil are not closed after reaction, as it is the case for AUP coils

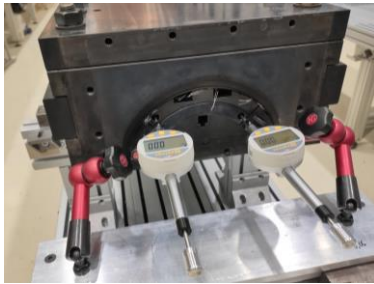
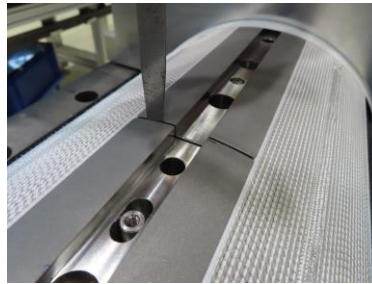
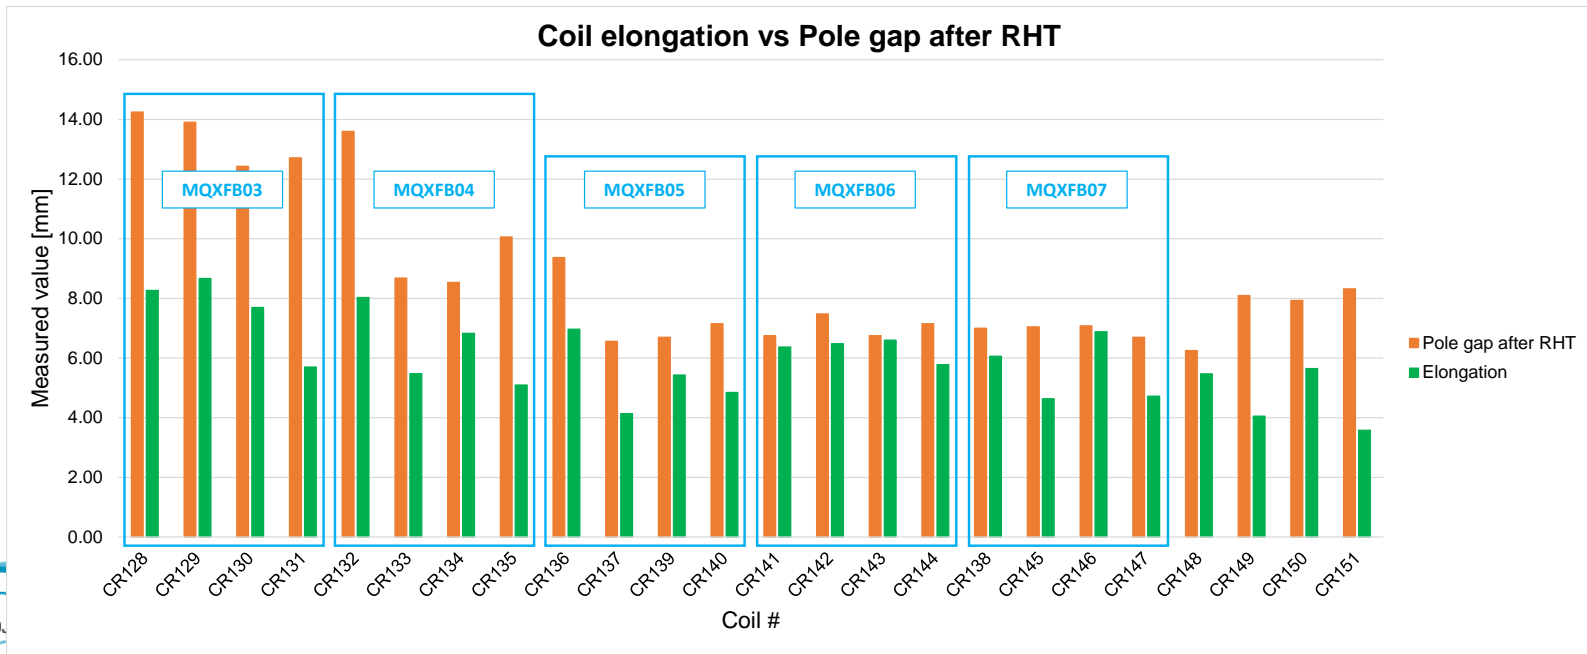
Pole gaps vs Coil elongation

- The reacted coil gradually elongates on both ends during the mold opening and pole gap increases ([indico 1220226](#))
- From coil CR150 pole increased: 2.46 mm/m → 2.69 mm/m

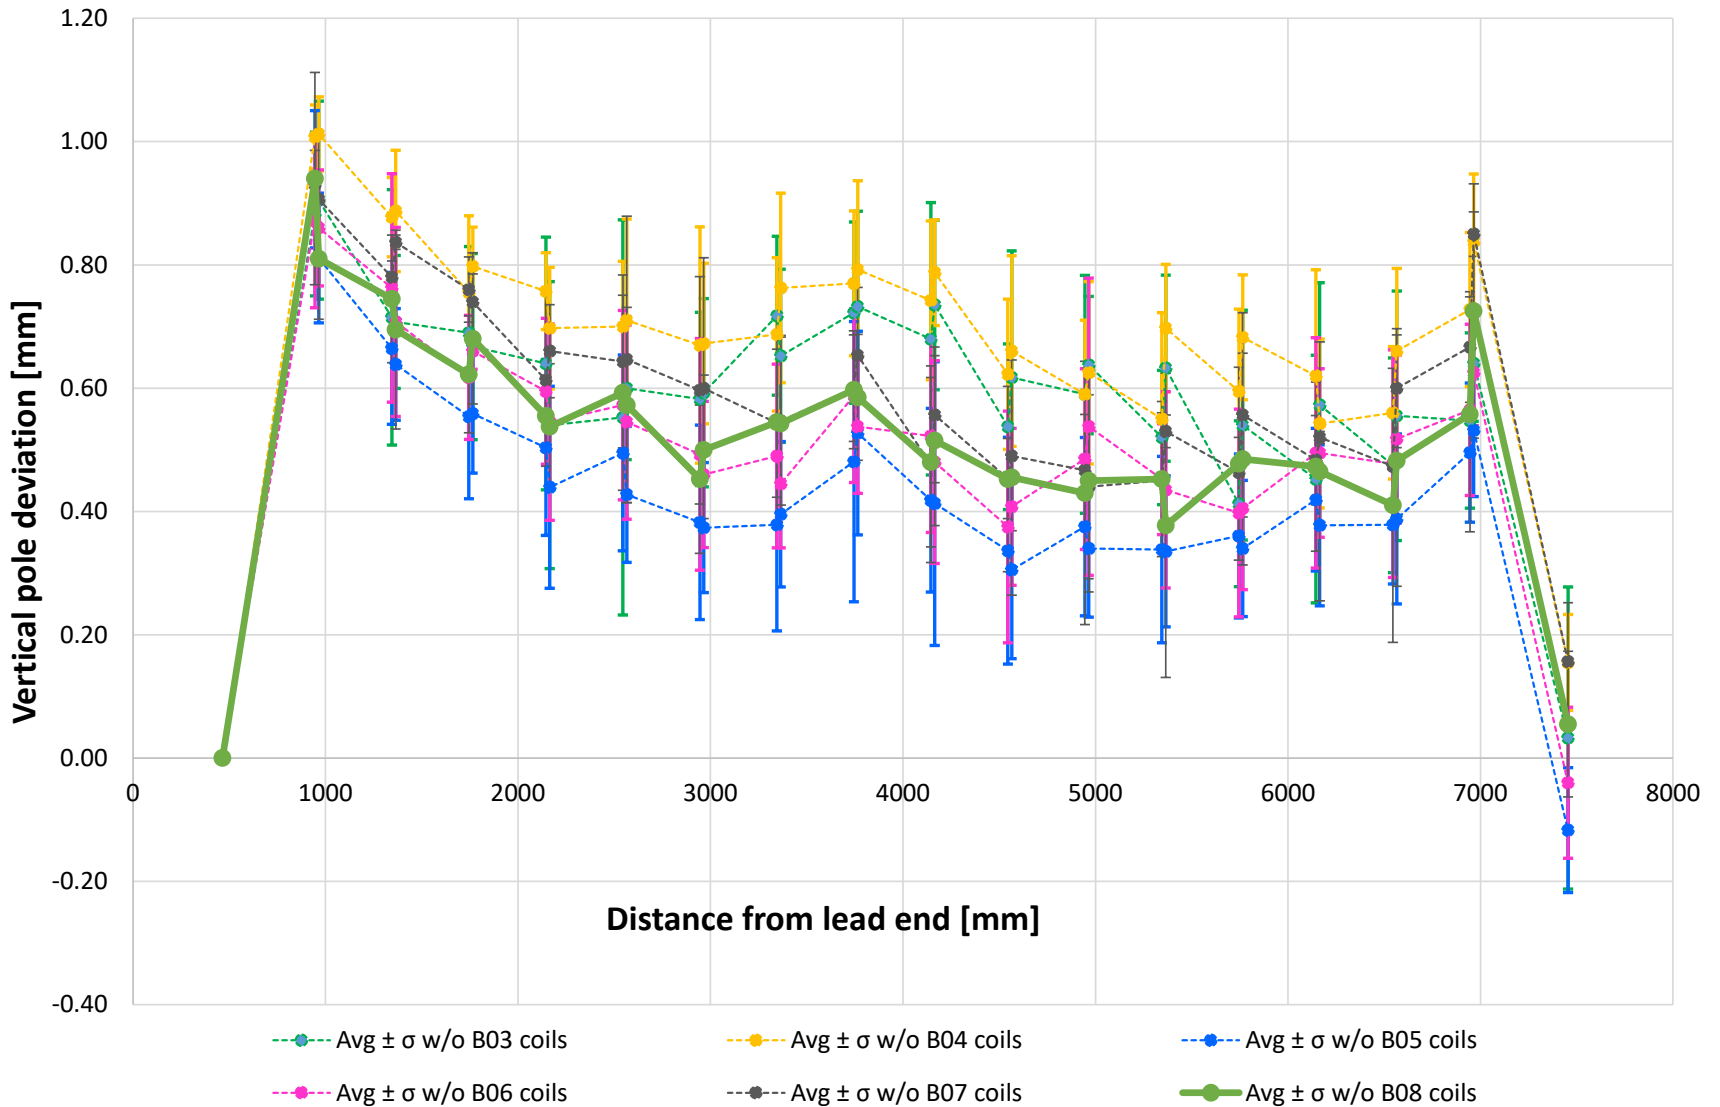
Coil hump after reaction

Coil hump comparison for B03, B04, B05, B06, B07 and B08 coils

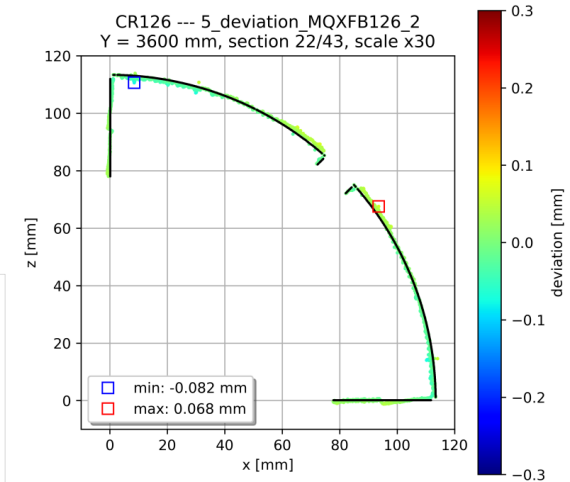
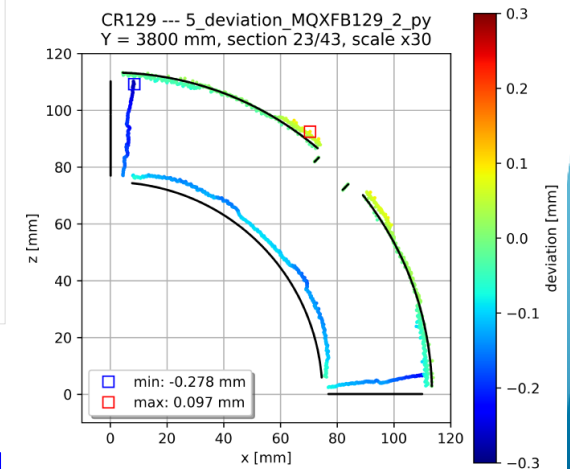
- Systematic behavior in terms of coil shape to previous coils without binder: mid-plane has a little 'wedge' (the coil covers 89.6 degrees instead of 90 degrees)
- Based on FEM we expect ≈ 15 MPa increase in the mid-plane stress (inner edge) under conservative assumptions, confirmed with a mock-up test, see <https://indico.cern.ch/event/1260584/>

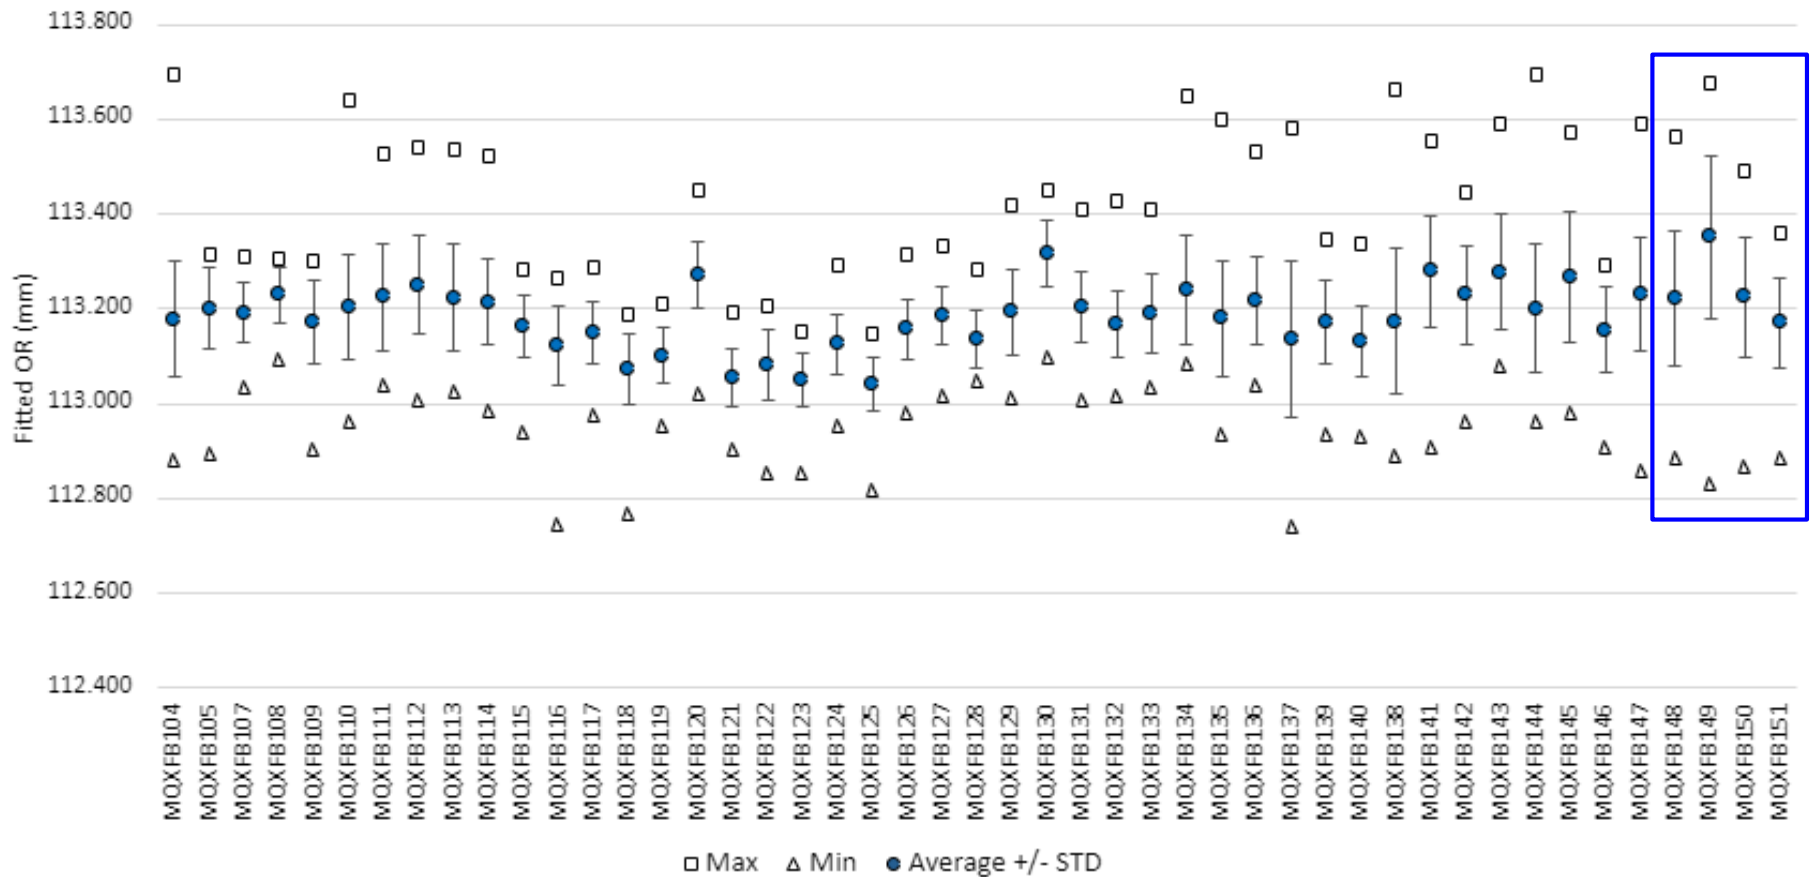
Impregnated coil geometry (Faro arm) - OR

- The proposed coils are very similar in terms of OR

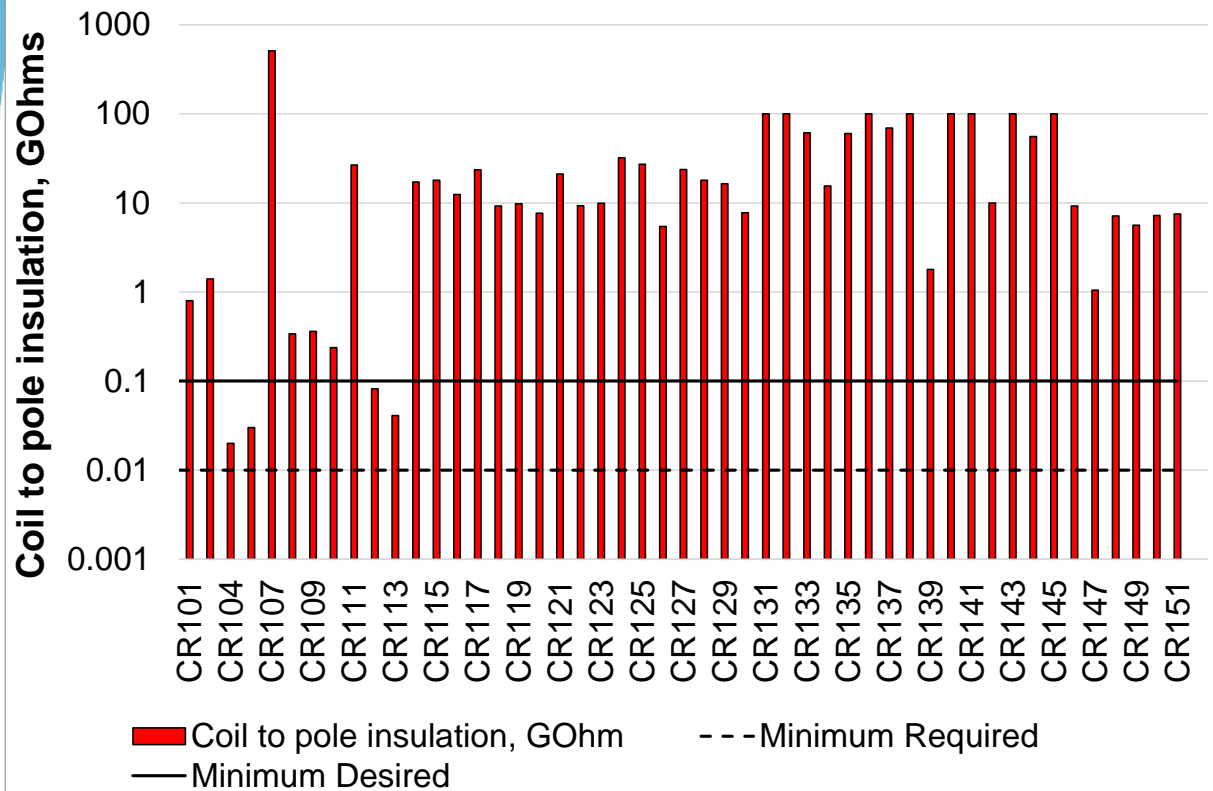
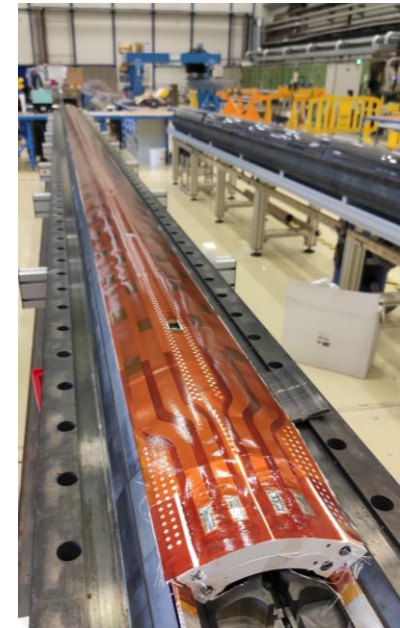
- Since coil 114, coil to pole insulation always above the minimum desired thanks to the reduction of ceramic binder and the use of heat cleaned fiber glass around the pole

- From coil 126, 'mini-swap' quench heaters with improved fabrication process and higher qualification test voltages (see [EDMS 2646046](#))

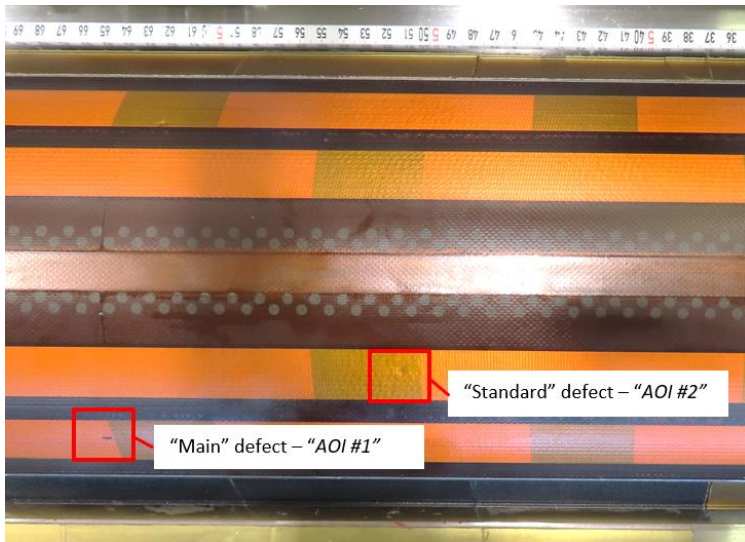
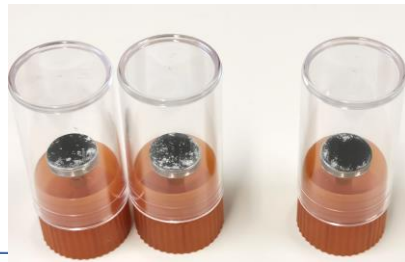
Results 2/2

1. Based on the analysis of the replica the maximum depth of the defect is 150 μ m (in principle above the QH)
2. Inspection of the surface showed a shallow cavity with a burnt aspect and no metallic particle was observed
3. The electrical test passed successfully up to nominal (3.7kV for 120s)

- It was decided to collect samples from the main defect (AOI#1) and from a more standard one (AOI#2) to analyse with SEM-EDS ([EDMS 3175548](#))

- The main defect AOI#1 disappeared during the manual scratching (very superficial as from replica measurement)
- The integrity of the quench heater was not compromised (confirmed by the microscopy)
- SEM-EDS analysis did not reveal any exogeneous particle (only S2 glass chemical composition)
- Local repair of the scratched area was performed
- Coil acceptance electrical test successfully performed
