Richard Soluk – MoEDAL Collaboration (Technical Coordinator)
University of Alberta

MAPP TS2 2024 STATUS

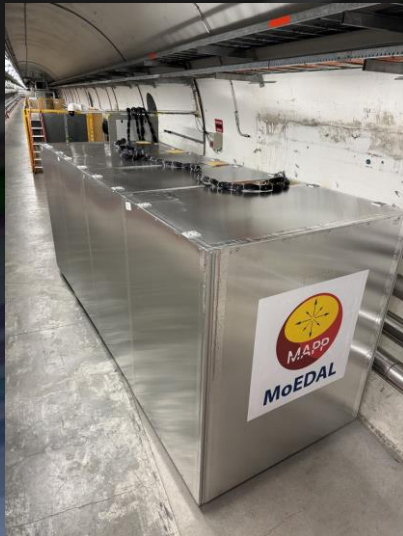
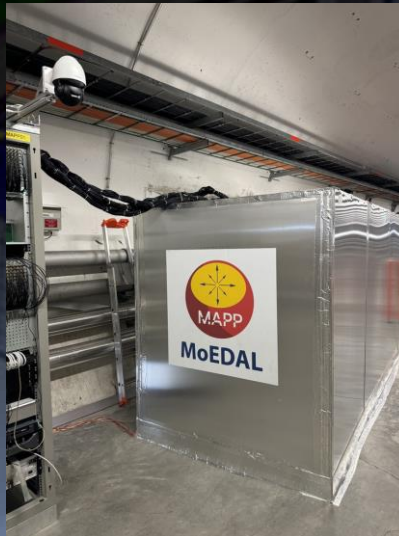
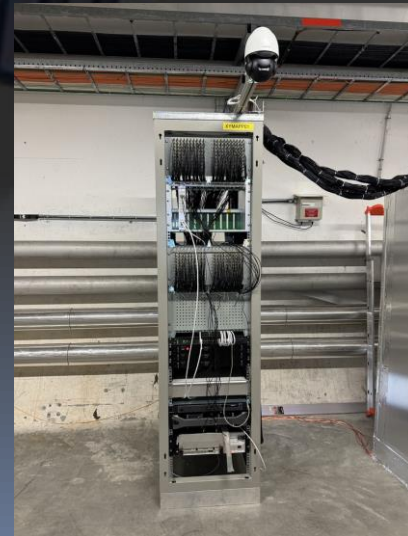
MAPP Electronics

- Electronics installation and rack configuration
- All detector frames individually grounded
 - Oct 22, 23 Paul Davis
- Safety inspection done 12:30 Oct 23
 - Special thanks to Evelyne Dho and James Devine for making the safety inspection possible
