Lessons learned on IT String relevant for HL-LHC installation #3

HL-LHC Integration Meeting, Friday 13th of December

D. Bozzini from TE-MPE-SF, on behalf of WP16 and IT String contributors

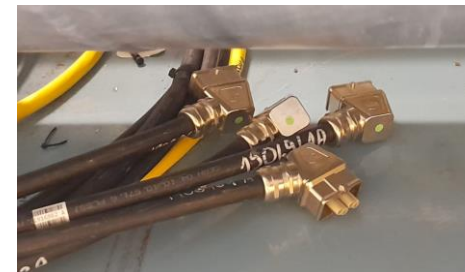
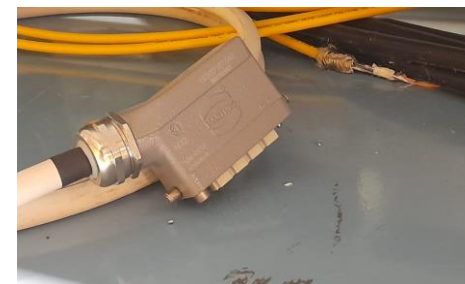
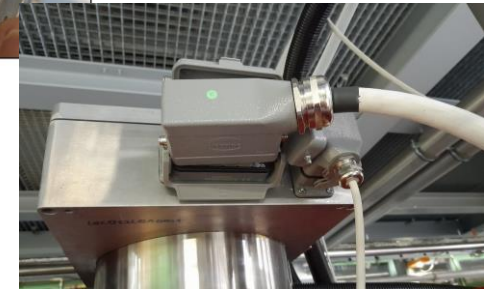
Figure 2 – Examples of recessed (unseated) pin

- Quality of assembly is still a concern. In particular for the recessed pins that might have major functional implications
- Mounting of nonsymmetric connectors shall be reviewed and the required mounting orientation shall be specified in the DIC by the cable requestor
- WP16 recommends to put protecting covers on connectors at least on machine side (as it was done for the LHC)

- 14 connectors with visibly recessed (unseated) pins (male and female types) (See appendix - 7.1).
- 1 missing cable ID label.
- 19 cables with one wire whose resistance deviates from the average significantly ($>3\sigma$)
- 4 minor functional positioning errors (excluding DFHX cables not yet routed to the mezzanine).
