Post-irradiation examination of a prototype tantalum-clad target for the Beam Dump Facility at CERN

(Dated: October 4, 2024)

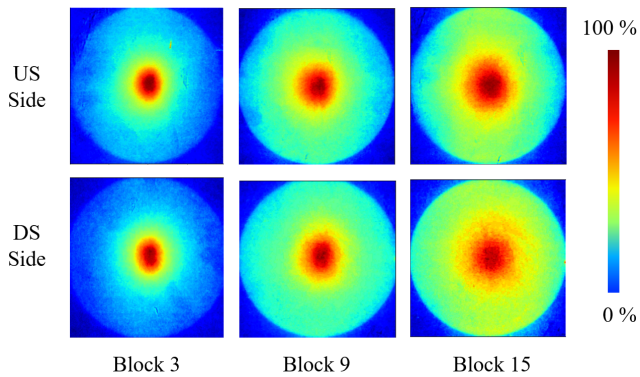
Figure 4 shows the Gafchromic film results, and Fig. 5 shows the data collected on two machine development (MD) days after postprocessing. The color scheme of each image is based on its respective maximum and minimum values. From the film imaging, beam diffusion from Block 3 to Block 15 can be observed, along with a slight but consistent beam offset from the block center toward the right-bottom side, resulting in an average beam offset of (1.8 mm, -0.5 mm). On all MD days, the US camera displayed higher measurement accuracy than the DS camera, which exhibited a defocused beam spot without a Gaussian beam distribution. The beam profile monitored with the US camera was vertically elongated, and this matched the shapes observed on the Gafchromic films. The US camera failed on MD day 2, and the DS camera failed on MD day 1. The beam offset was determined solely by the US camera, and an approximation was applied for MD day 2. The beam offset for MD day 2 was derived based on the correlation between the DS camera and the US camera on MD day 3. The BTV beam offset was determined by considering the share of PoT for each MD day (38%, 59%, and 3%, respectively), resulting in an offset of (1.0 mm, -1.7 mm). Figure 6 shows a plot including all of these beam offsets, with ✖ symbols indicating the target center and the determined average values. Both final beam offsets were located downward and to the right of the target center, and they were separated by approximately 1 mm in their horizontal and vertical coordinates.

FIG. 4. Heat maps of Gafchromic films displaying the activation levels of each block. The scale of the legend is applied to each block individually. The DS-side films are displayed horizontally mirrored.

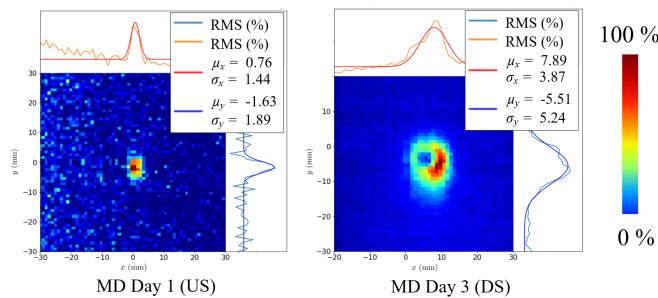
FIG. 5. Heat maps of the accumulated protons per BTV camera and day and their Gaussian fit parameters over both axes.

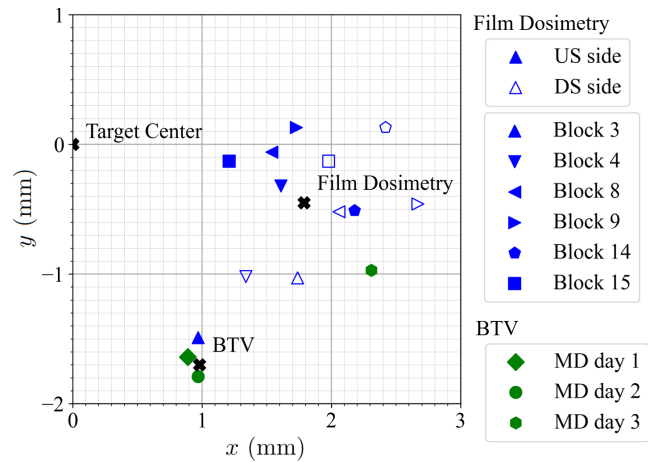
FIG. 6. Overview of the beam-impact locations from the film dosimetry and the BTV data with \star representing the determined average values and the center of the target block.

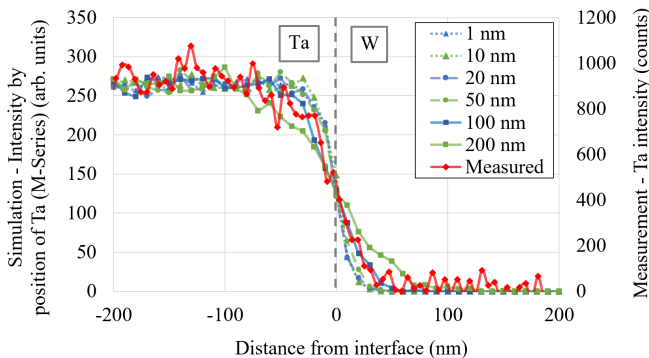
FIG. 12. Ta signal perpendicular to the interface measured by EDS mapping compared with the simulated Ta signals from electron beams of different diameters.

The diffusion bonding of BM1 (Ta/W) was determined by EDS mapping, which showed multiple Ta signals on the W side in the form of tips. The longest tips had a depth of 180 nm from the interface, while along the interface, the tips occurred at distances of 0.1–1.0 μm , similar to the size of the newly formed W grains at the interface. In addition, an EDS line scan was performed perpendicular to the interface, which revealed an S-shaped logistic function. Comparing the measured EDS signal of Ta with the simulation results showed a correlation with the 100-nm beam diameter (see Fig. 12). The expected electron-beam diameter of the machinery used was 10 nm, meaning that the beam diameter was ten times that predicted.

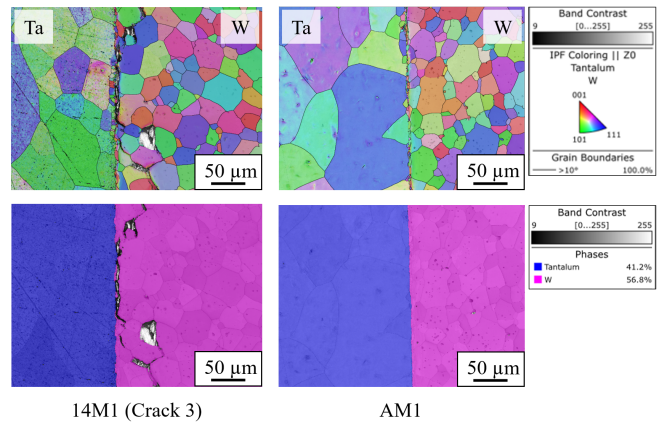
FIG. 14. EBSD inverse pole figures (IPFs) and phase maps at the interfaces of Block 14 (US side), and Block B.
