Integration and System Qualification of the ATLAS Pixel Detector

Markus Keil

On behalf of the ATLAS Collaboration

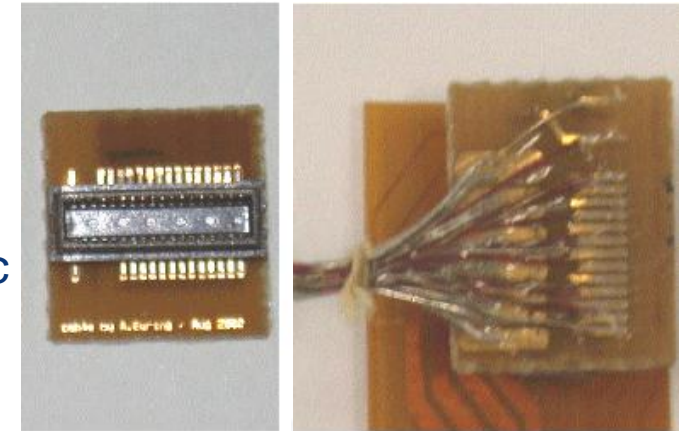
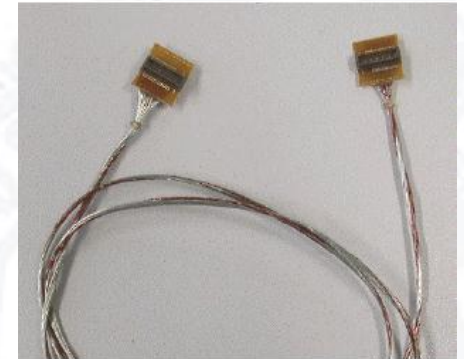
- Problems with connectors of micro-cables:
 - Soldering of the connector broke mainly on the outer pins
 - Had sporadically shown up before, but no systematic stress-tests done, only repair of defect connectors
→ continued to show-up
- Type-0 cable problems (barrel):
 - Discovered during integration
 - Went back to vendor for change of production sequence
 - Scrupulous test program for new cables
- HV return:
 - Tests were blind to a defect in the HV return due to parasitic current paths
 - Problems were found and had to be repaired during installation

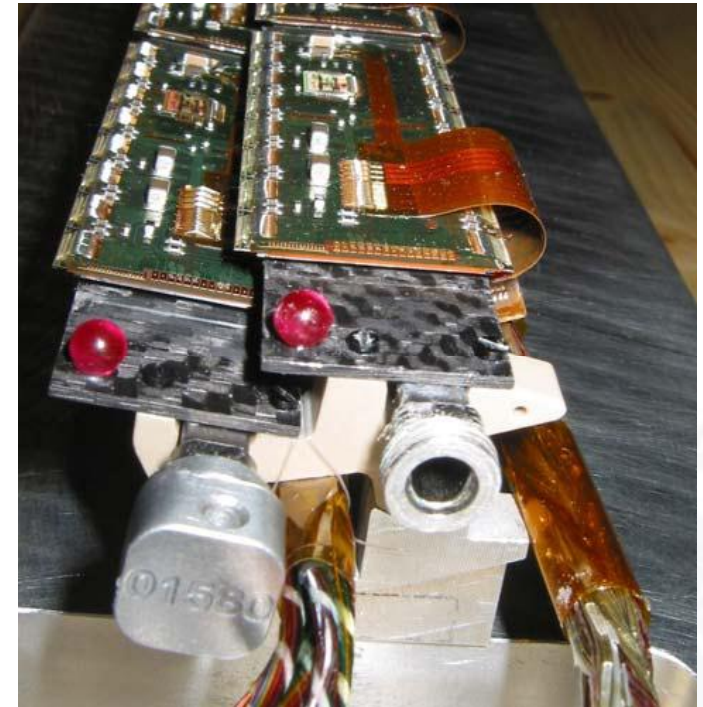
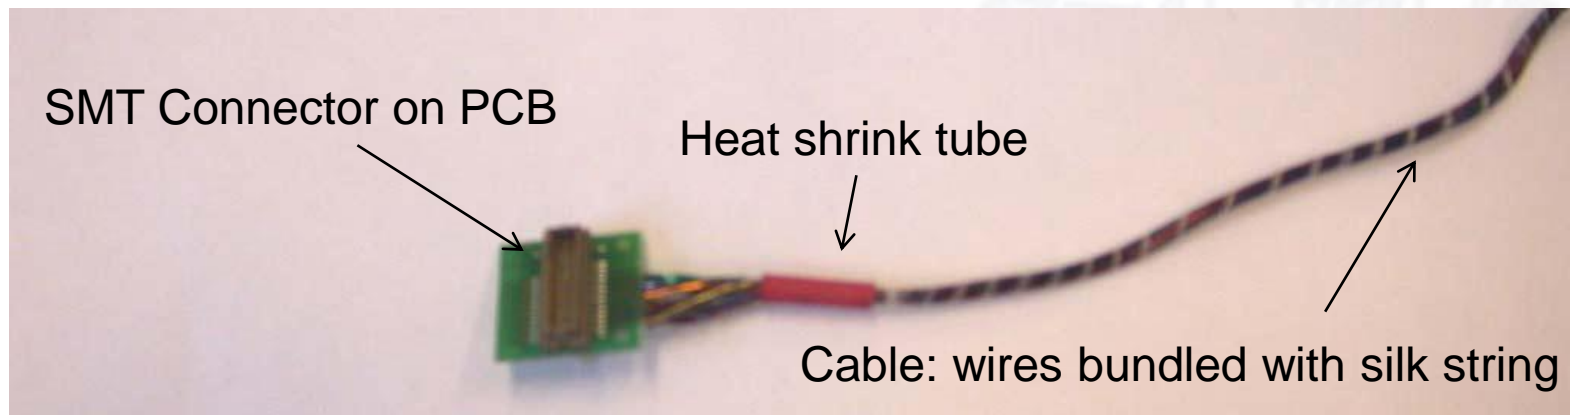
- Connectors at both ends
(mounted on PCB board)
- Round Al conductors
 - 30 individual wires per cable
 - 16 x 100µm diameter
 - 14 x 300 µm diameter
 - Custom thickness polyurethane insulation

Close-up of a typical cable
Close to heat shrink tube:

- Reproduced enough cables for layer-0, layer-1 and part of layer-2
- For rest of layer-2 accepted part of initial production after stricter quality control
 - Mechanical stress testing
 - Electrical test and visual inspection before and after stress testing
- After that only very few failures of type-0 cables and not clearly related to the old failure mode

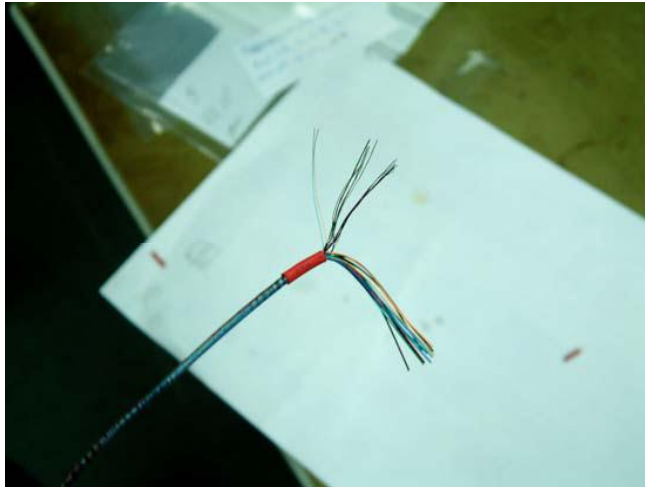
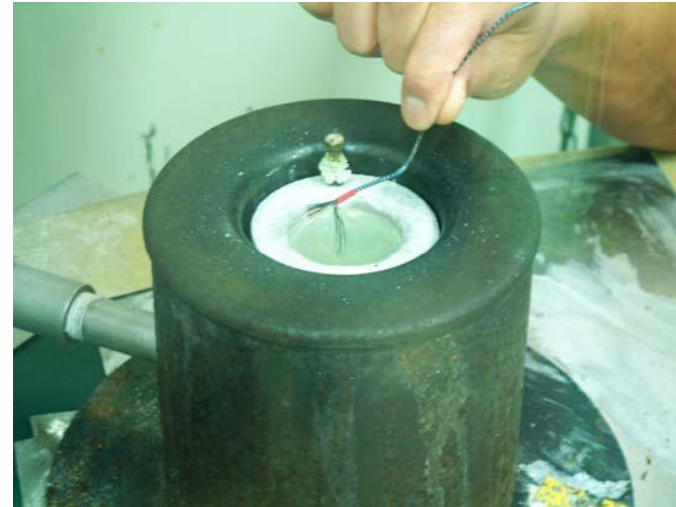
- Wires were bent before stripping, separating thin and thick wires (to be stripped in two different phases)
- Stripping solution is molten NaOH ($T \sim 400^\circ\text{C}$)
- Pictures of insulation heated above 250°C :

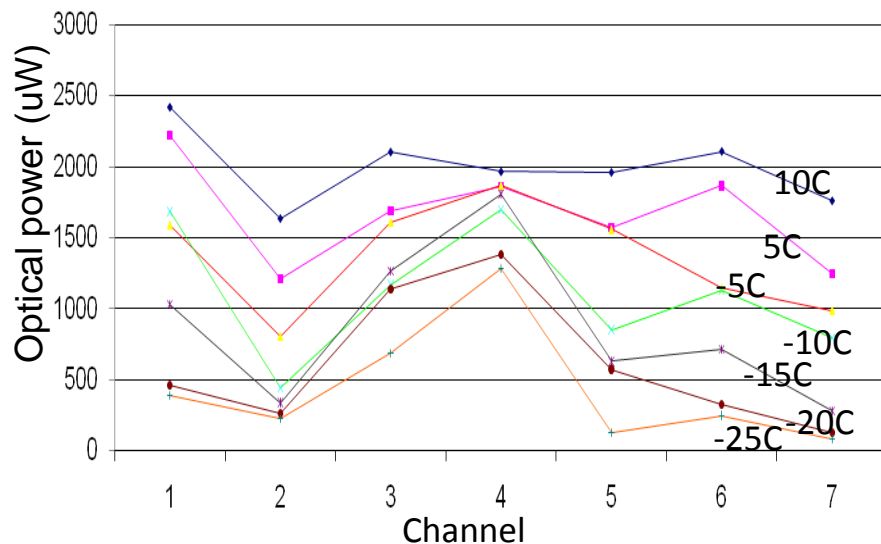
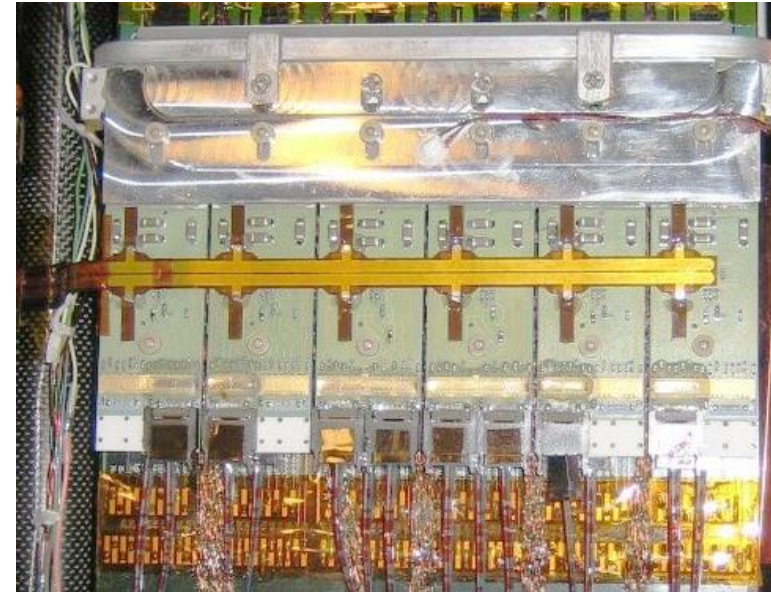
- Problem I: Discovered opto-board channels with slow turn-on
 - Would have led to data corruption during operation
 - Added additional QA step for the opto-boards in the final service quarter panels
 - Several opto-boards with slow turn-on found and exchanged

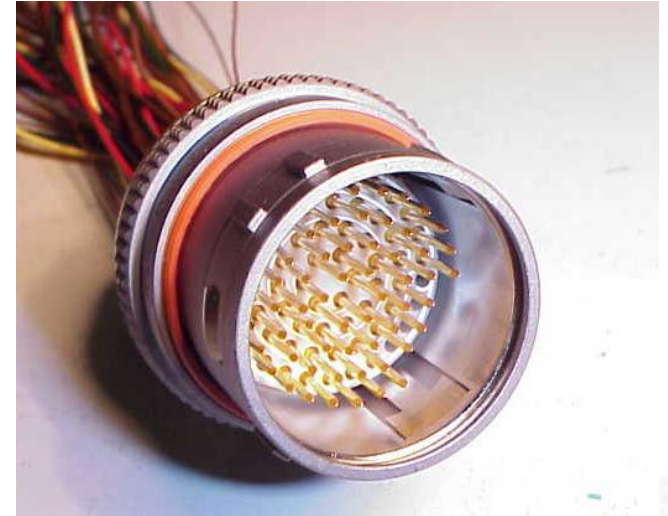
- While setting up system test: Found problem with LEMO-F connectors at PP1 (end of cryostat, point of final connection in the pit)
 - Not exactly the usual cm/inch problem but nearly
 - All components had passed QC but ...
 - Male Lemo-F connectors on the upstream cables (made in collaboration with LEMO-Europe) have movable pins to allow for self-alignment
 - Female Lemo-F connectors in the pixel package (made in collaboration with LEMO-US) were backfilled and thence had fixed pin-receptacles
 - In case of misalignment the receptacle would push the pin back
 - Developed special tool with LEMO to check for vulnerable pins
 - Find, repair and reinforce those pins
 - Check each single pin during service tests
 - Introduce procedure in power-up that checks for open sense lines

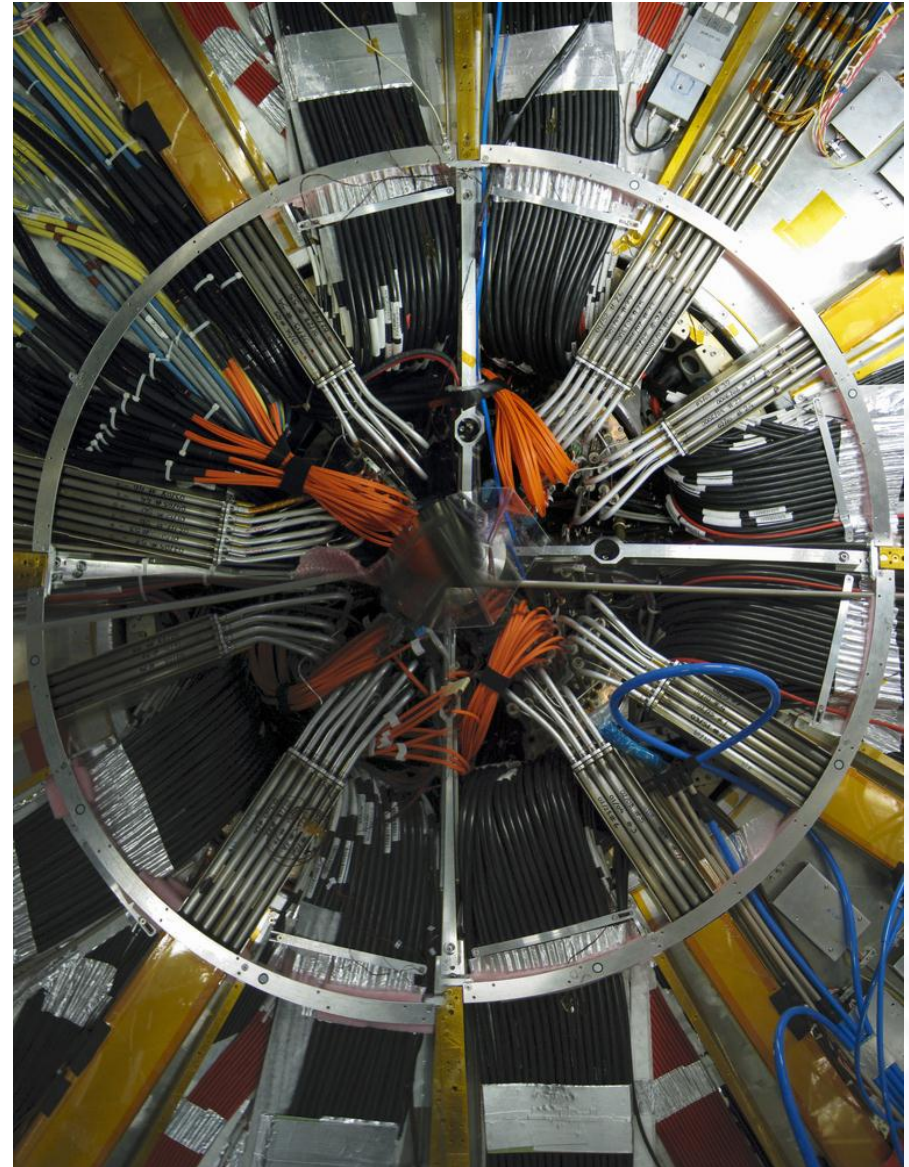
- Connectivity test after installation found
 - Aforementioned problem with HV return; could be bypassed
 - 11 unrecoverable modules
- HV Opens are responsible for majority of unrecoverable modules after installation
- At this point not possible to distinguish between cable and wire-bond problem
- Wire-bonds had low intrinsic reliability so that even after QA some weak parts got through
- Might argue that QC was not strict enough
