A FLØW RATE ISSUES IN THE ALICE SPD COOLING

Rosario Turrisi

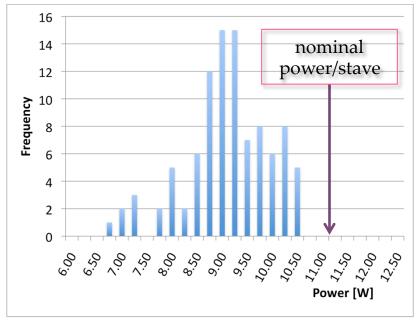
Typical distribution during run

- Performed with AOS 52029 thermal grease
 - real K measured (slightly less than promised)
 - mechanical stress tested
- Long term performance?
- Thermal/mechanical stress?
- It is a minor issue (by now): good sectors

do not show a worse performance

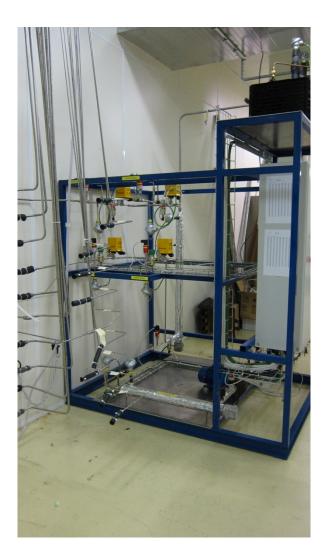
Plant + dummy

- Loss of flow-rate due to filter clogging
- Local inefficiencies due to impedance non-perfect equalization
- Bubbling in the pipe section before the detector
 - caused by a combination of pressure drop (due to filter clogging) and heating of the fluid (thermal contact with environment and slow translation)

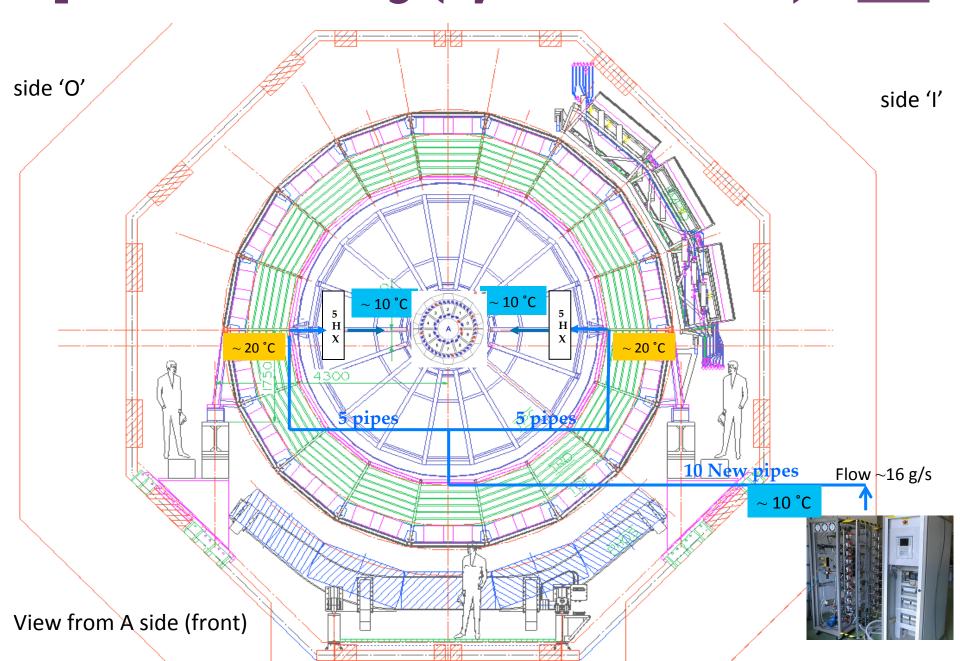
Pipes New routing (Symmetric inlet)

Very low flow rate in sectors 7 and 9;
