CMS ZDC Status

TREX 2025.01.31 D. Lazic Boston University

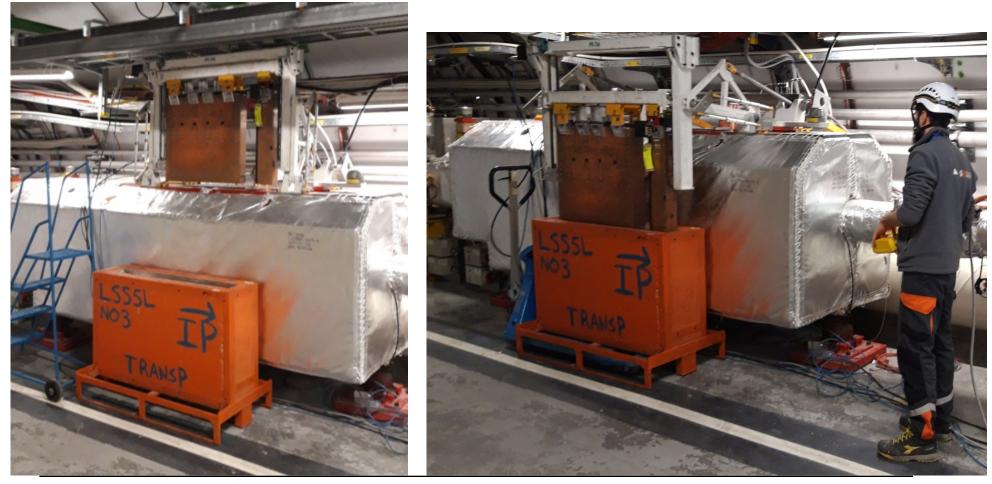
Friday 24th

Steel bars

Presence of a shim under the BRAN reduces the available space for the insertion of the absorber bars. **Could it be replaced with a smaller piece?**

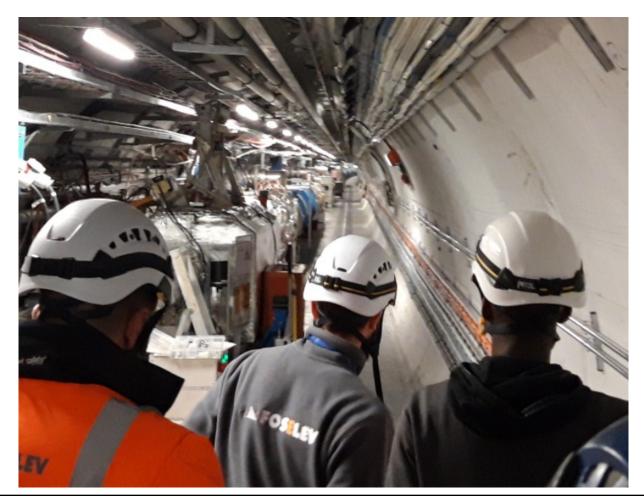
"The Tool"

Lowering objects into the TAN is always complicated due to uneven surface of the gaps. The bars and/or calorimeters occasionally get stuck.

Instead of wiggling the (highly radioactive) absorber bars by hand, the new tool allows to do it from a much safer distance!

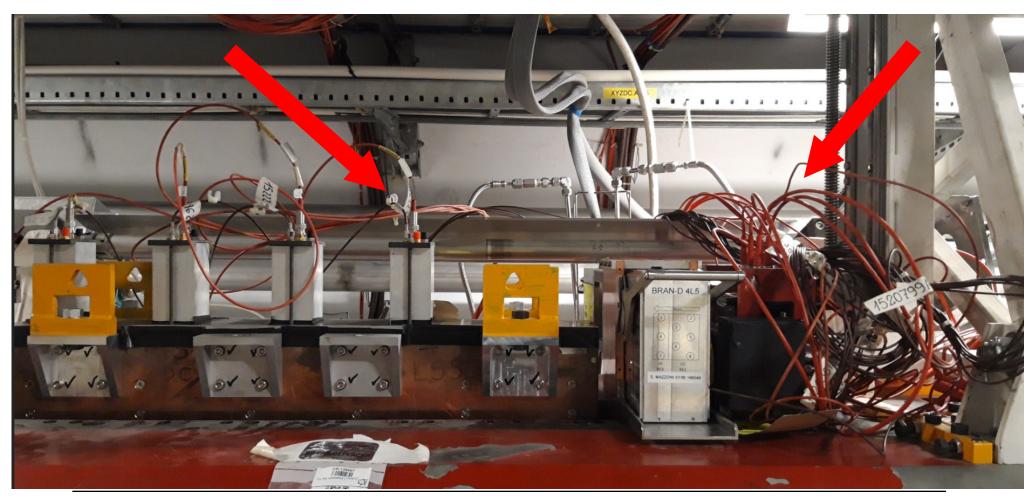
The shortest intervention

The shortest path to the Transport side of TAN is between the arms of the minicrane...

... but it conflicts with ZDC removal and absorber bar insertion, so at the end of the run you have to disconnect the cables and put them back to the rather inconvenient place!

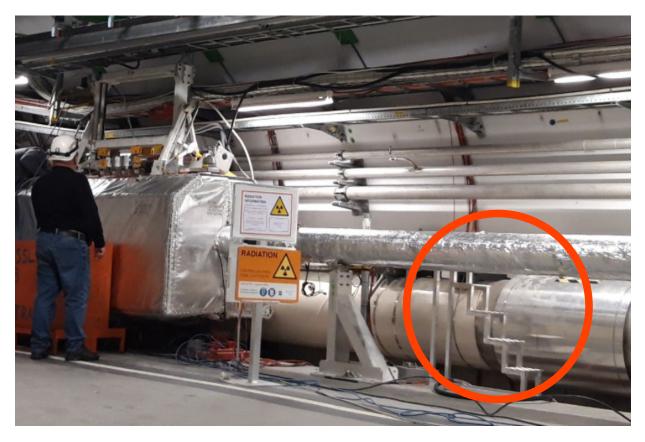
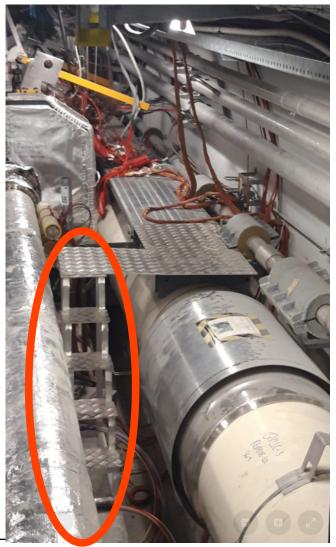
Platform

Platforms behind TANs were built for this kind of interventions and the access is quite simple by using the stairs.
