MQXFB09 Coils: Coil fabrication, manufacturing data and NC

N. Lusa, S. Izquierdo Bermudez, L. Baudin, A. Vieitez Suarez, P. M. Quassolo,
L. Grand-Clement, R. Berthet

06/02/2025

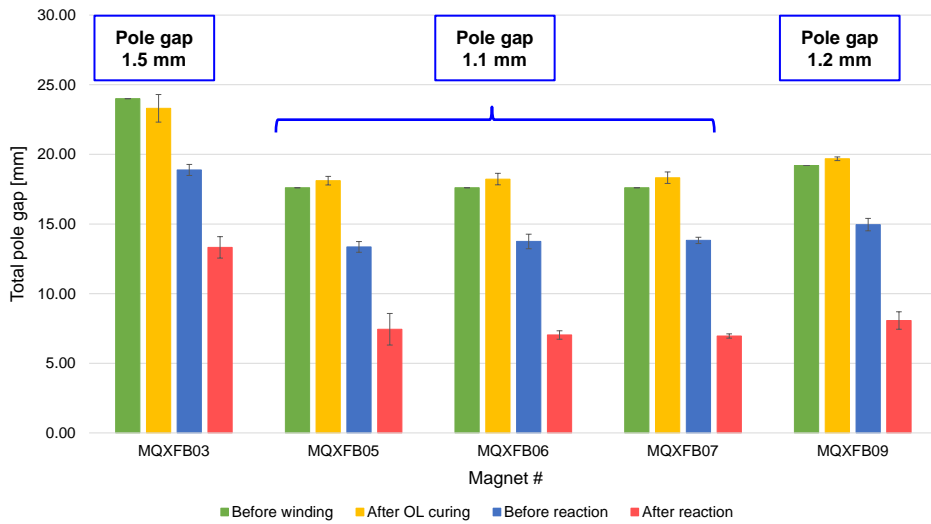
Pole gap evolution: from winding to reaction

- In new generation MQXFB coils pole gaps in the middle of the coil are not closed after reaction, as it is the case for AUP coils

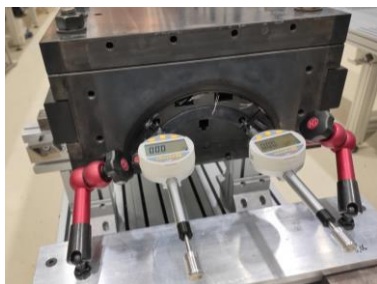
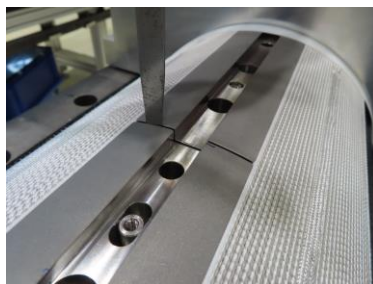
Pole gaps vs Coil elongation

- The reacted coil gradually elongates on both ends during the mold opening and pole gap increases ([indico 1220226](#))
- From coil CR150 pole increased: 2.46 mm/m → 2.69 mm/m

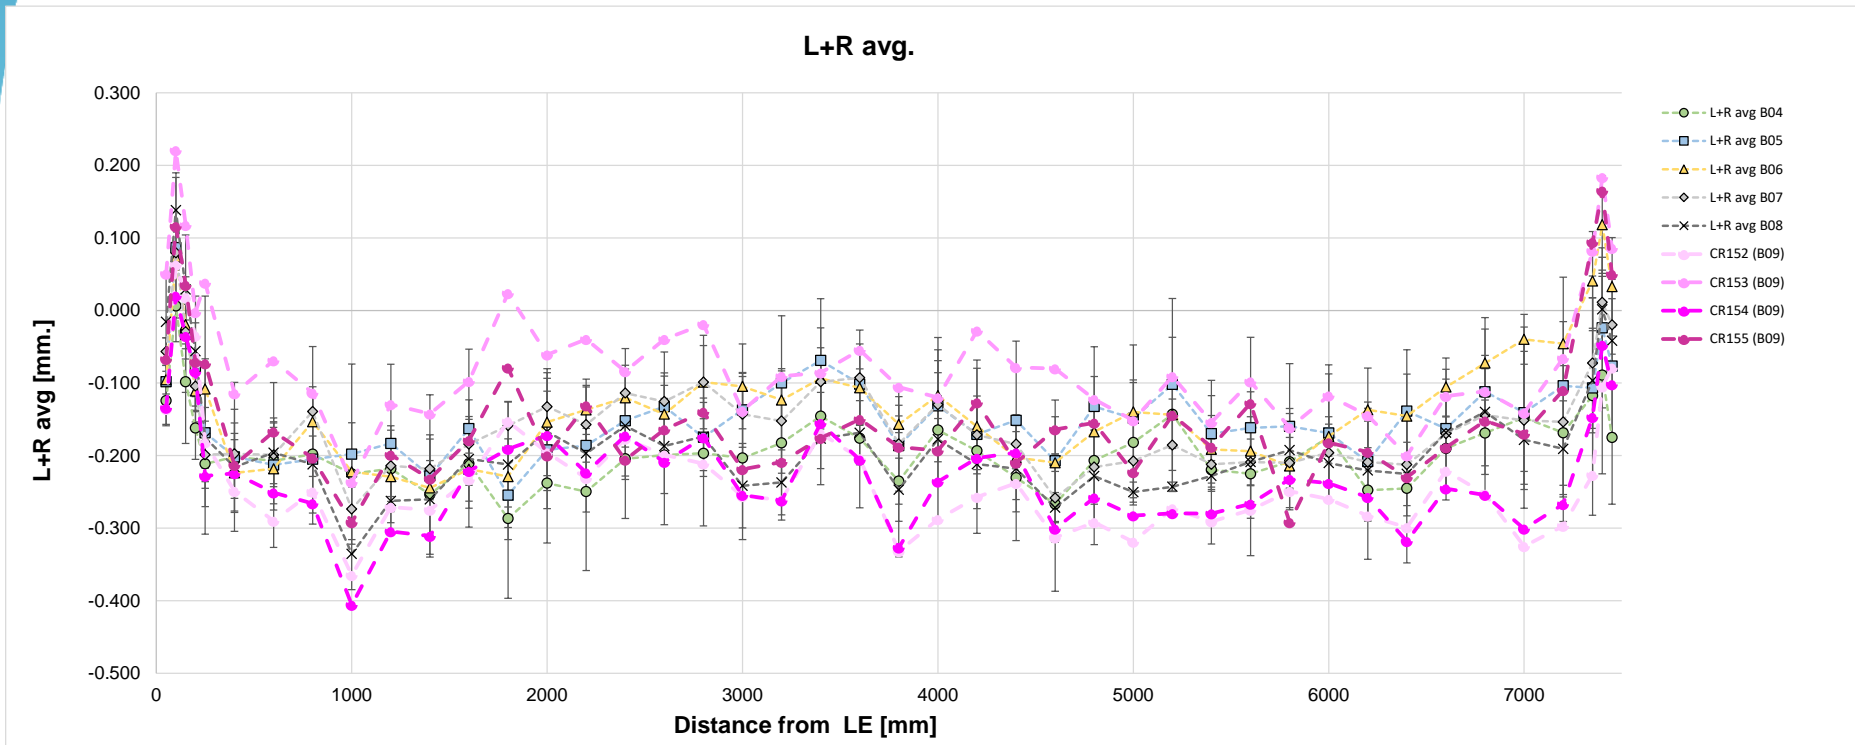
Impregnated coil geometry (Faro arm) - L+R

- The coils do not have 'belly'

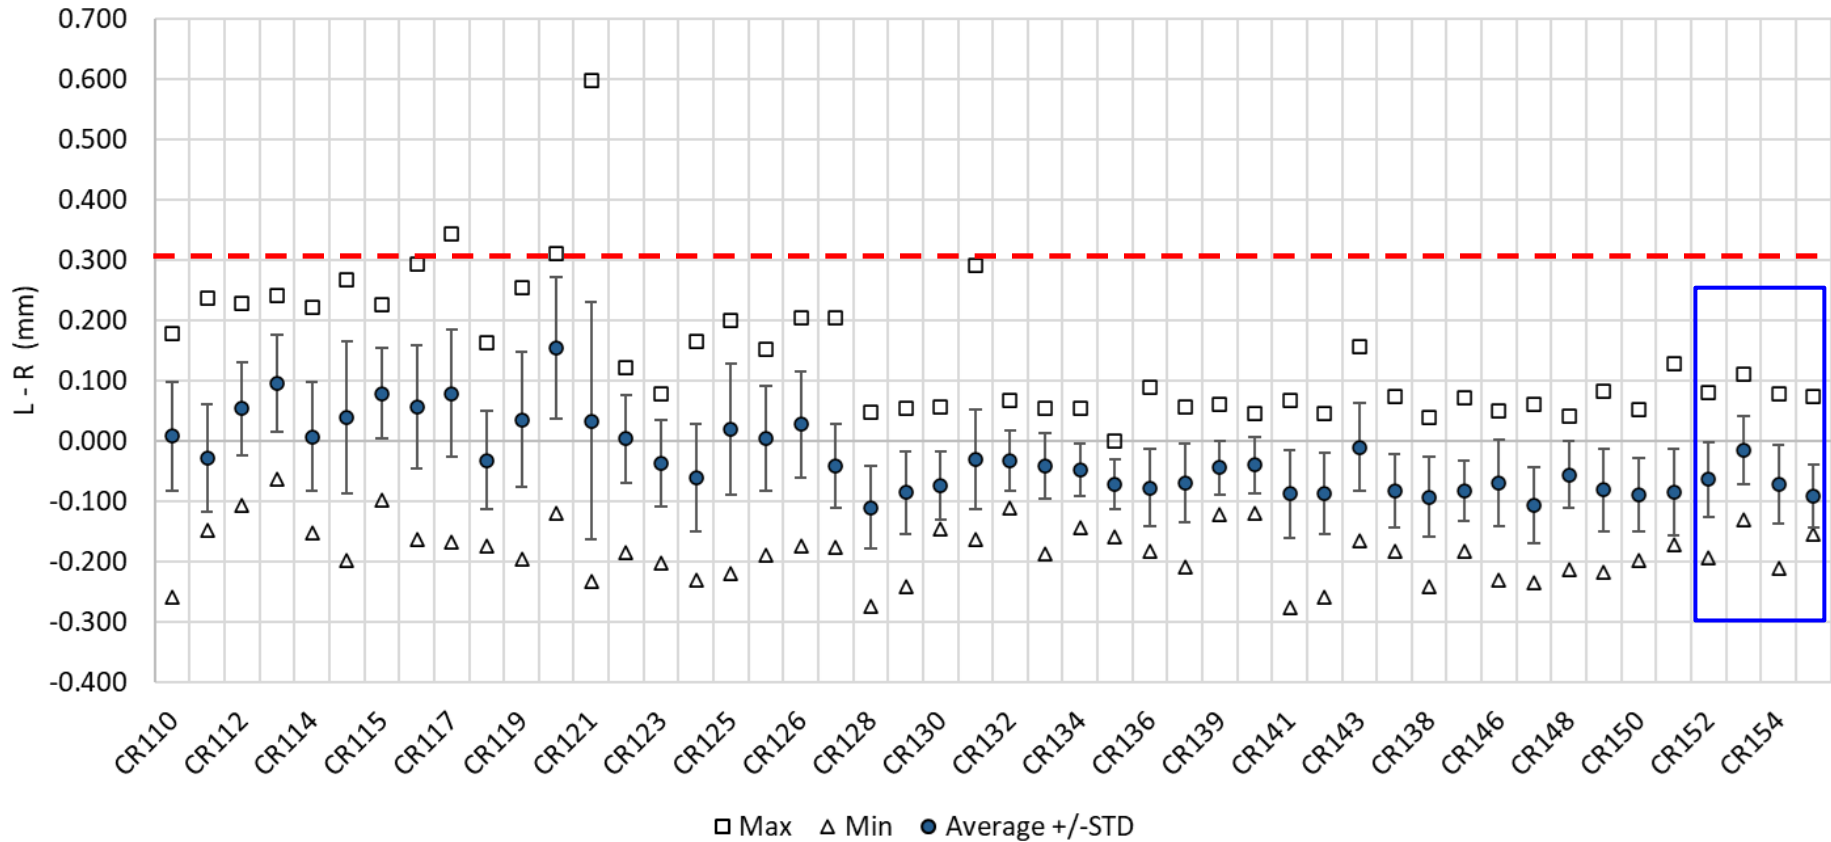
Impregnated coil geometry (Faro arm) – L-R

- In terms of asymmetry, within specification (<0.3 mm) → no need of pole key machining

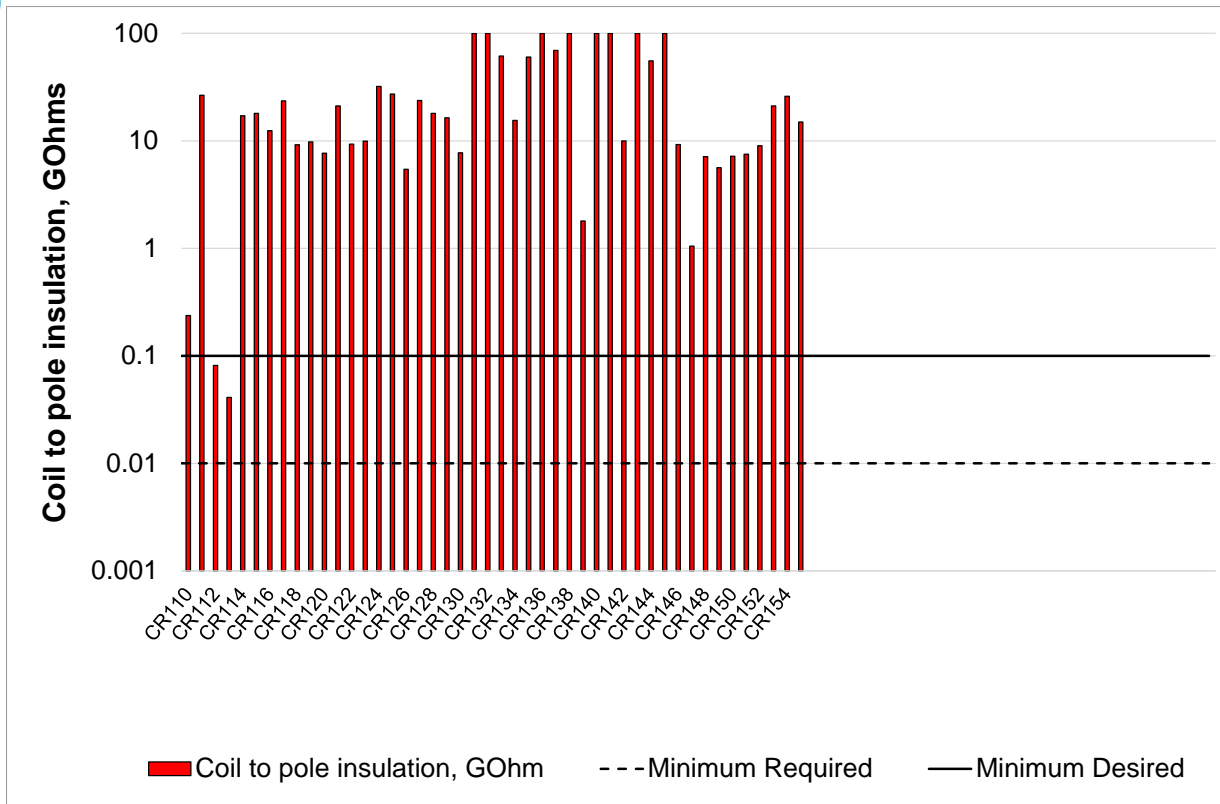
Coil to pole

- Since coil 114, coil to pole insulation always above the minimum desired thanks to the reduction of ceramic binder and the use of heat cleaned fiber glass around the pole

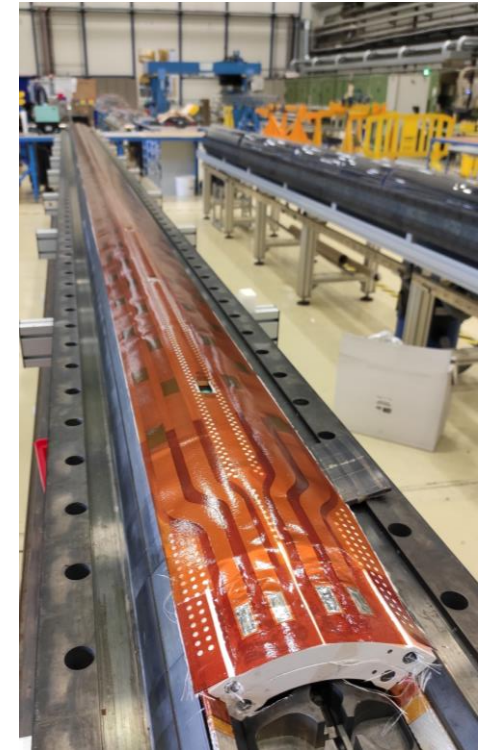
QH to coil

- From coil 126, 'mini-swap' quench heaters with improved fabrication process and higher qualification test voltages (see [EDMS 2646046](#))
