Target Status

Edward Overton on behalf of the
Target Team

T1 Failure

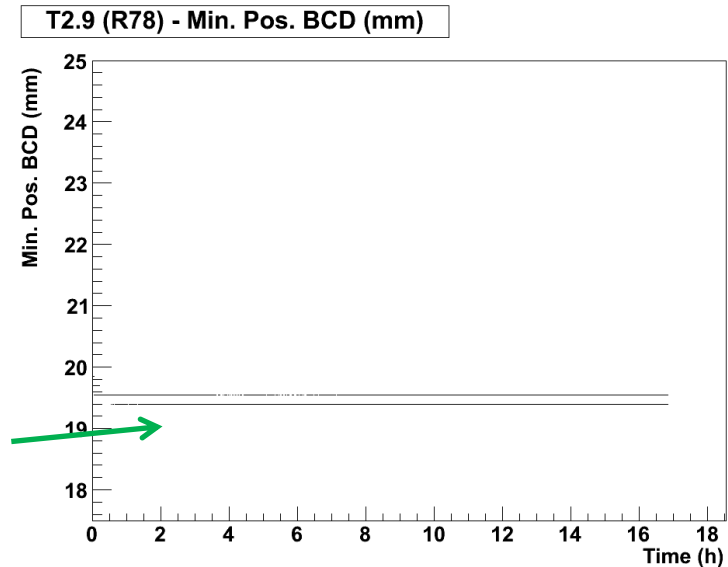
- Replaced T1 with stator from R78 (T2)
- Using DLC/VESPEL design which has achieved 1M+ Actuators on T2.4 to T2.8
- T2.9 has been fitted with a new shaft and bearings
- T2.9 was installed on 13th September
 - Tested in R78 for 50K actuators, looks OK.

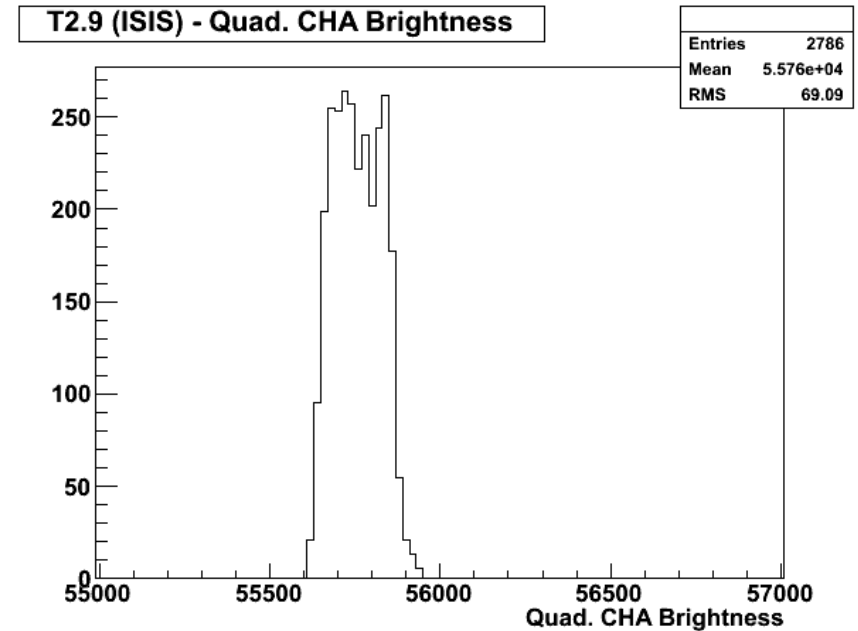
- FPGA controller reads out a digital summary after each actuation. This is written to disk.
- Includes information such as the minimum position reached and duration of the actuation.
- Brightness of optical fibres from optics block added to readout.
- Brightness now monitored in Sheffield. Warnings raised if it drops below 55,500. (ADC output, 16 bit - out of 65535)
- BPS status is also monitored over this interface.

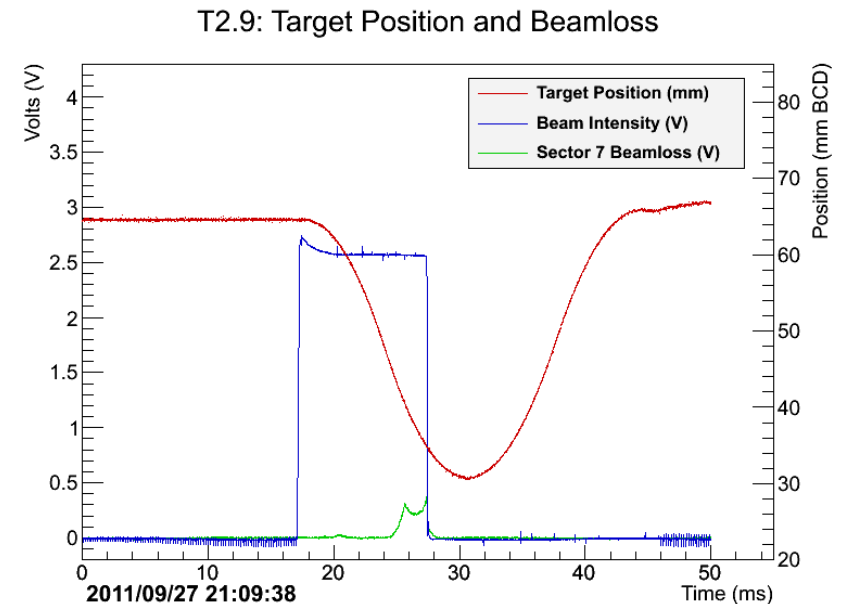
T2.9: Commissioning (Tue 27th Sept.)

- Needed to test system with beam to ensure the system was fully operational, with live signals from ISIS and to MICE DAQ.
- Main goals:
 - Connect target up to ISIS signals and Check operation
 - Find Location of ISIS beam
 - Scan ISIS beam in depth and time
- Found preset values in target (delays, markers) needed minor changes.
- Updated target quick-start checklist
