# Operating experience of the J-PARC RFQs

Y. Kondo, T. Morishita, K. Hasegawa

## contents

- Breakdown problem of the RFQ since 2008.
- Estimated cause of breakdown
- Improvement in current RFQ and next RFQs

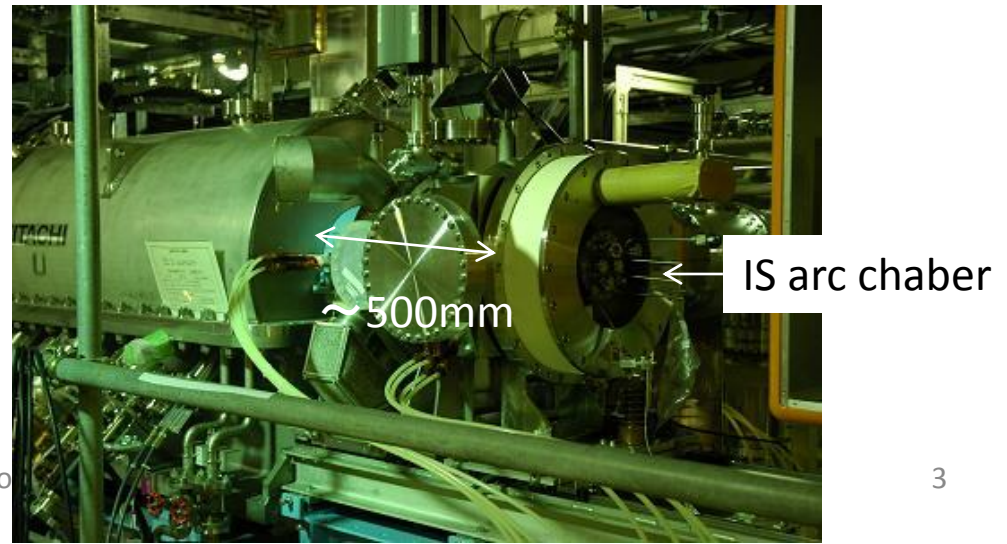
- Surface field of the RFQ is at most 32 MV/m, this value is not extremely high, but...
- An ion source (IS) is “attached to” the RFQ.
- Gas flow from IS is extremely high, especially H<sup>-</sup> ion source.
- Our RFQ is stable enough just as an RF cavity. (i.e. if there is no beam from IS, the RFQ is stable), however, it is useless as an accelerator.
- There are only two high intensity H<sup>-</sup> RFQ, J-PARC's and SNS's, under user operation in the world. SNS's had similar problem.

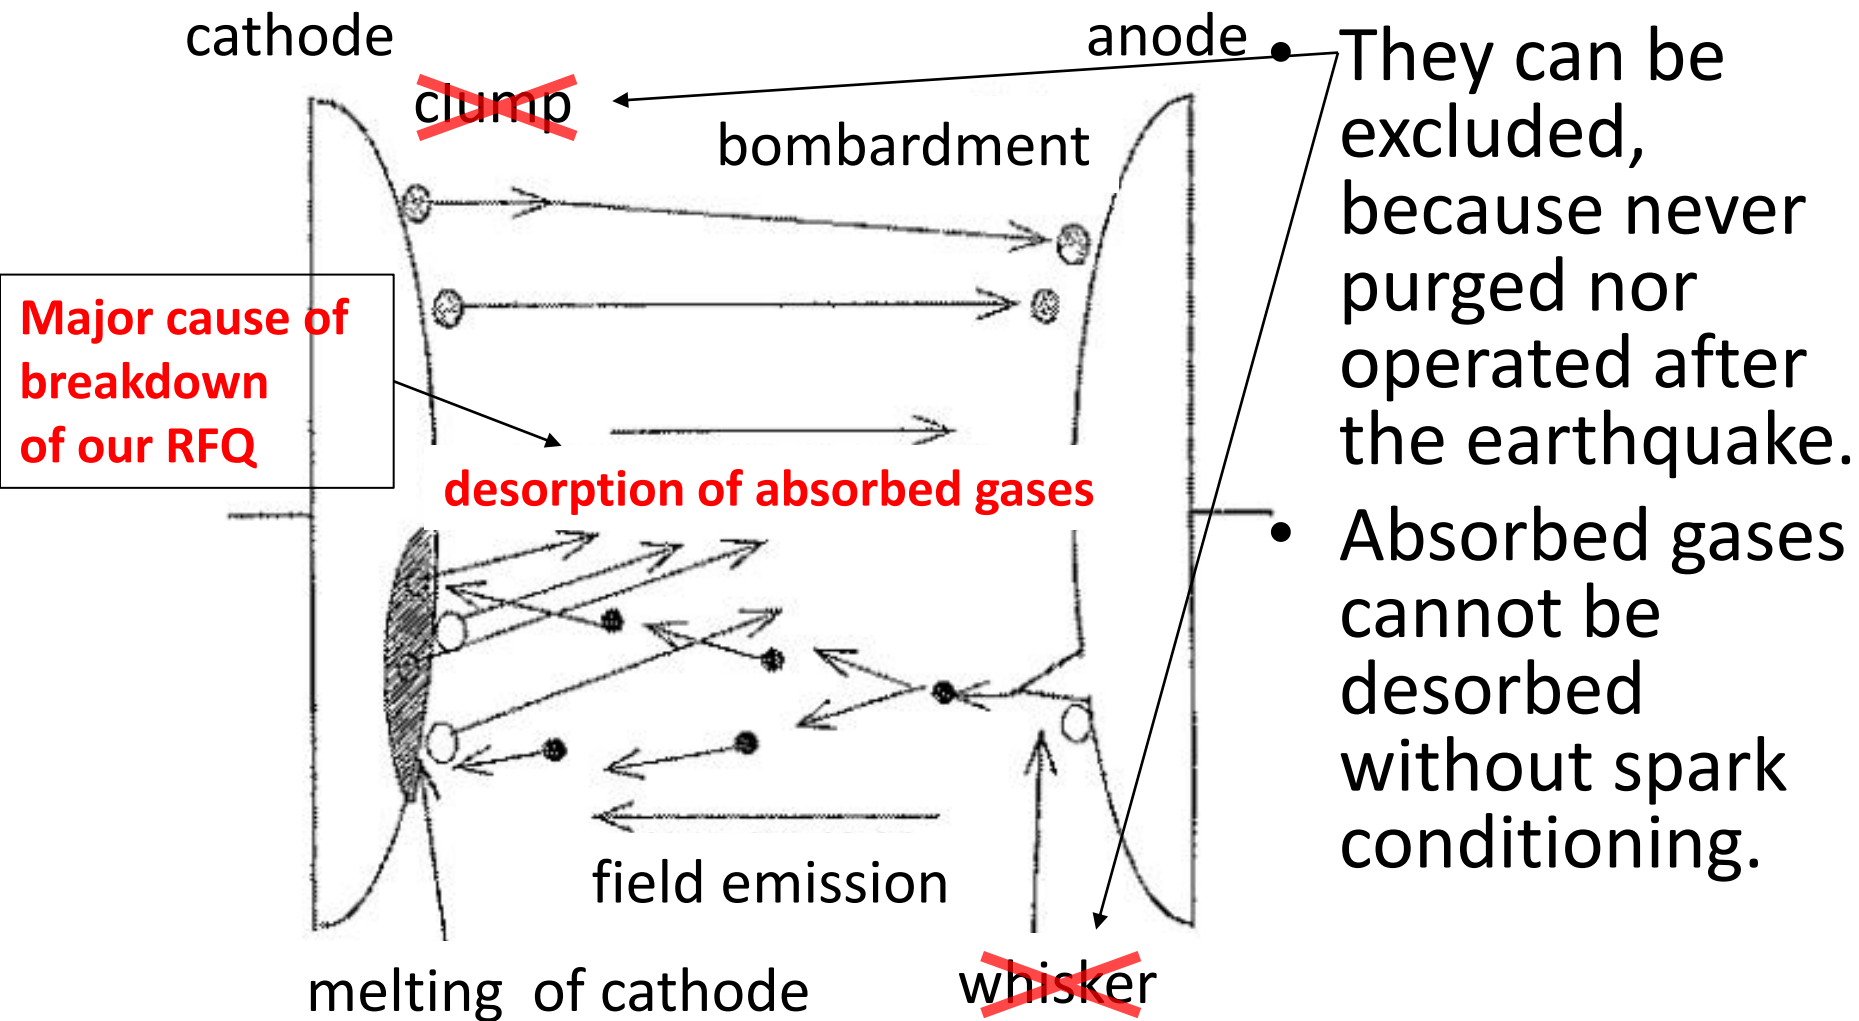
図 1 電界が印加された真空ギャップ電極間で生ずる素過程<sup>12)</sup>

# Various causes of breakdown

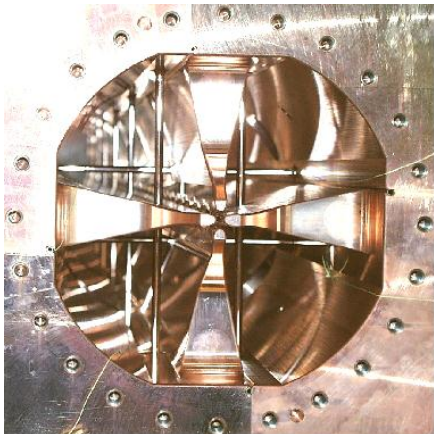
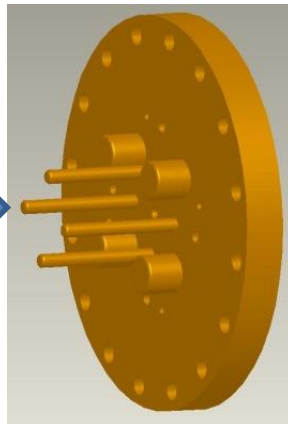
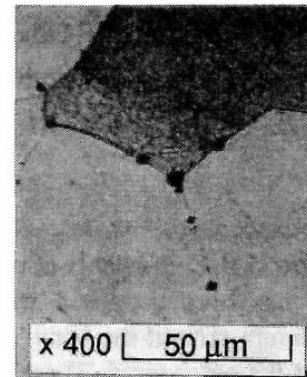
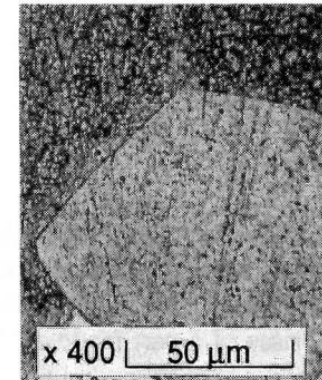
H. Matusmoto et. al., PAC1991, p1008  
Figure 2. Optical micrograph showing forged OFHC (left) and HIP-OFHC (right) at a temperature of 800 °C and an isostatic

- PISL -> DSR (Dipole stabilizing rod)
  - Reduce high field region and source of multipacting

- HIP (Hot Isostatic Pressing)
  - Reduce voids between grains
