CMS Preshower Excess Leakage Currents

Alan Honma

Excess Leakage Current Problem History

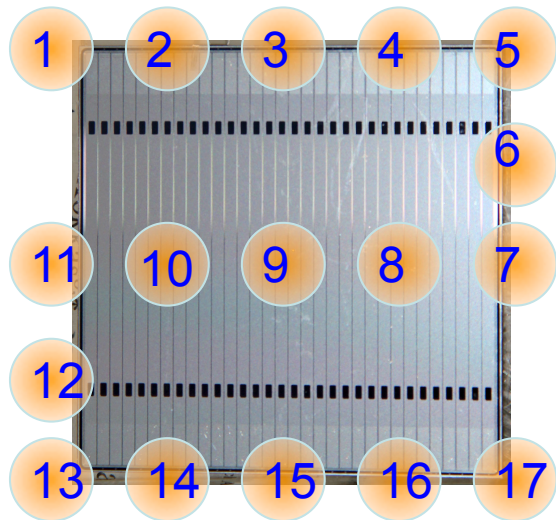
X-Ray machine in PH/ESE (bldg 14) used to provide high dose surface irradiation. Typical energy 20KeV (should stop in first few microns of sensor).

- So far excess currents from X-rays observed for MTC (6/6), ERSO and Indian sensors. Not for Russian or HPK even up to 60 Gy/point. No Demokritos available for testing.
 - Results not reproducible systematically.
 - No position correlations found so far.
 - Amount of radiation required (for MTC) is much more than we should be receiving in LHC (highest expected dose ≈ 5 Gy for all 2010)
- Interesting positive results with higher humidity to remove excess current. Likely explanation is humidity leads to negative surface charge which increases hole mobility, eliminating trapped charges. Unfortunately, adding humidity to Preshower volume could cause condensation/frost problems.
- Conclusion: many similarities between X-Ray induced currents and excess currents in Preshower. Thus, strong evidence for surface leakage but mechanism not fully understood.

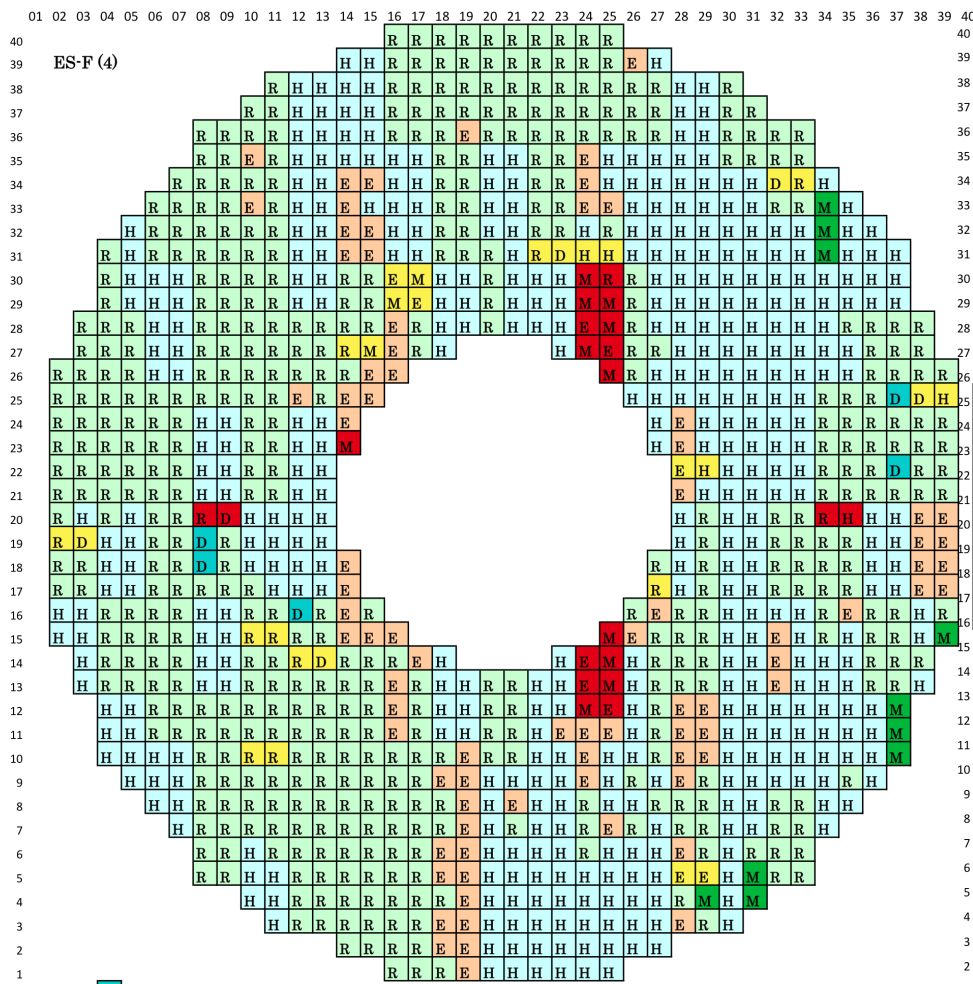
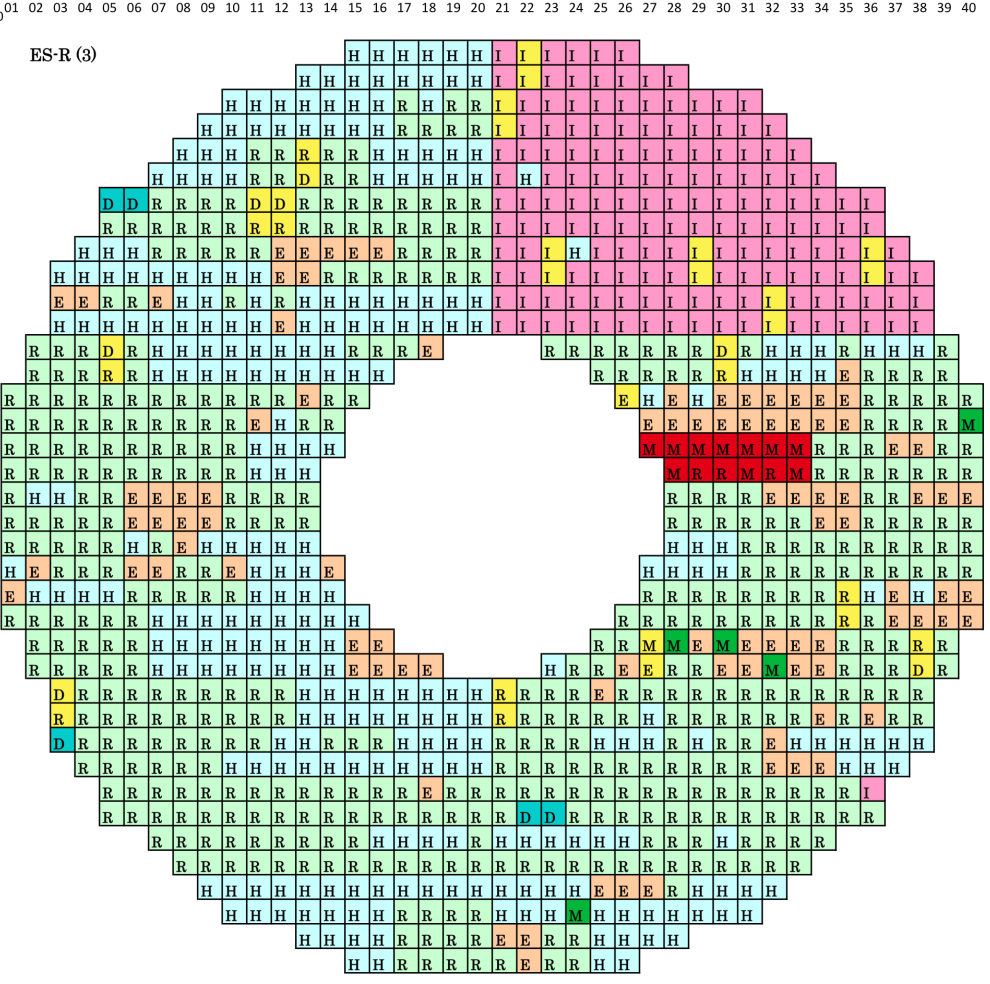
ES minus Rear

- D Demokritos
- E ERSO (Taiwan)
- H Hamamatsu
- I India
- M MTC (Taiwan)
- R Russia
- Disconnected
- Leakage current >20uA

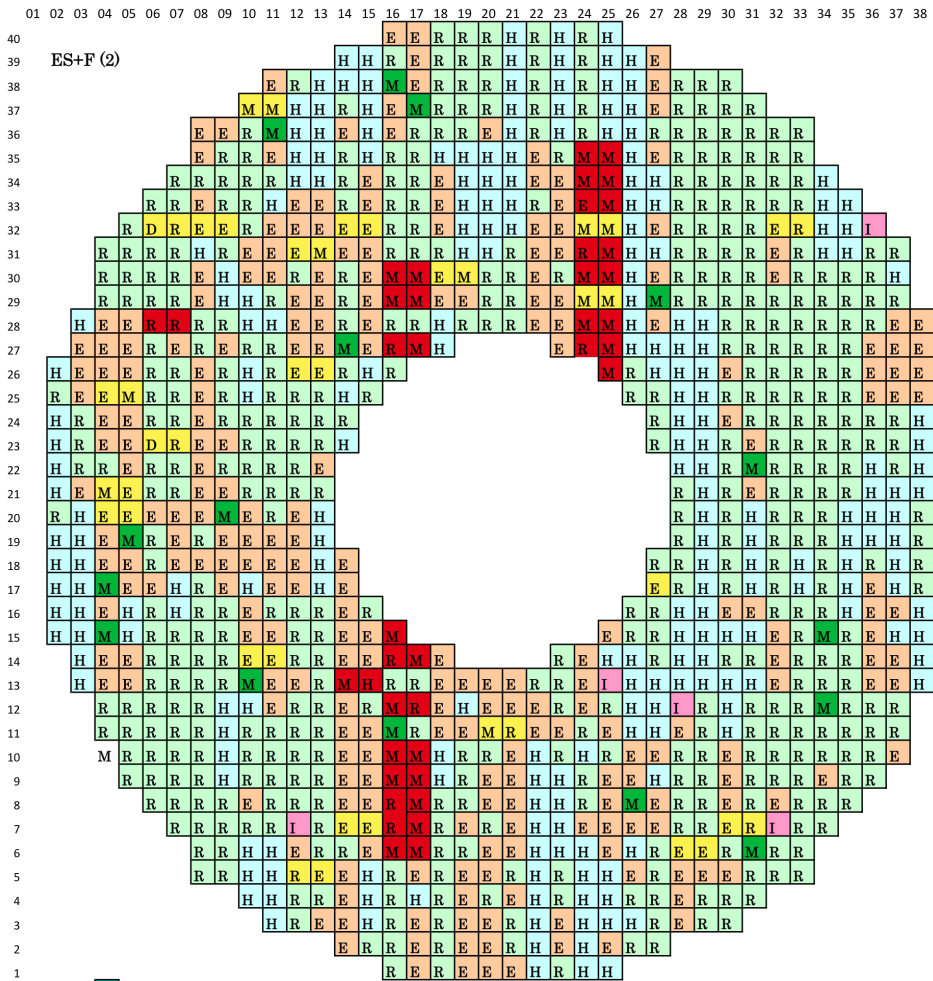
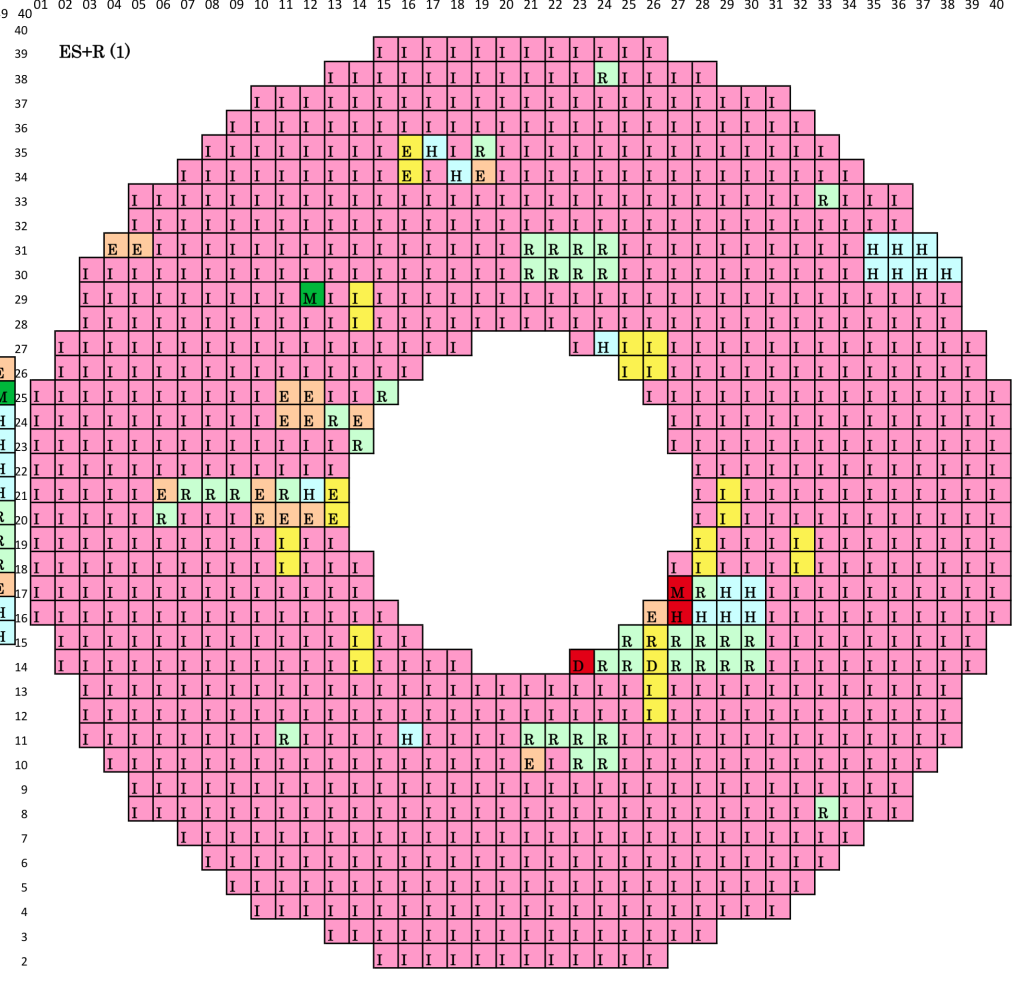
ES plus
Rear

- Demokritos
- ERSO (Taiwan)
- Hamamatsu
- India
- MTC (Taiwan)
- Russia
- Disconnected
- Leakage current >20uA
