Status of J-PARC Recovered from the Earthquake

Michikazu KINSHO

J-PARC/ KEK&JAEA

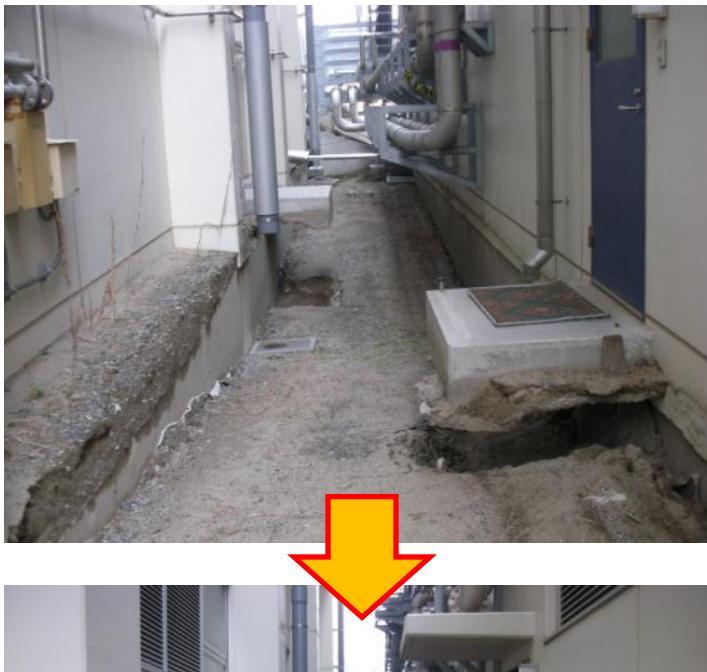
Hadron Experimental Facility

Immediately after the Earthquake

Repairing roads and plumbing have been completed.

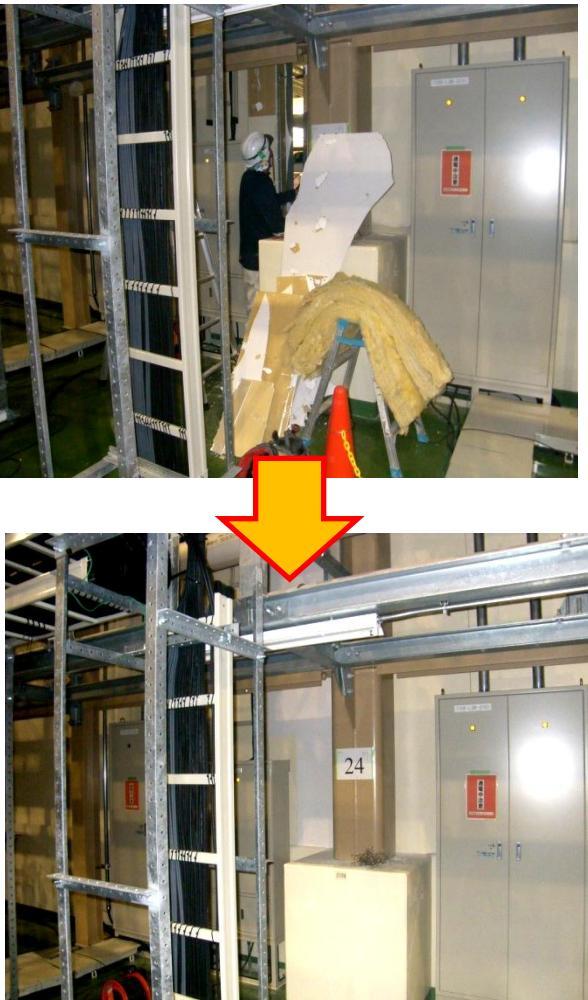
Many damages on partitions and ceiling boards of the building.

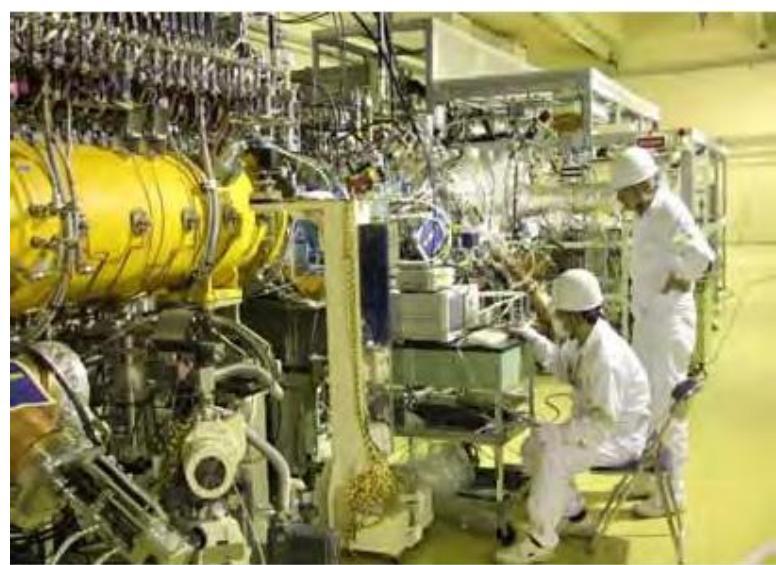
- Test of the vacuum.
 - > No serious problems. Mass spectroscopy detected H_2O .
- Q-value and frequency for DTL measured.
 - No serious problems.
- Inspection of the cavity has been continued.
 - No serious problems.

Low power test for DTL.

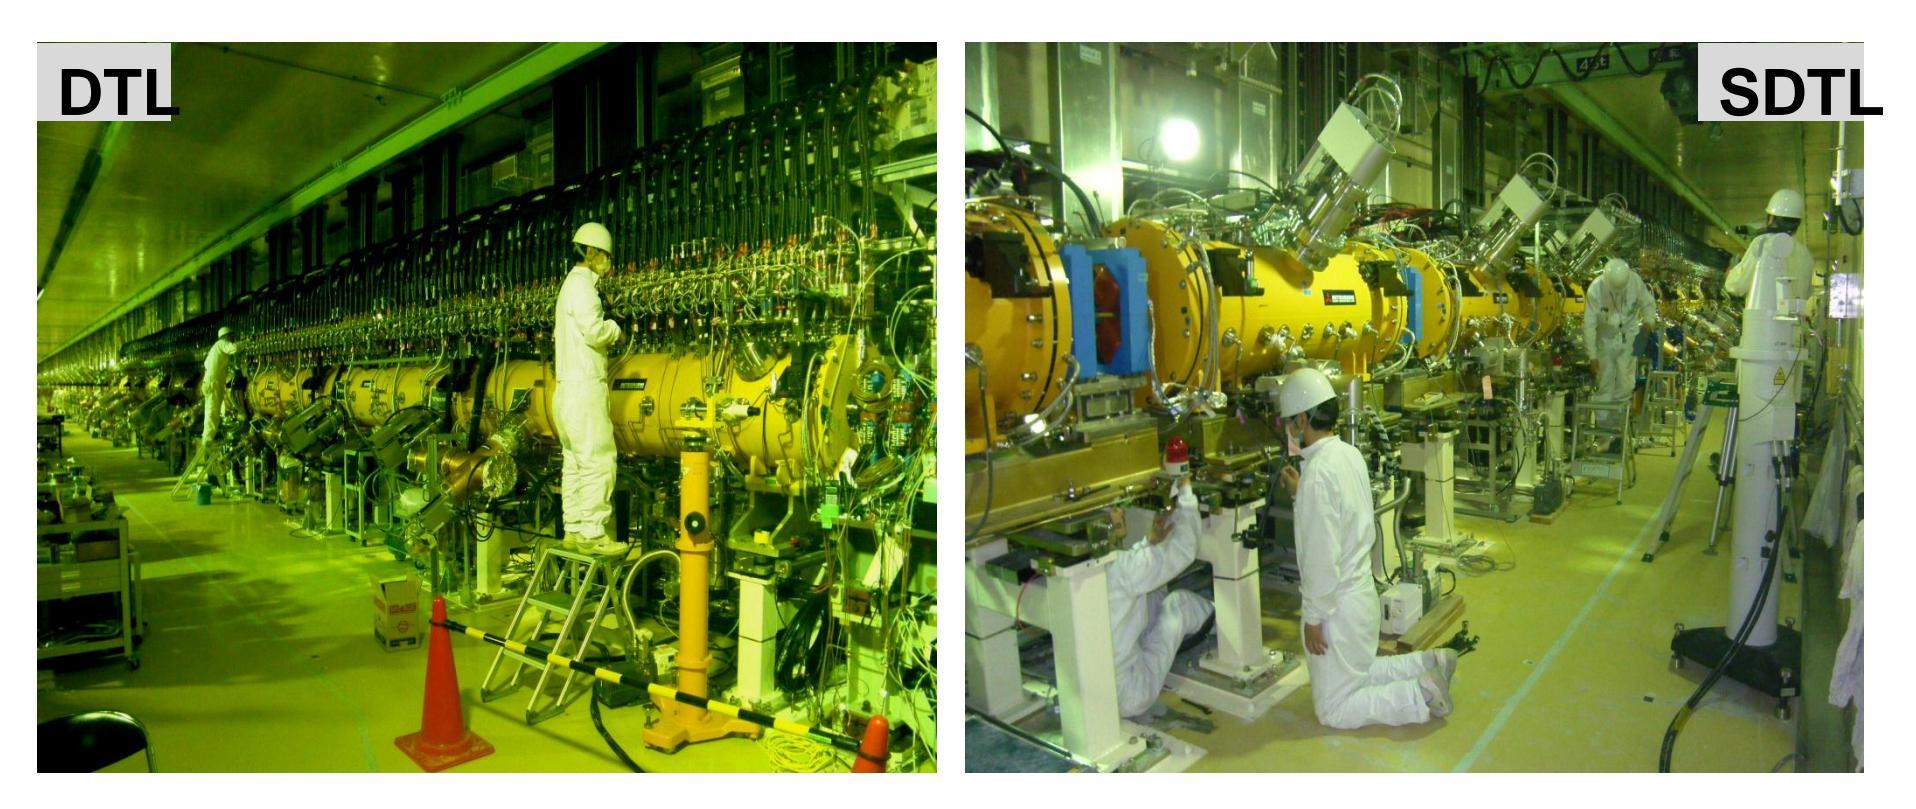
Realignment

The floor level sagged 4 cm downward in the tunnel. Since accelerator cavities should be aligned within $\pm 1 \text{ mm}$ to each other along the beam line for the operation, they have been leveled and realigned where necessary.

It is time-consuming work to move the DTLs by several centimeters because a large number of heavy cables for electromagnets are connected.

We considered a better scenario for the realignment of the DTLs and also SDTLs to meet the entire restoration schedule with minimizing an effort on the beam degradation.

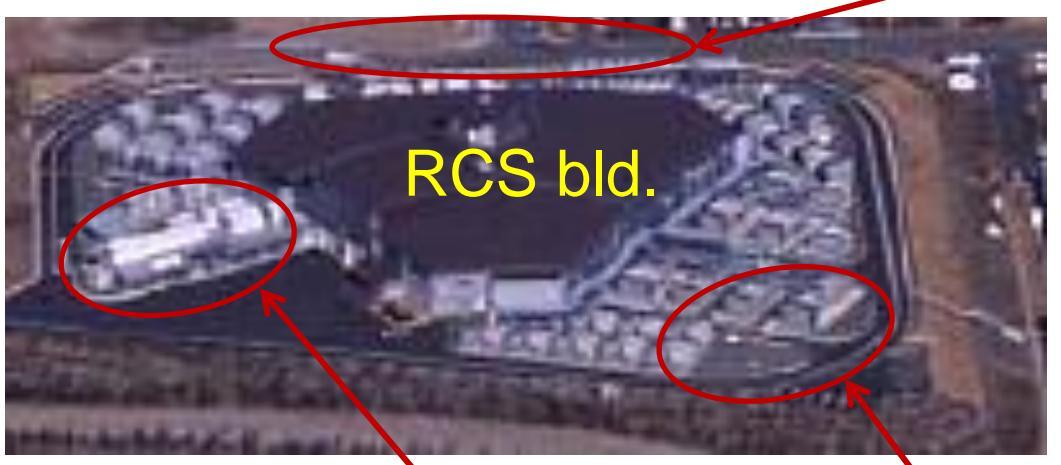
Damage - RCS -

The subsidence of the outdoor yard and the surrounding road was extensive at the RCS.

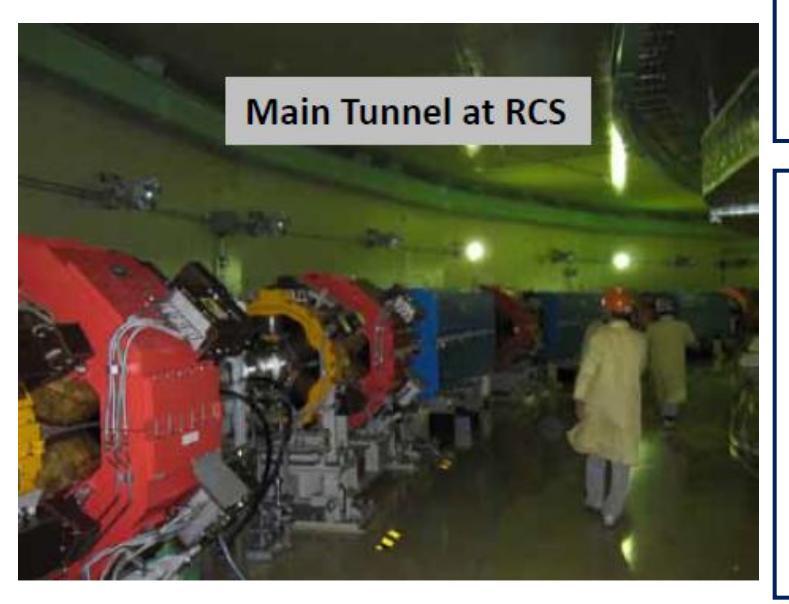
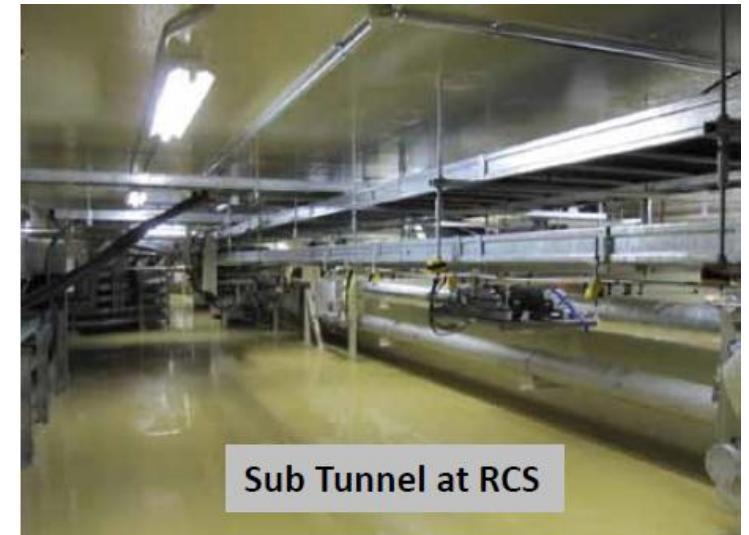
No obvious damages were observed.

The confirmation of the vacuum system, rf system and so on has been carried out by securing the lighting with a diesel engine power generator for a while. *Big problem was not found*.

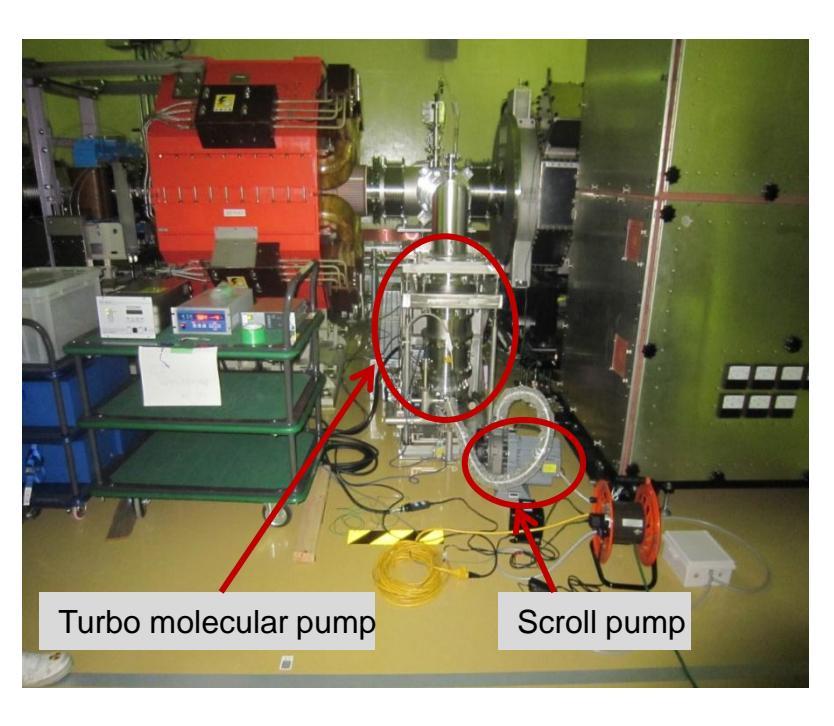
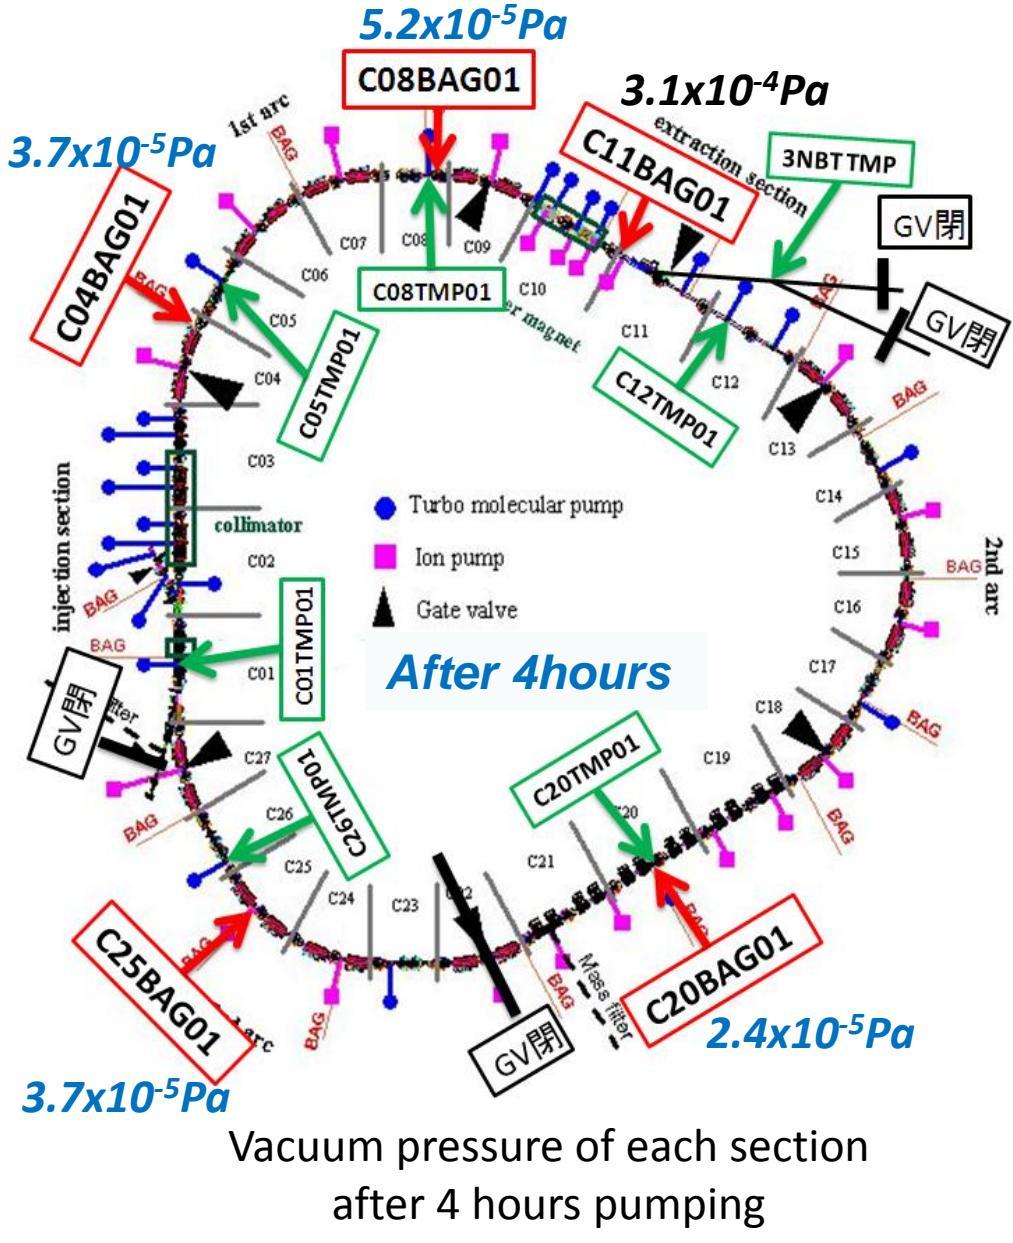
Vacuum test

Our biggest concern was the status of ceramic chambers.

- We conducted a vacuum test using 6 turbo molecular pumps.
 - The vacuum pressure dropped to an order of 10⁻⁴~10⁻⁵ Pa after 4 hours exhaust.

There were no large leaks in the chambers of the RCS.
