**2nd inter-experiment workshop
on pixel operational experience**

CERN, March 8, 2012

FLOW RATE ISSUES IN THE ALICE SPD COOLING

Rosario Turrisi

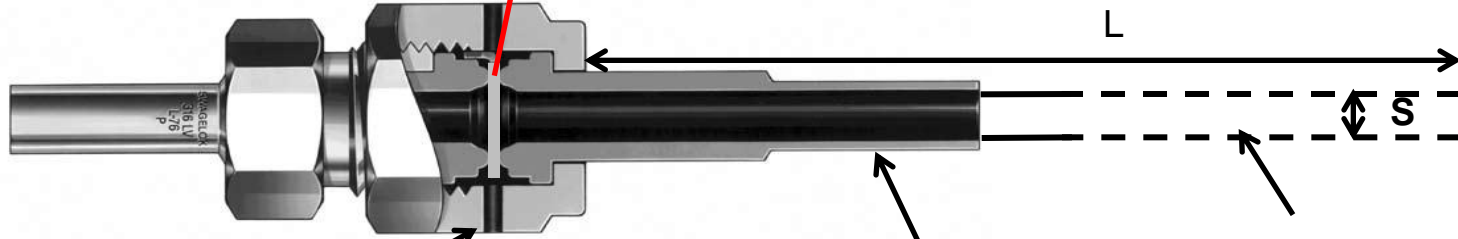
Filter Swagelok SS-4-VCR-2-60M

D = 5.6 mm

T = 11.8 mm

X = 0.7 mm (~1 mm in the filtering area)

S = 4 mm

L = ~5000 mm

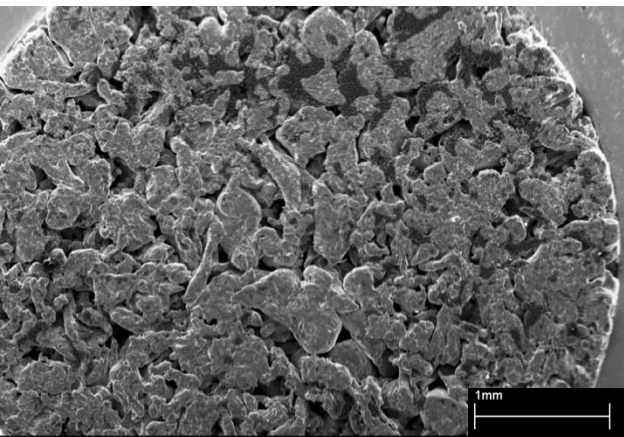
← SEM picture of the filter

Analysis of a filter taken from PP4, in place for 1 year approx.

Results and conclusions: "In the used filters several exogenous fragments were located clogging the filter. There were several fragments containing different composition elements. In addition to elements from the Stainless steel, the following traces of elements were found: O, Al, K, C, Sn, Cu, P, Ca, Cu, Na, Cl and Zn."

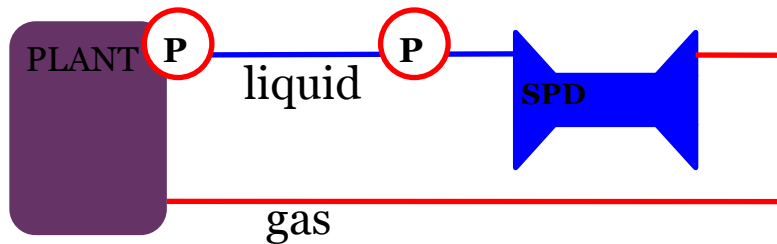
- Principle: look at the correlation (slope) between the pressure set at the plant and the pressure close to the detector

Test done in 2009

Observed behaviors:

1. "Good" sectors have a higher pressure drop
2. "Bad" sectors are more "sensitive" to pressure changes ...

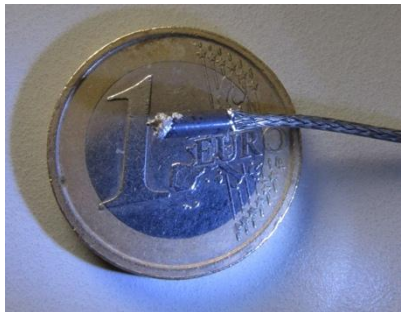
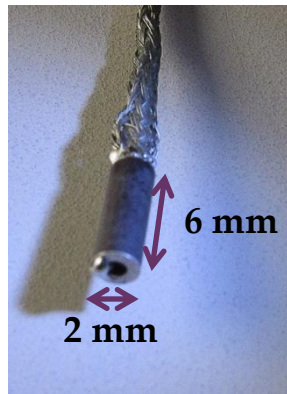
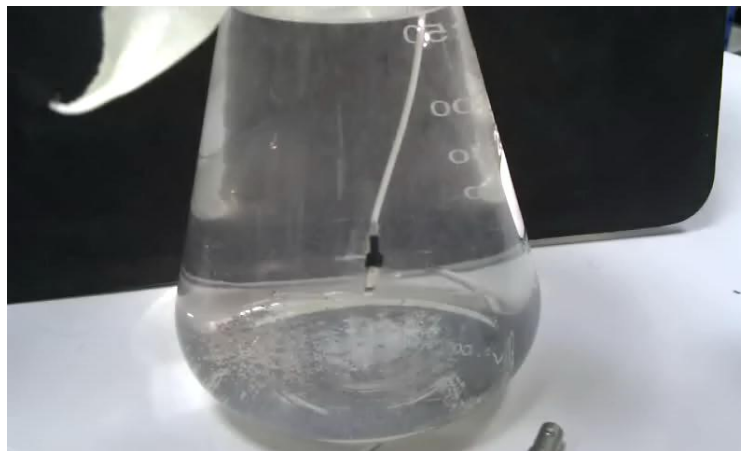
- Counterflow flushing with solvents
 - used METKLENE C3 ("SUPERFLUSH") for ~1 h
 - no clear effect – flow changed <10%
- Generate the ultrasounds close to the filter with piezoceramics:
 - tubes with size $6 \times 2.2 \times 1.0$ (LxODxID), transversal oscillation, $\nu_R \sim 3.8$ MHz
Material is PIC 181, a modified lead zirconate-titanate

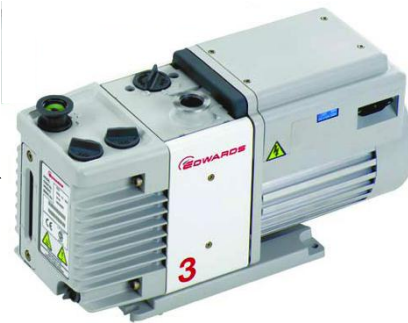
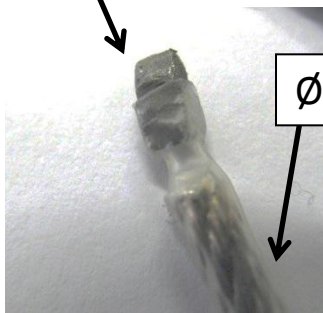
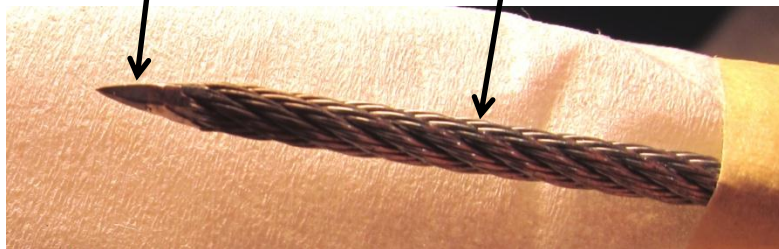
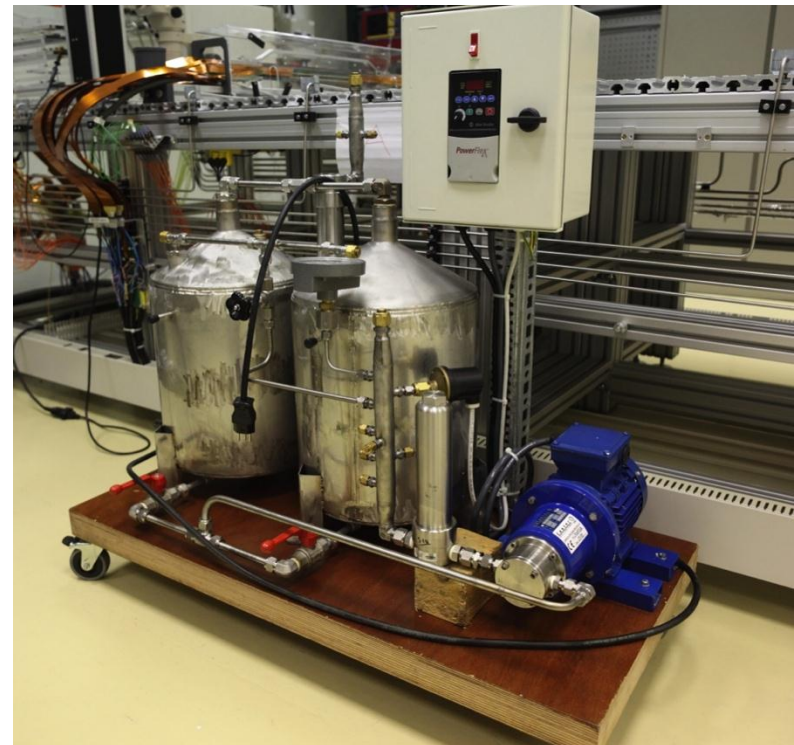
Edwards RV3 rotary vane 2-stage pump

magnet

Ø 2.5 mm ss twisted cable

cleaning machine

tungsten carbide 5-faces tip

- rotation of the tool inside the pipe by the drill
- pressure drop (~20-50 mbar) on a manometer with specific trend when hole done

1. suction of drilling remains with small pipe inside the stainless steel pipe (down to the filter) and vacuum pump
2. “walk” with magnet inside the pipe
 1. the steel of the filter is slightly magnetic
3. counter-flow with C_6F_{14} for 30' @ 1.5 bar
4. pipe drying with Ar flow @ 1.5 bar
5. repeat 1-4 4 more times (5 cycles total)
6. last counter-flow with fluid lasts 12 h

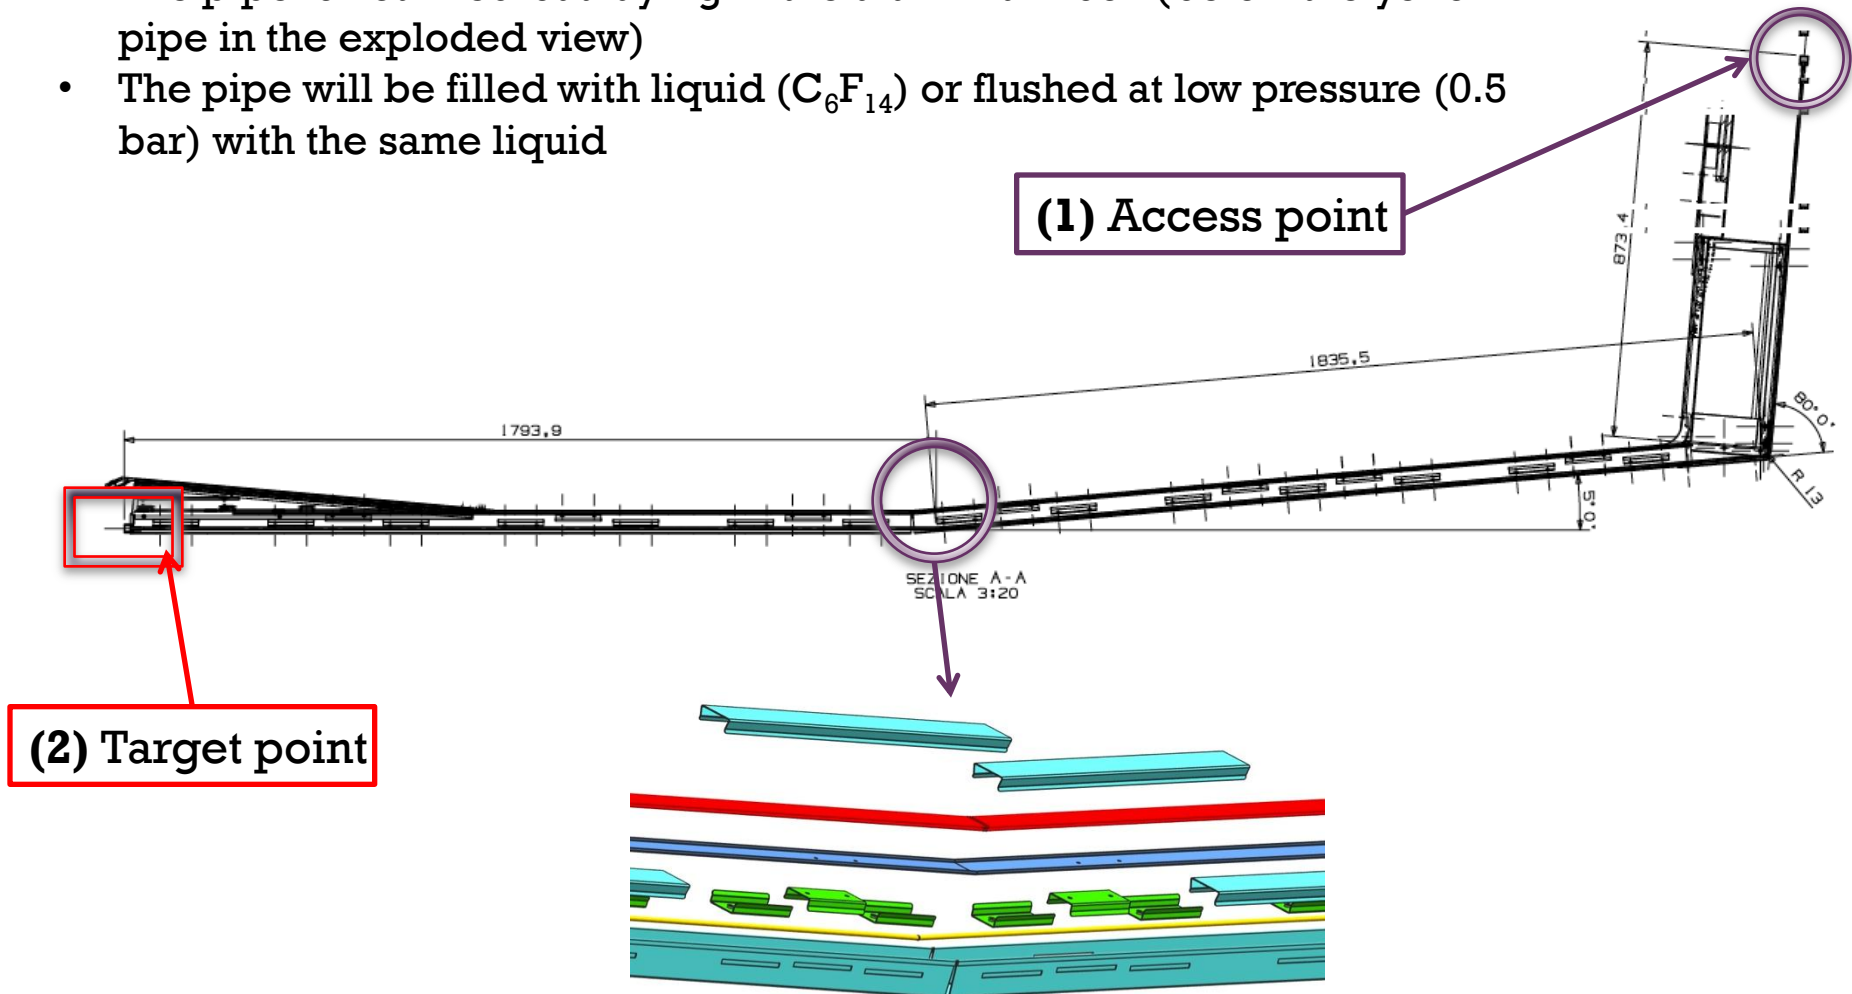
+ Layout of the circuit

- The pipe is in yellow
- The access point (1) is ~4.5 m away from the target point (2).
- The pipe is not fixed but laying in the aluminium box (below the yellow pipe in the exploded view)
- The pipe will be filled with liquid (C_6F_{14}) or flushed at low pressure (0.5 bar) with the same liquid
