# Cooling Tubes-Pipes & their connections from the ATLAS SCT

Richard French – The University of Sheffield

Forum on Tracking Detector Mechanics– CERN 04/07/12

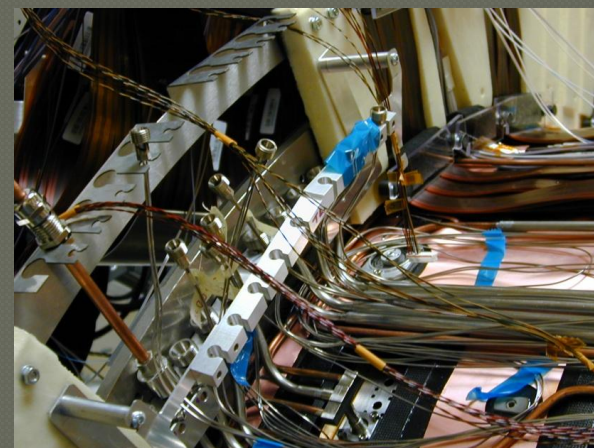
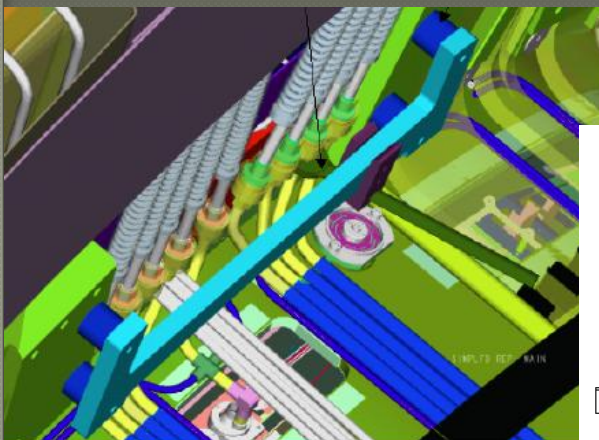
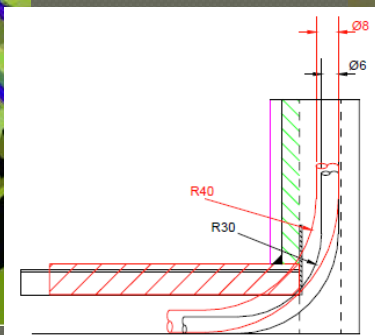
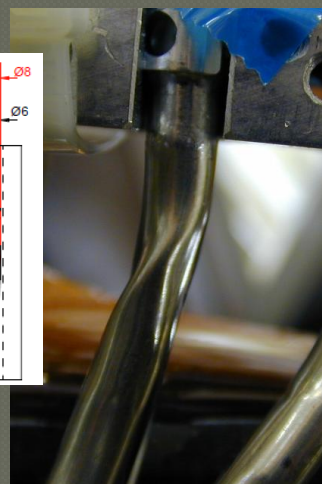
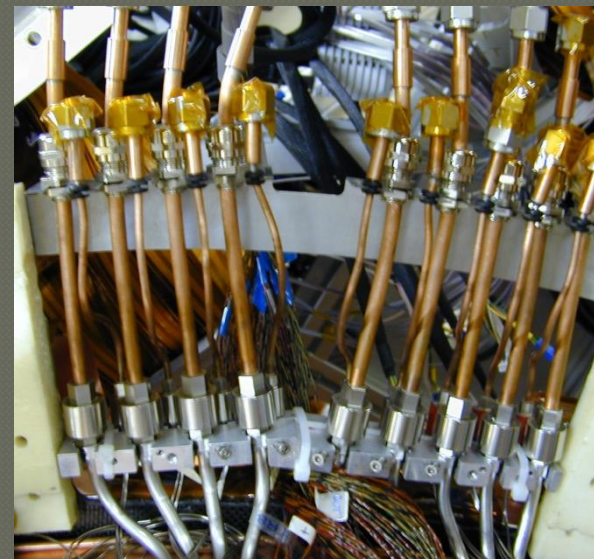
- Services Thermal Feed-through
- Design of restraint problematic
- Torque from fitting damages either:
  - Restraint device or
  - Cooling circuit
- Circuits not ideal fit in area.
- Eventually “made to work”
- Schedule prevents alternative

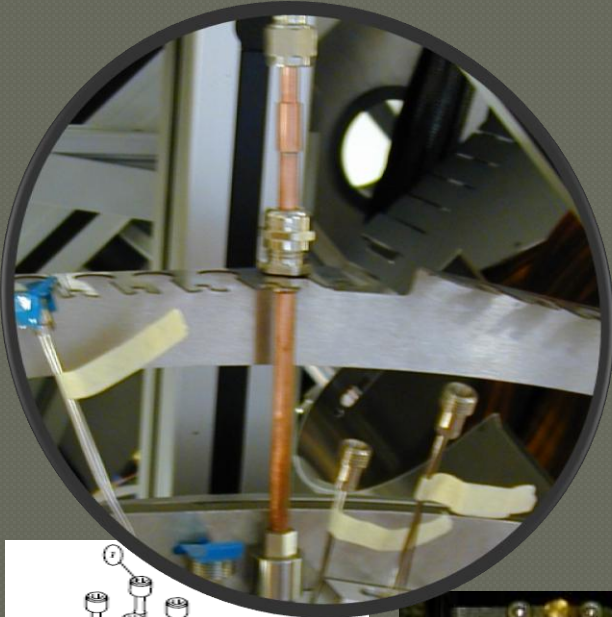
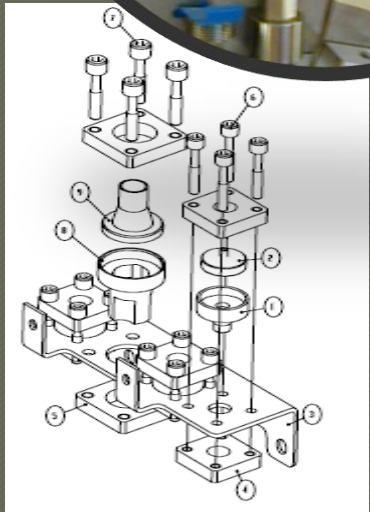
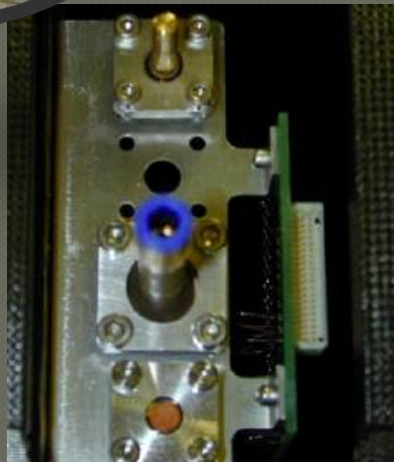
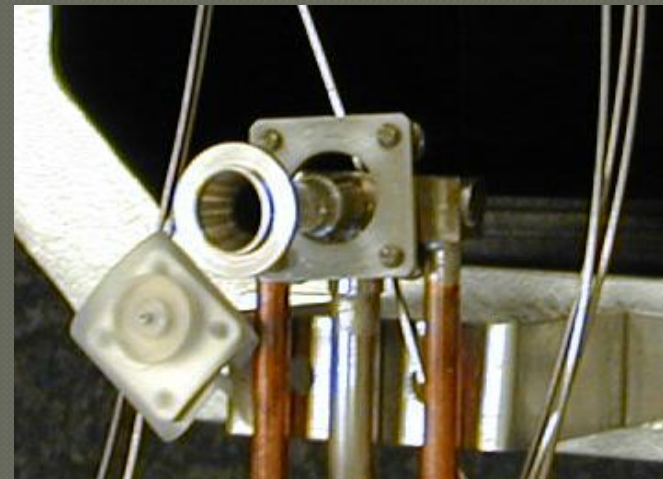
# Temporary Connectors

- Temporary pipe extensions to remove wear and minimise damage to the permanent connections was at time troublesome but overall worth it.
- You never realise how fragile a connector is until you've broken it.
- Testing will cause the majority of failures through simple errors, especially HANDLING.
