Experience with services for the CMS Tracker endcap

The Good, The Bad and The Ugly

Nick Lumb

CERN, 3 July 2012

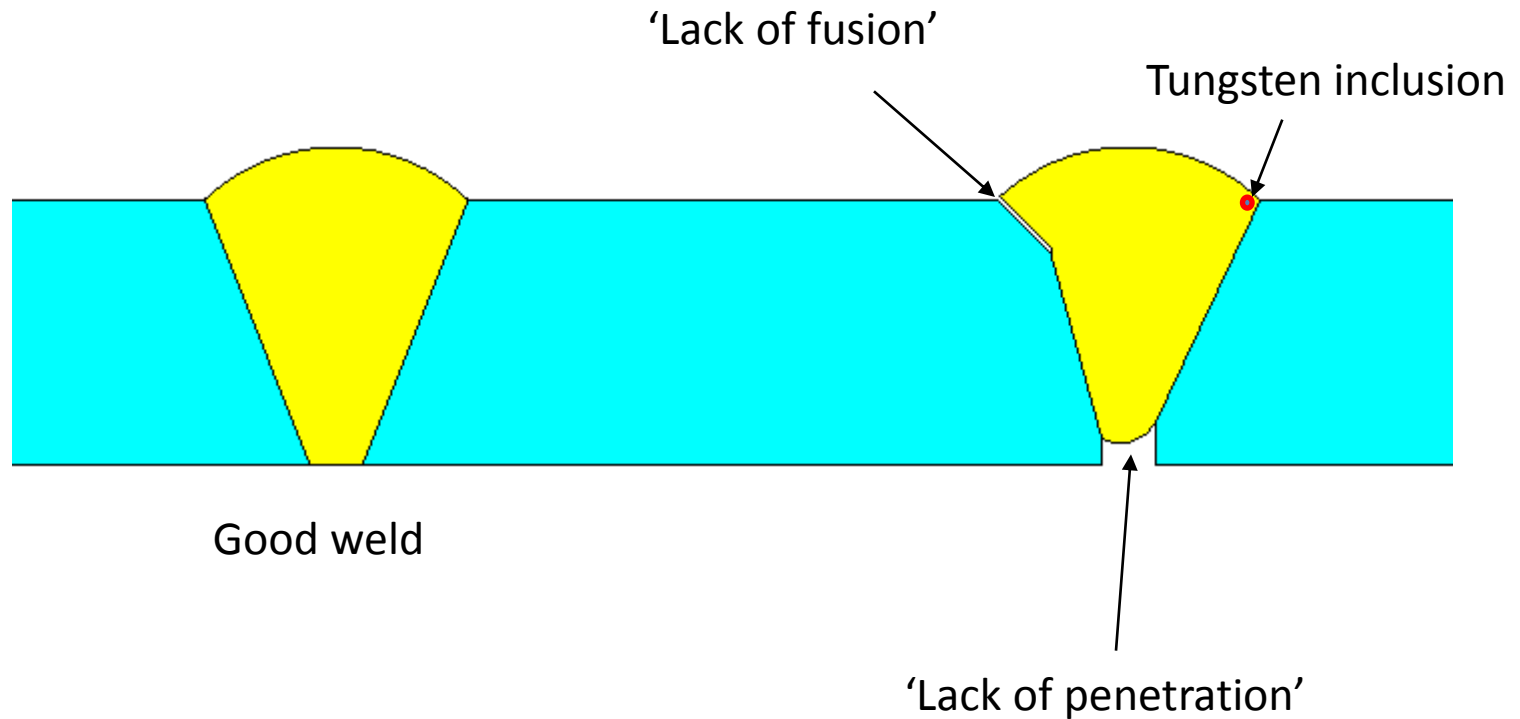
Common weld defects

- Tests performed at Norisko (France)
- Standard: ISO 5817, class C; 2 X-rays per weld
- Results:
 - Lancashire second protos (4 welds tested) – FAILED (lack of penetration)
 - Lancashire production set (5 welds) – FAILED (lack of penetration)
 - ACC, Paris, 0.5 mm (1 weld) – FAILED (lack of penetration)
 - ACC, Paris, 1.0 mm (1 weld) – FAILED (lack of fusion)
 - Microsoude, Lyon (3 welds) – FAILED (tungsten inclusions)

- Finally a company (Fraunhofer Institute / IPT, DE) is found
- Back-up company also found (Process Fluides, FR)
- Both capable of passing X-ray tests and providing needed mechanical precision
- Lancashire Fittings to provide cut and bent pipework but to cease welding
- Branch pipes compared to drawings by IPT and adjusted when necessary
- Process Fluides produces spares
- 100% X-ray testing of welds (704 welds)

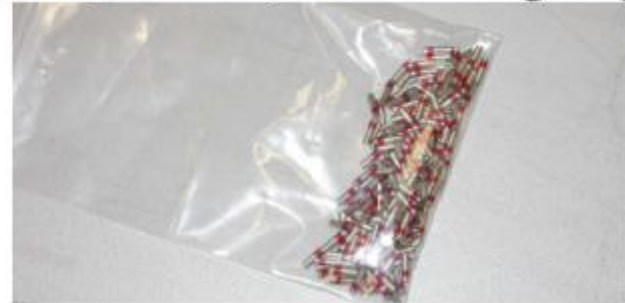
pigtails as delivered by Adapt:
stripped, crimped and inserted into connector

Decision to **repair ALL connectors** (LV, HV, control) in following way:
