# Recent experience with NuMI graphite targets and dumps (plus some NOVA & LBNE target information)

Jim Hylan / Fermilab

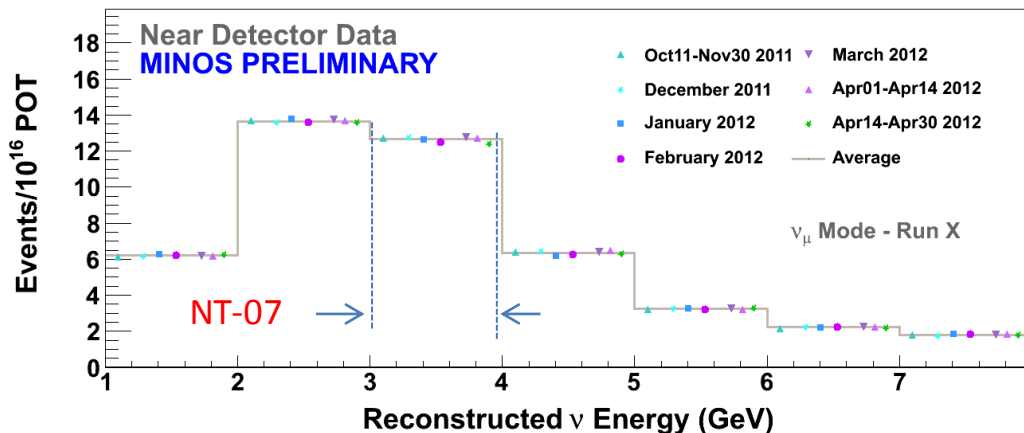
## NT-07

No indication of degradation  
over  $2.6e20$  POT  
Why does later graphite  
appear more robust ?

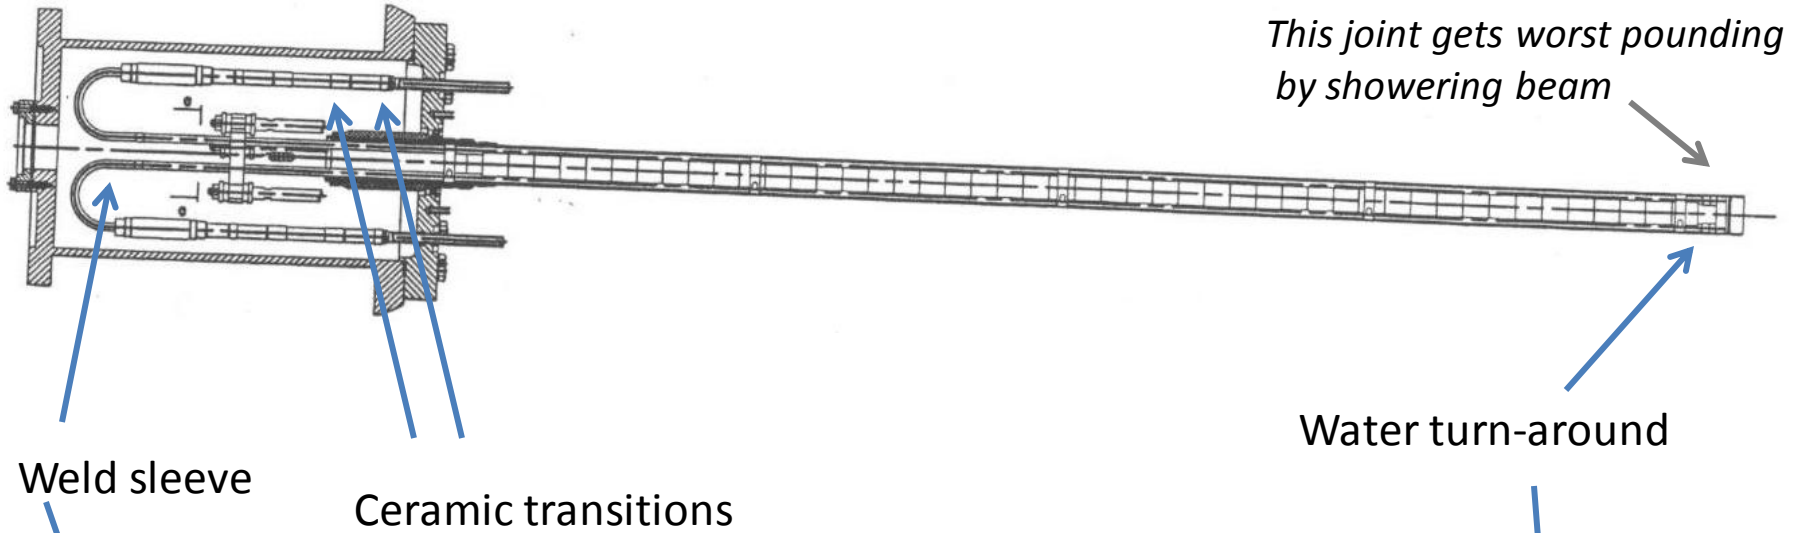
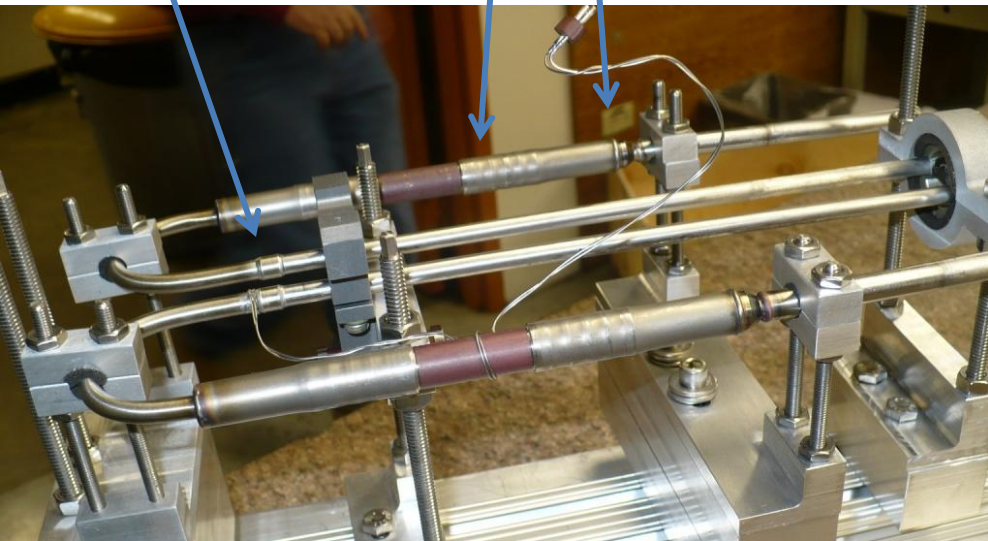
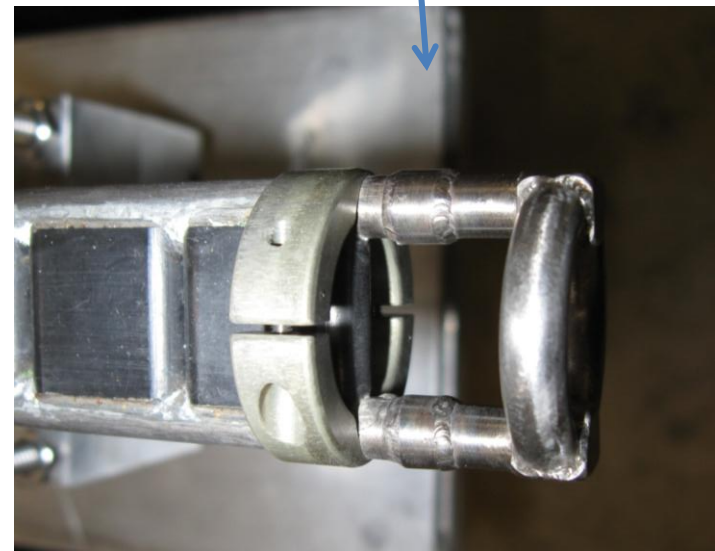
# What joints can fail, to produce water leaks in helium volume?

# What does water leak do?

Water leak inside helium volume leads to unacceptable conditions in couple ways:

- 1) Beam ionization dissociates water to H and O;  
gas then explodes, causing misalignments or bursting windows
- 2) Water partly fills helium volume; extra material would cause experimental systematic errors by changing beam spectrum, so target must be discarded

If outer tube is breached, water may run out, and target may continue operation as long as reasonable helium over-pressure can be maintained.
