Operating Experience and Reliability Update on the 5 kW CW Klystrons at Jefferson Lab

Richard Walker & Richard Nelson Jefferson Lab, Newport News VA

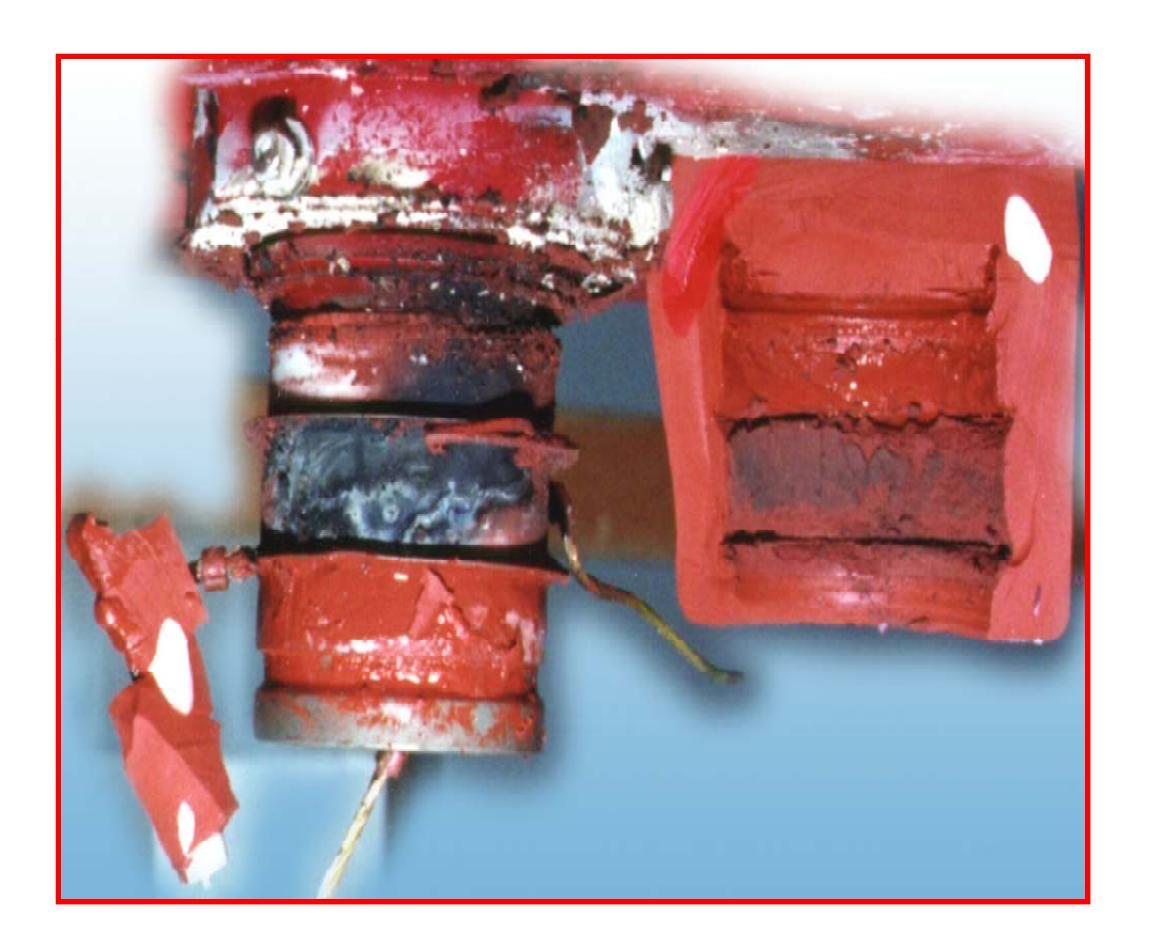
Failure Types

- External arcing
- Internal arcing
- Potting failure
- High leakage
- Ceramic fracture

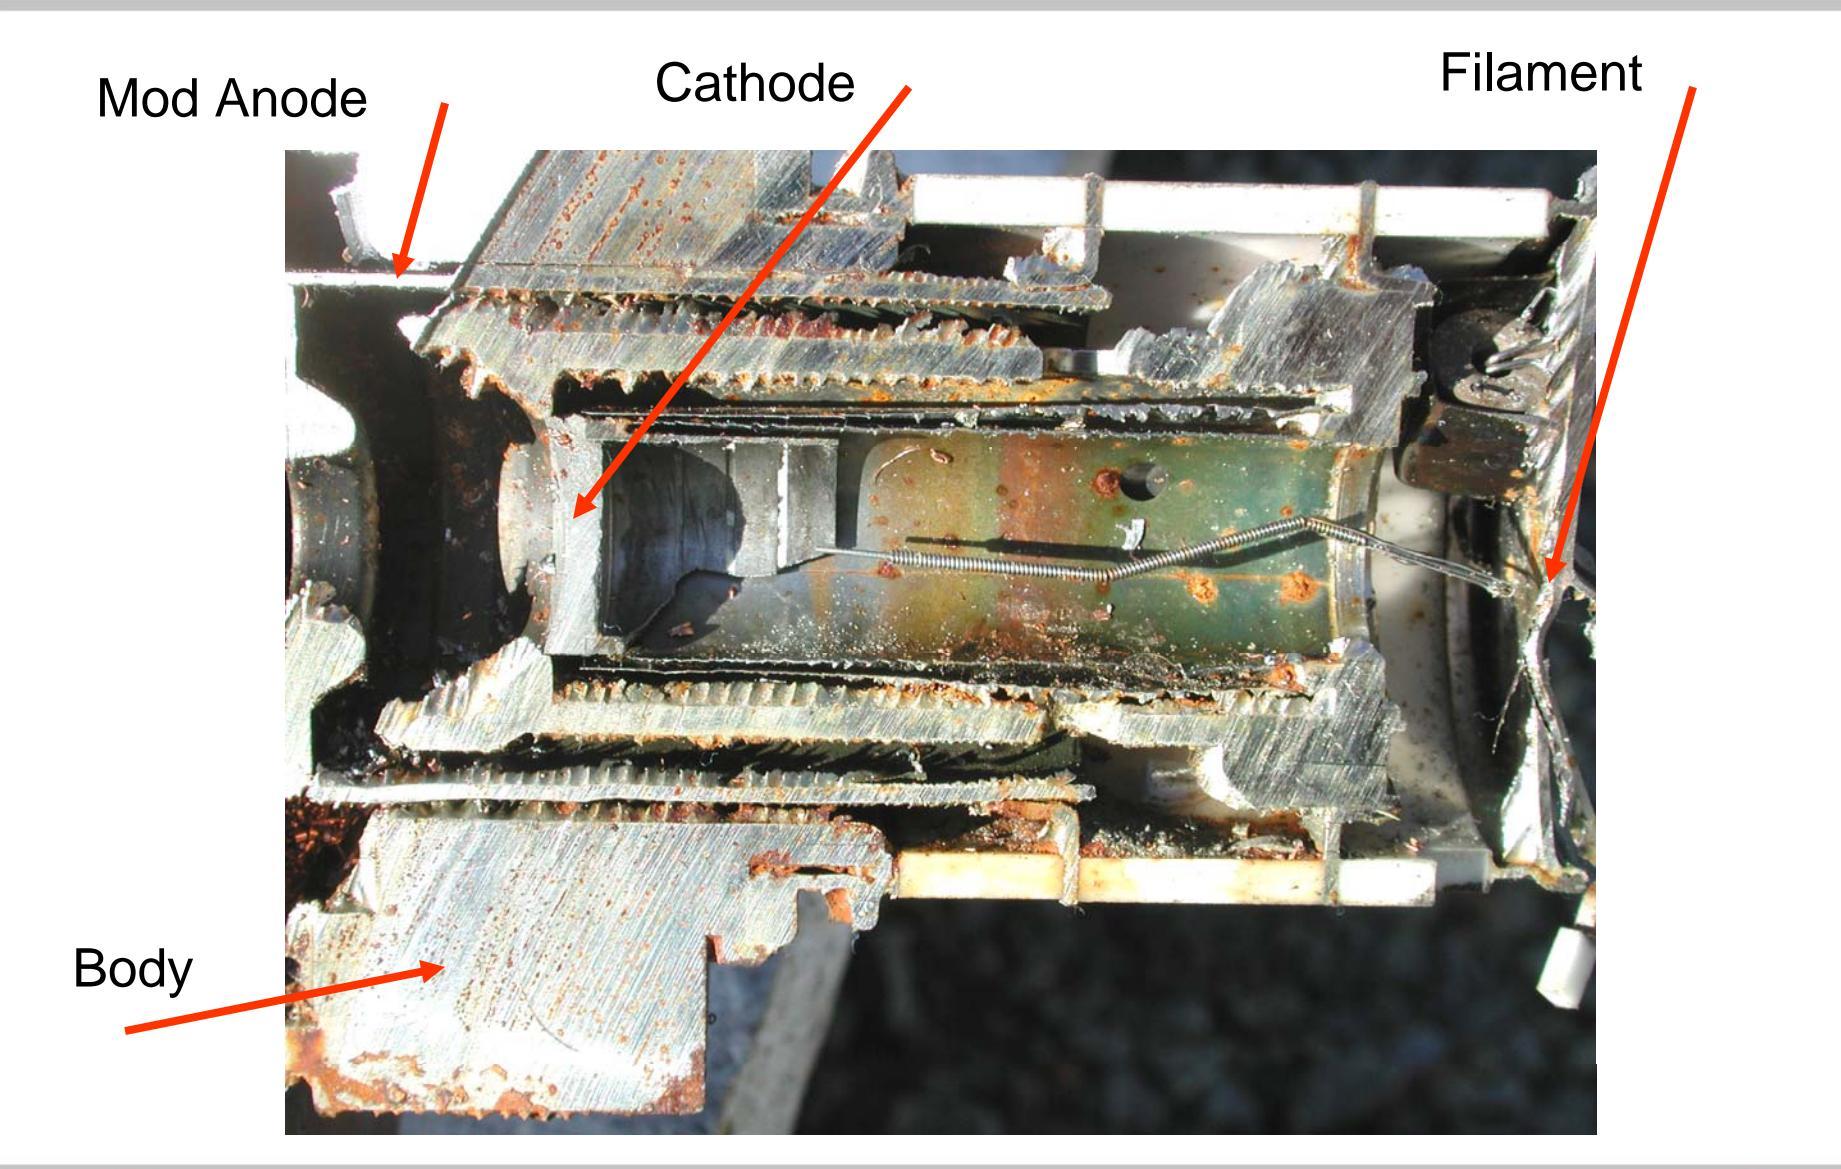
Gun Cross Section

- Increase operating cathode voltage
- Lower mod anode voltage
 - This increases voltage across the ceramic
- Demand higher RF power
 - Additional mod anode intercept with RF
- Fail to observe the onset of problems and take action before catastrophic failure

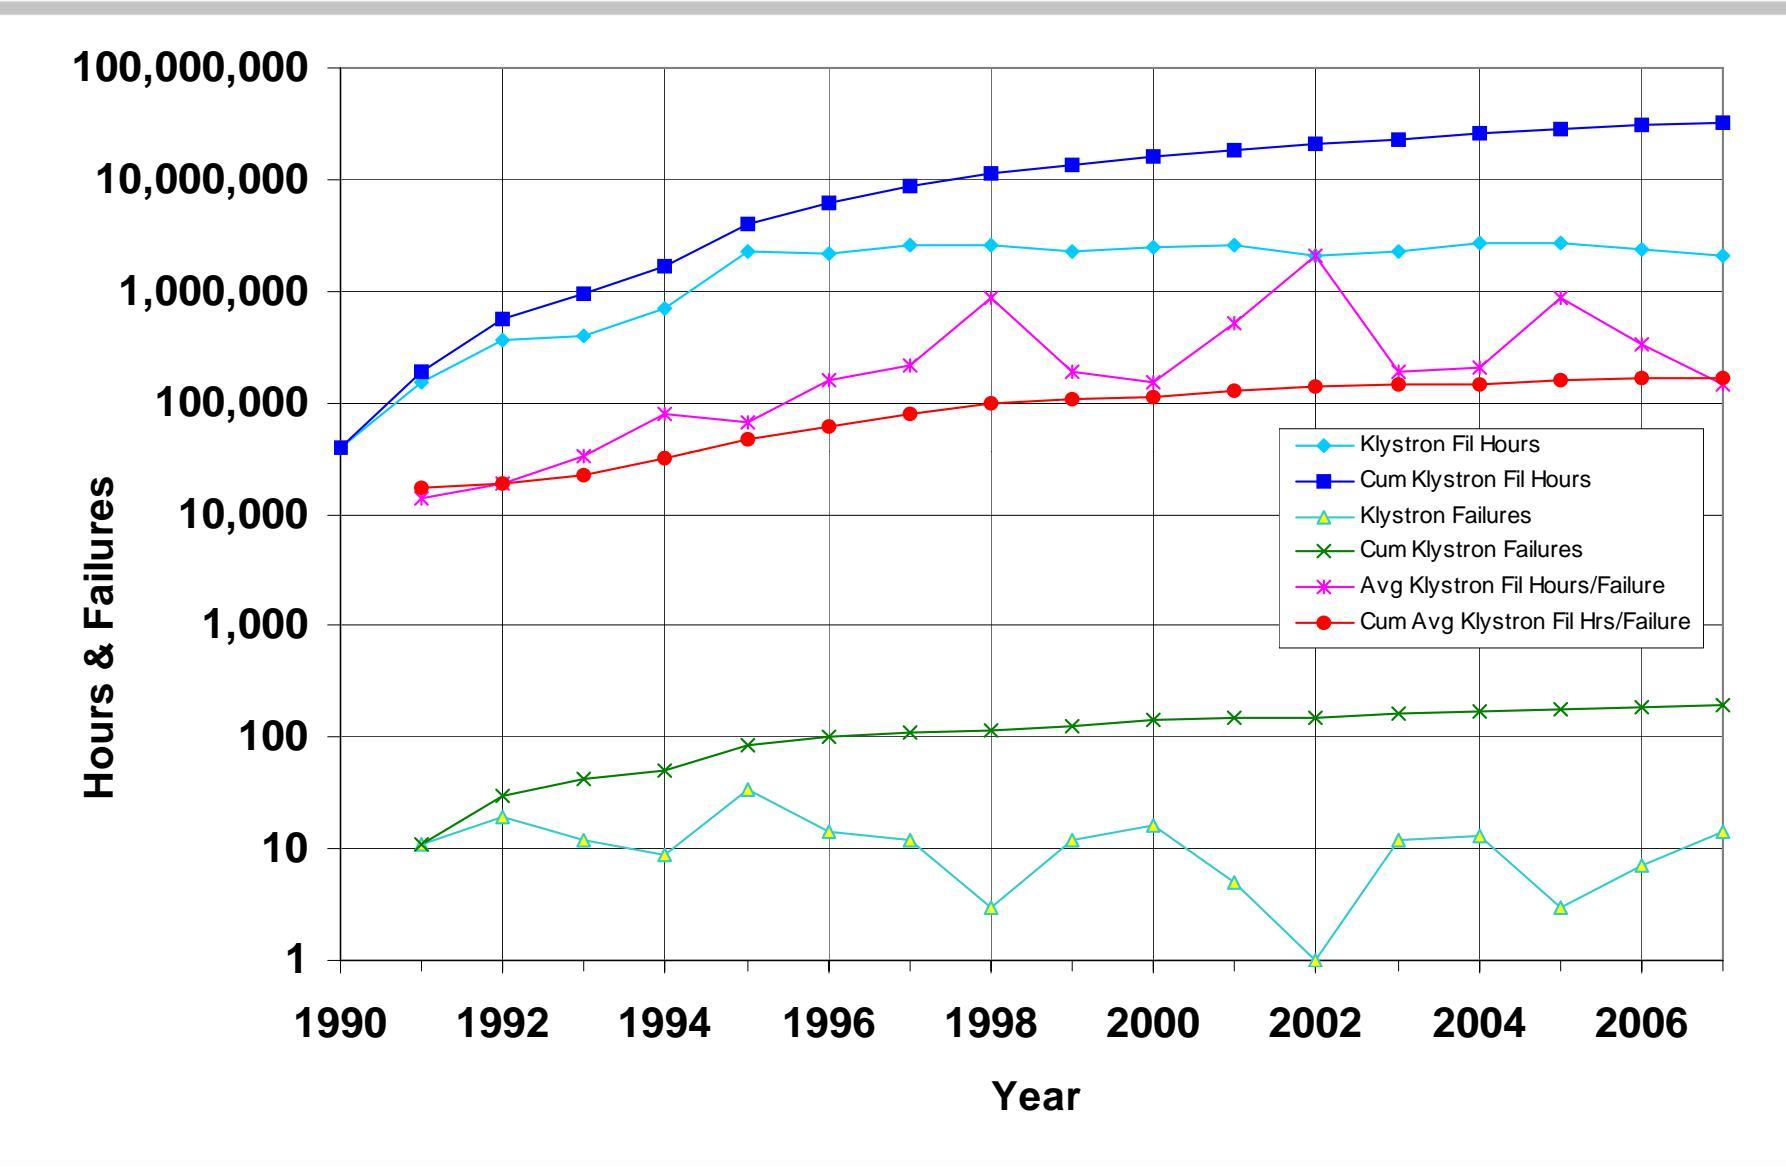
Klystron Reliability Graph

- Several failure modes have been addressed
 - Reduced failure rate though
 - Operating mode changes, when possible
 - Lowered filament voltage
 - Reduced cathode voltage
 - Constant monitoring and adjustment of Mod Anode
 - Potting changes
 - Used better material (higher temp. & conductivity)
 - Internal mechanical design changes
- Present average life is 165,000 hours
- After repotting all klystrons in mid-1995 to 1996, 61.7% have not failed nor even been moved
