ABSTRACT

The CMS Silicon Strip Tracker was successfully completed and first operations started in March 2007 in the Tracker Integration Facility at CERN. In September 2007 the Silicon Strip Tracker will be lowered to the LHC to get integrated into the CMS experiment. To finalise the two CMS Tracker End Caps 6400 silicon microstrip detector modules in 10 different geometries were needed. In total 7228

TEC MODULE PRODUCTION

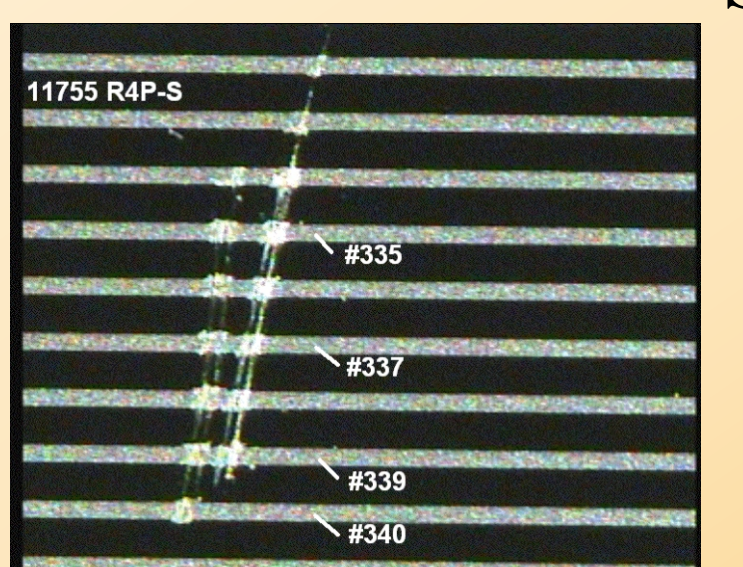
Scratches on

- pitch adapter → increased number of bad channels → sensor recuperation
- sensor → increased number of bad channels or IV problem → frame + hybrid recuperation

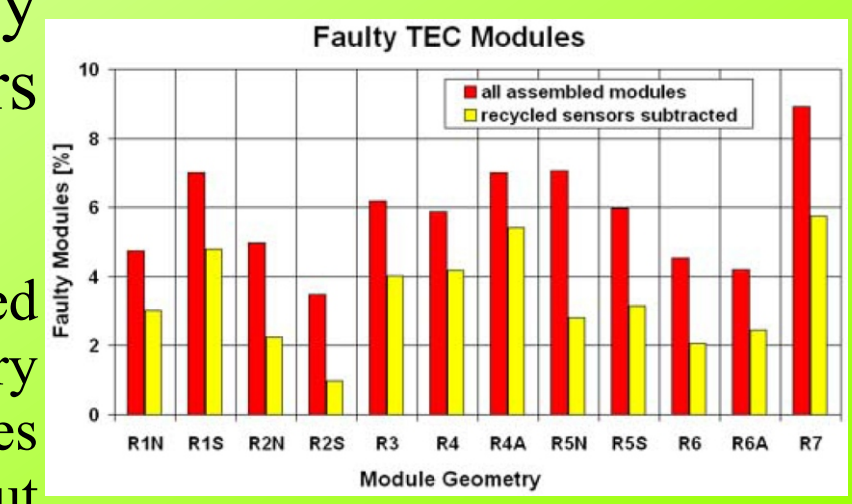
Thanks to this huge effort only 3,4% of the assembled sensors are lost in faulty modules.

Plot on the right: percentage of assembled faulty modules per geometry red: all assembled modules yellow: disassembled modules taken out
