# (1) SEM Study of bent silicon

- Using the low power SEM at QMUL's NanoVision.
- Small sample of bent silicon.
- Radius of curvature is 25mm.
- Sample size  $\sim 11 \times 11 \text{mm}$

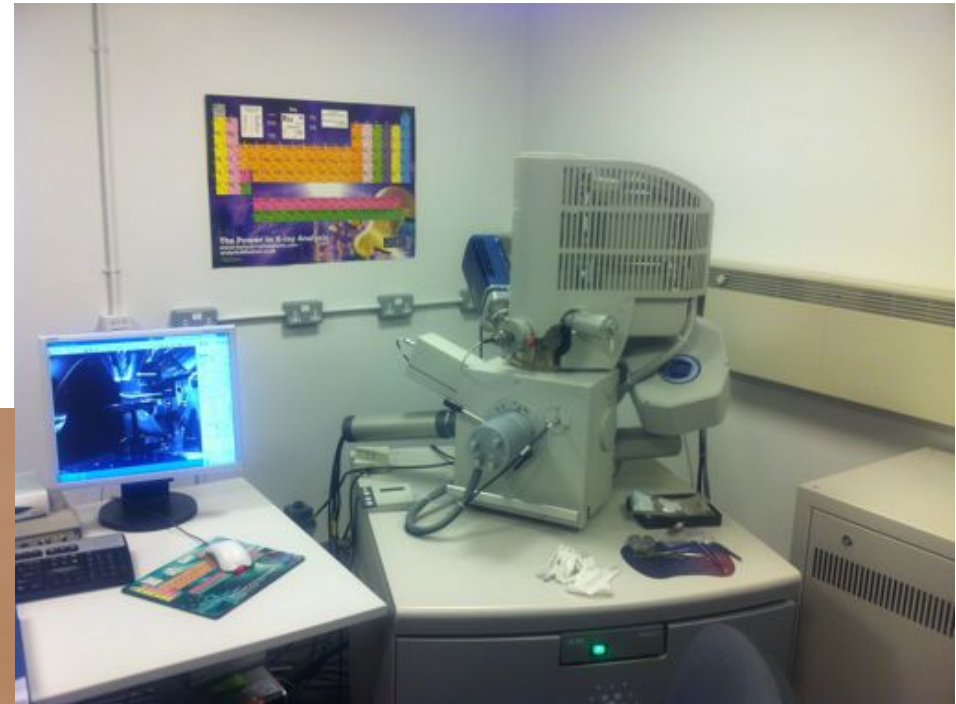
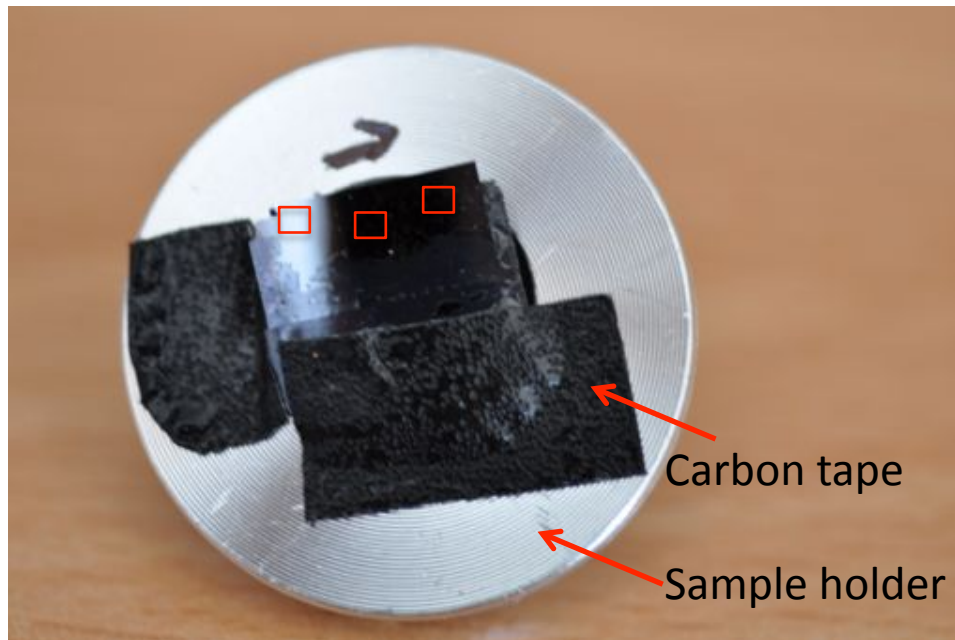
Three areas inspected:  
Left  
Middle  
Right  
+ the edge, just for curiosity

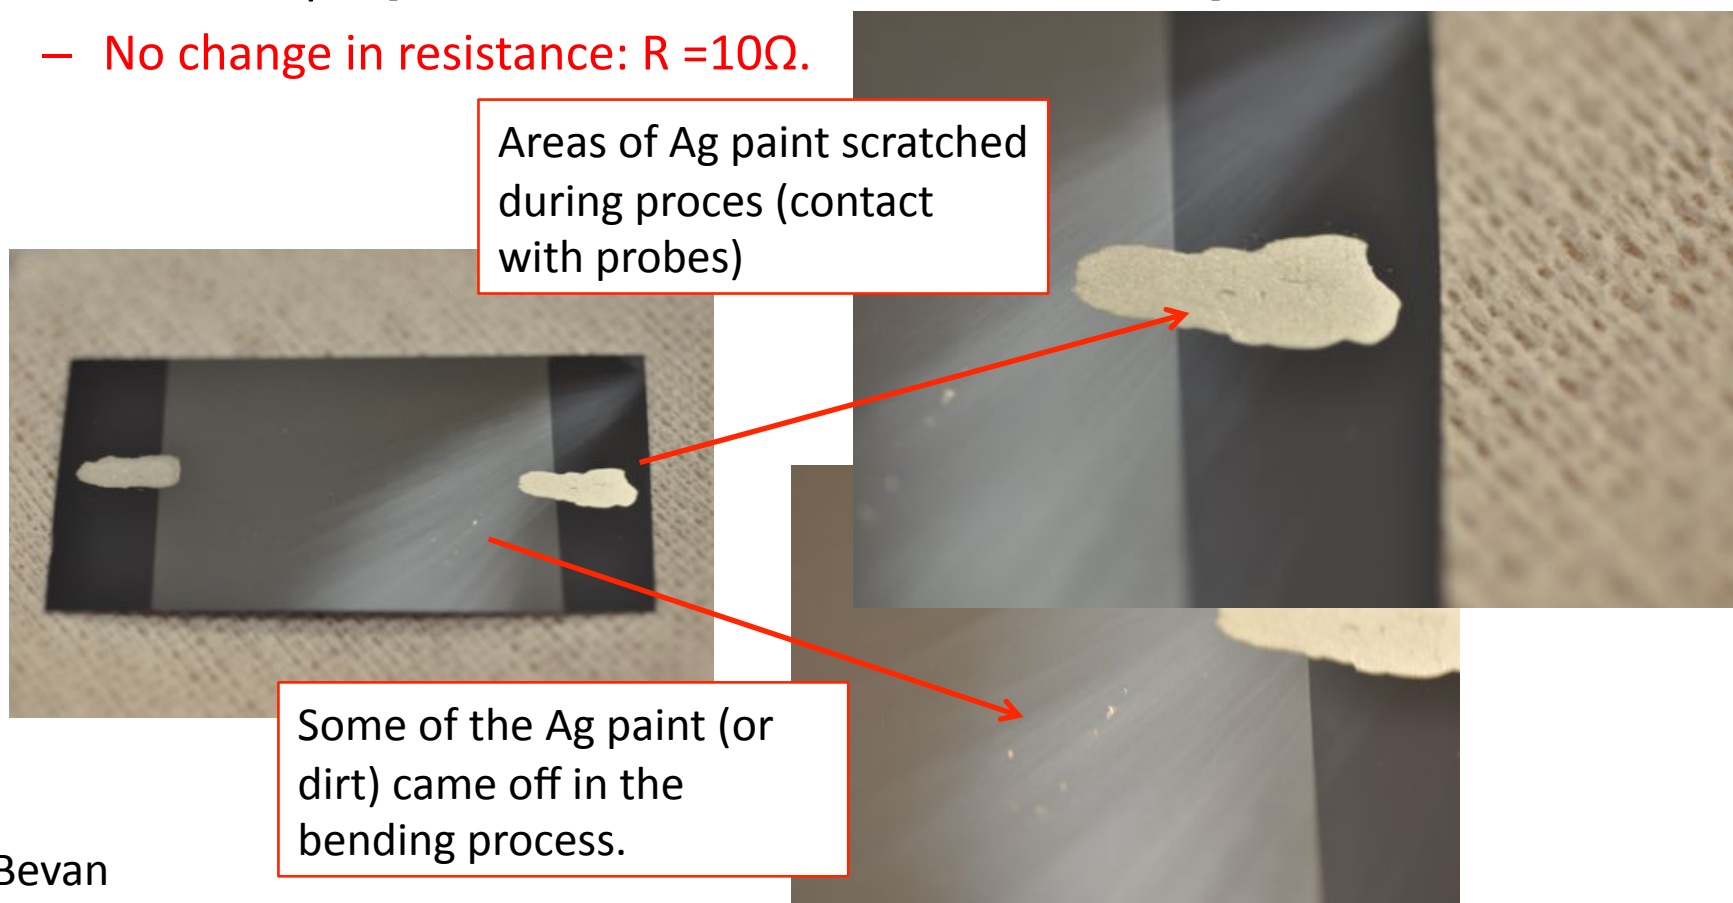
- Plated a  $\sim 200\text{nm}$  thick coating of Al on Si die, uniformly over an area of approximately  $33 \times 25\text{mm}$ .
  - Painted 2 contact pads using Ag paint: one at each end.
  - Bent sample [measured resistance before and after].
  - No change in resistance:  $R = 10\Omega$ .
