# "WHAT YOU GET" INJECTION & DUMP SYSTEM

### Outline

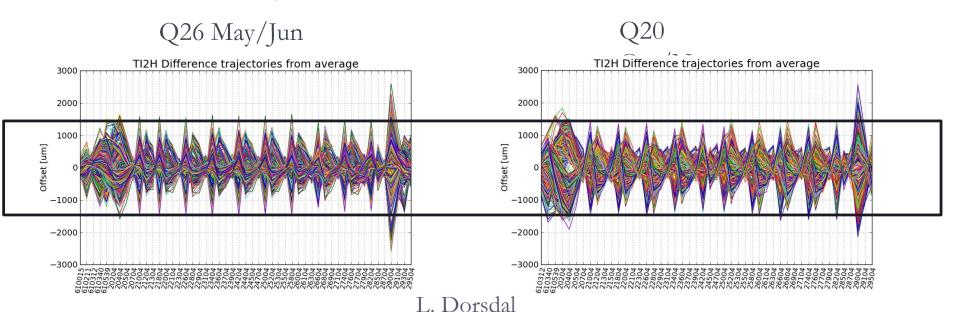
- L. Dorsdal analysed transfer line uncorrected trajectories for 144 bunches injection since beginning of October (Q20 period) and a similar period in May/June (Q26 period)
- Model Independent Analysis (MIA) used to **define sources of variations** from the different trajectories

- No or only a small worsening of the trajectory variations was observed for the Q20 optics
- Two main sources for trajectory variations were identified:
  - Current ripples in the SPS extraction septum (MSE) are the main source of shot-by-shot variations (already mentioned in Evian 2011). Currents were changed by 5-8% to match Q20, but ripples are not larger than for Q26.
    - During TS4, further checks are foreseen to investigate any eventual deterioration of the system (visual inspection of the septum and a test campaign for the Power Converter units). Possibly a new type of converter (capacitor discharge) will be installed during LS1.
  - Orbit variation in the SPS. These variations were only monitored for the Q20 optics while a reasonable statistic for Q26 is missing → not possible to say if any worsening was introduced when moving to the new optics

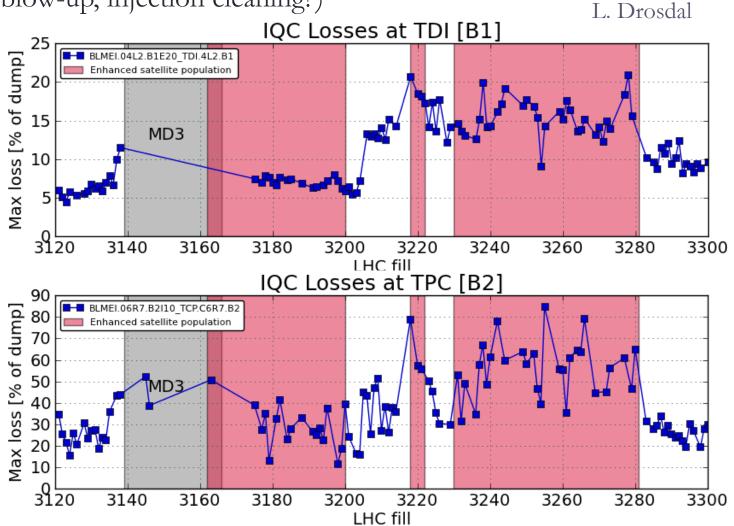
• Some effect from **satellite enhancement** but **not only contribution** (batch-by-batch blow-up, injection cleaning?)

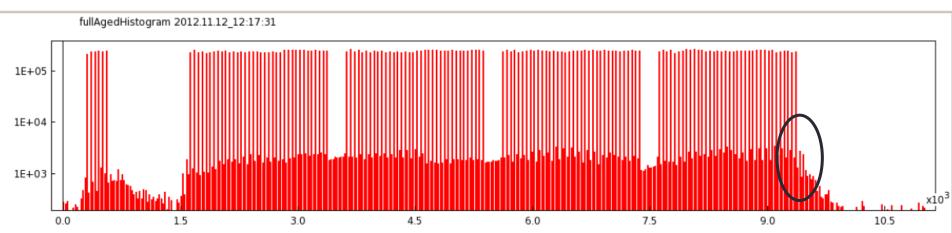
- Some effect from **satellite enhancement** but **not only contribution** (batch-by-batch blow-up, injection cleaning?)
- Beam was dumped twice by LHCb BCM at injection because of two trailing 50ns bunches (11/11 and 12/11)
- Situation was improved by shortening the **PS extraction kicker** pulse length
