# The LHCb Silicon Tracker: Lessons learned (so far)

A. Vollhardt, Uni Zürich/Switzerland

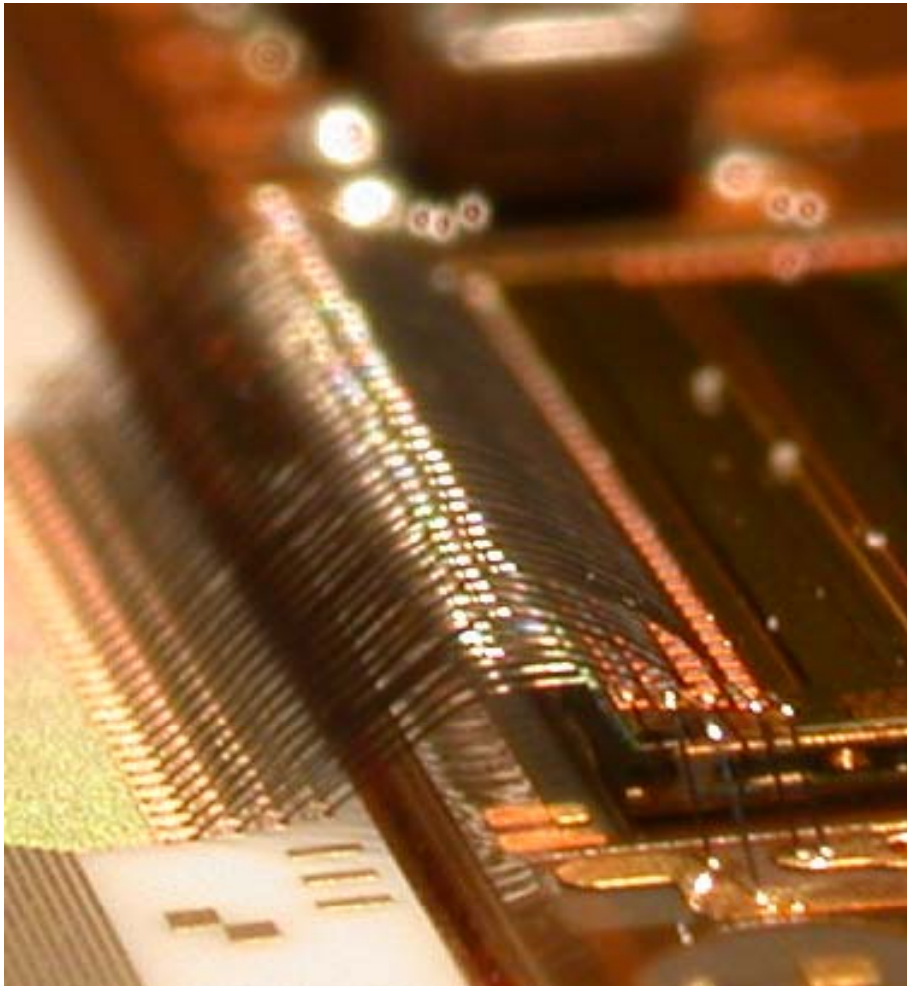
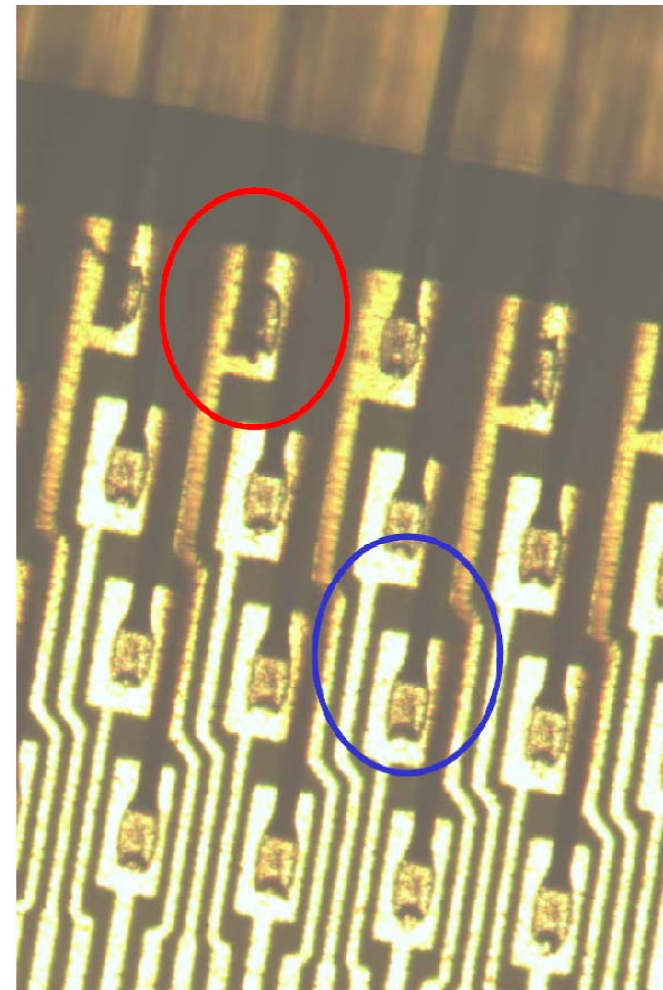
# 4<sup>th</sup> channel problem

- Strange pattern seen after some weeks: low noise on every 4<sup>th</sup> channel
- Ca. 320 bonds in total (concentrated on 5 readout hybrids)
- Problem not seen in multiple burn-in tests in Lab (incl. few dozen temperature cycles)

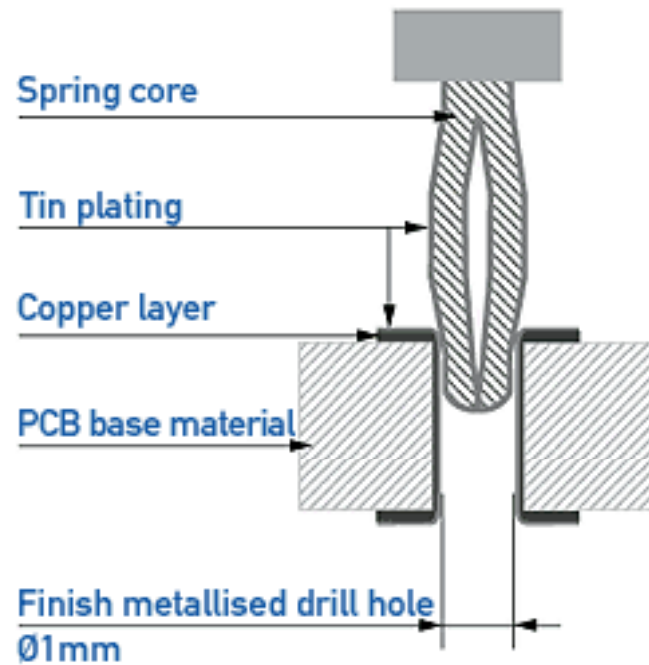
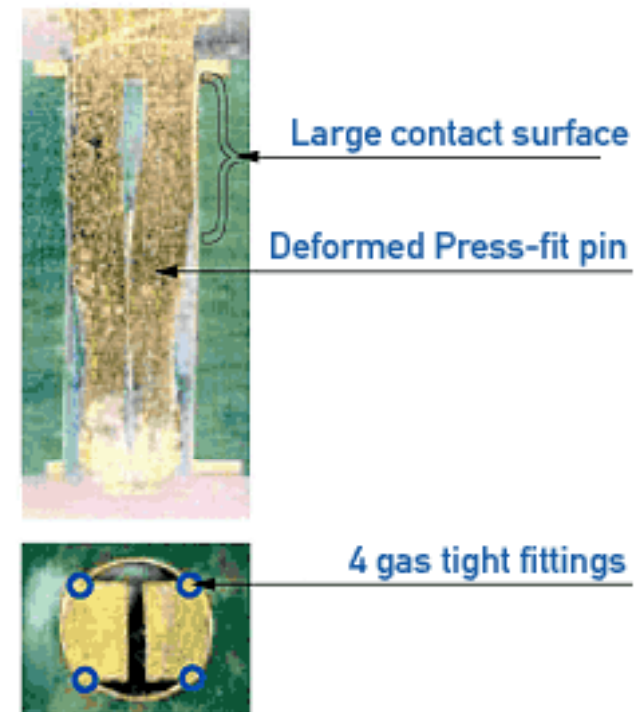
# Pressfit Connectors

- Pressfit technology used for Box backplane connectors (DIN41612)
- Part of the pins got bent during delivery, rework by company
- Pin loses tension/reliability/contact
- Fix: all pins resoldered by hand
