Korean GEMs tests

Christopher Armaingaud

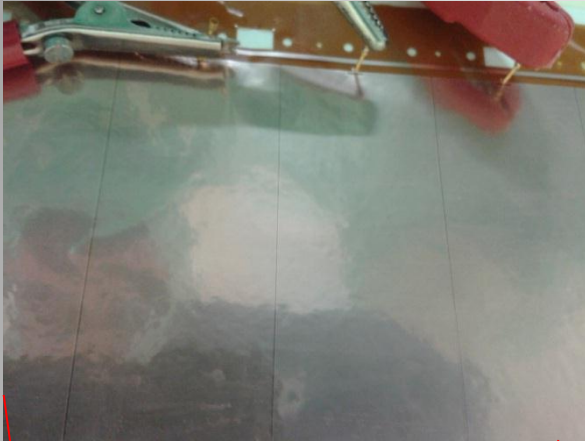
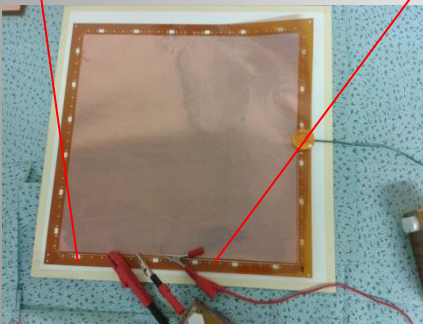
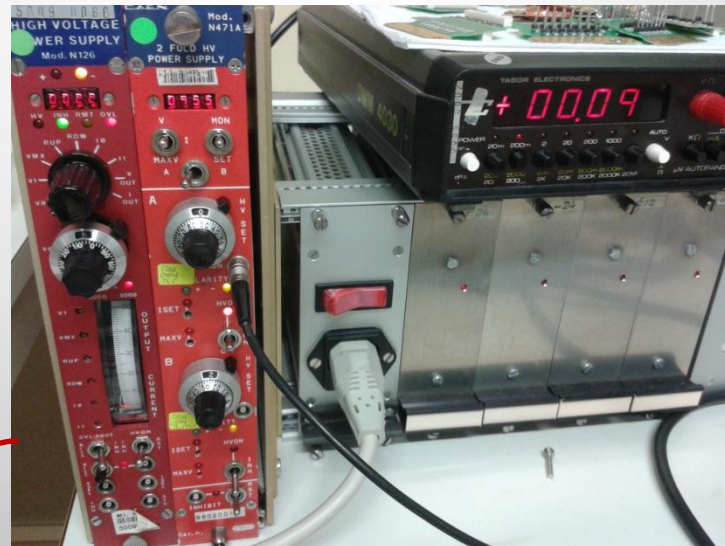
Test performed and Set up

- Sector to test from -50V to -500V by step of 50V.
- High voltage applied on the top, bottom and first neighbors sectors connected to ground.
- Measuring the leakage current

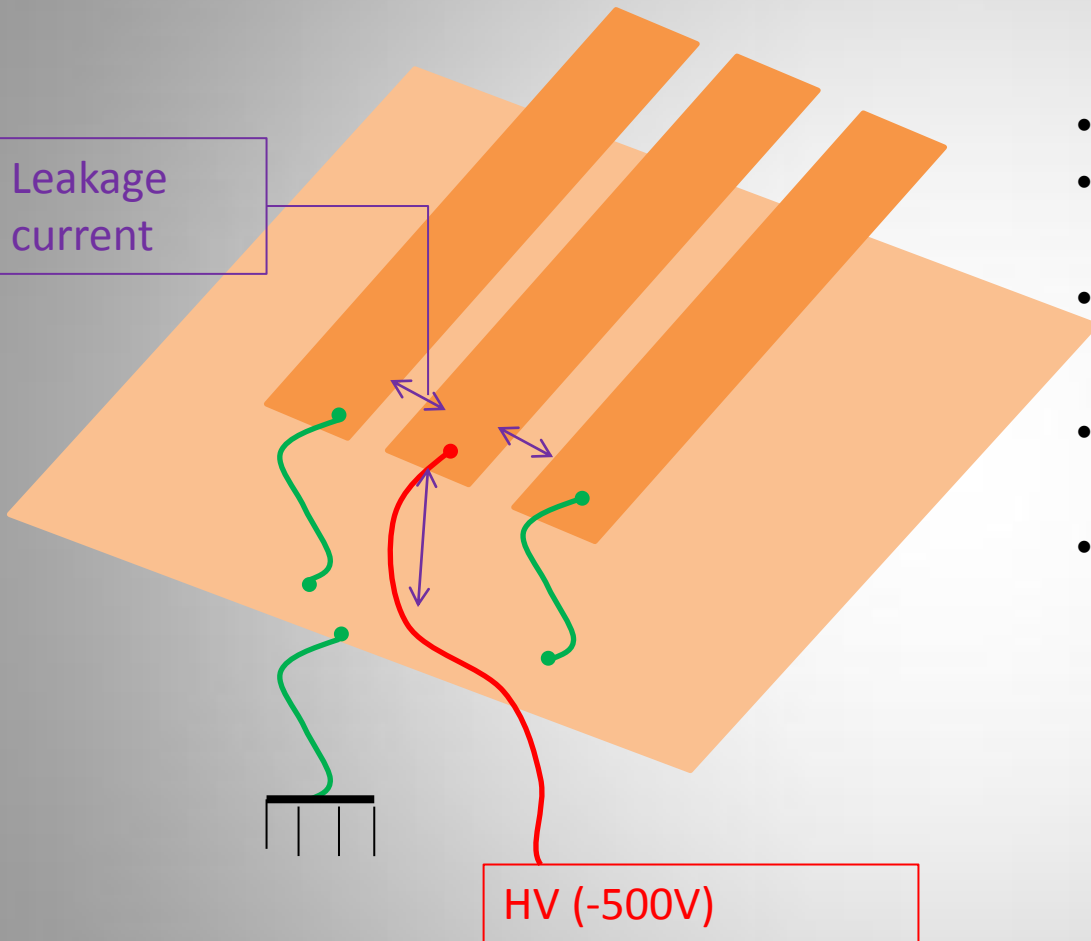
Expected leakage current

- Kapton resistivity $\sim 10^{19}$ ohm.m
- Air resistivity $\sim 10^{16}$ ohm.m
- $R_{//} = R_{\text{kapton}} \times R_{\text{air}} / (R_{\text{kapton}} + R_{\text{air}})$
- $R_{//(60\mu\text{m})} \sim 10^{16} \times 60 \cdot 10^{-6} = 6 \cdot 10^{11}$ ohm
- $I_{\text{expected}} \sim 500 / R_{//(60\mu\text{m})} = 0.8$ nA
