# Quality Test of the KLOE-IT GEM foils

*Danilo Domenici  
on behalf of the KLOE-IT group*

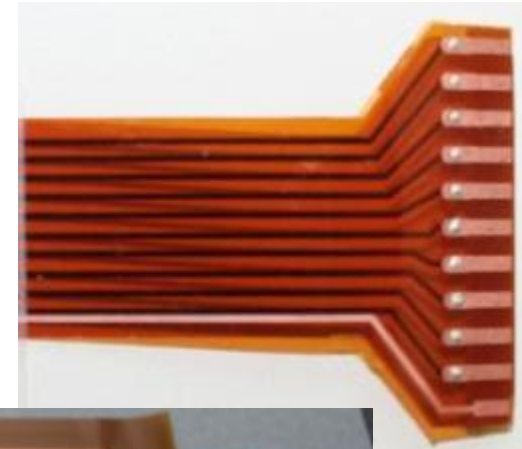
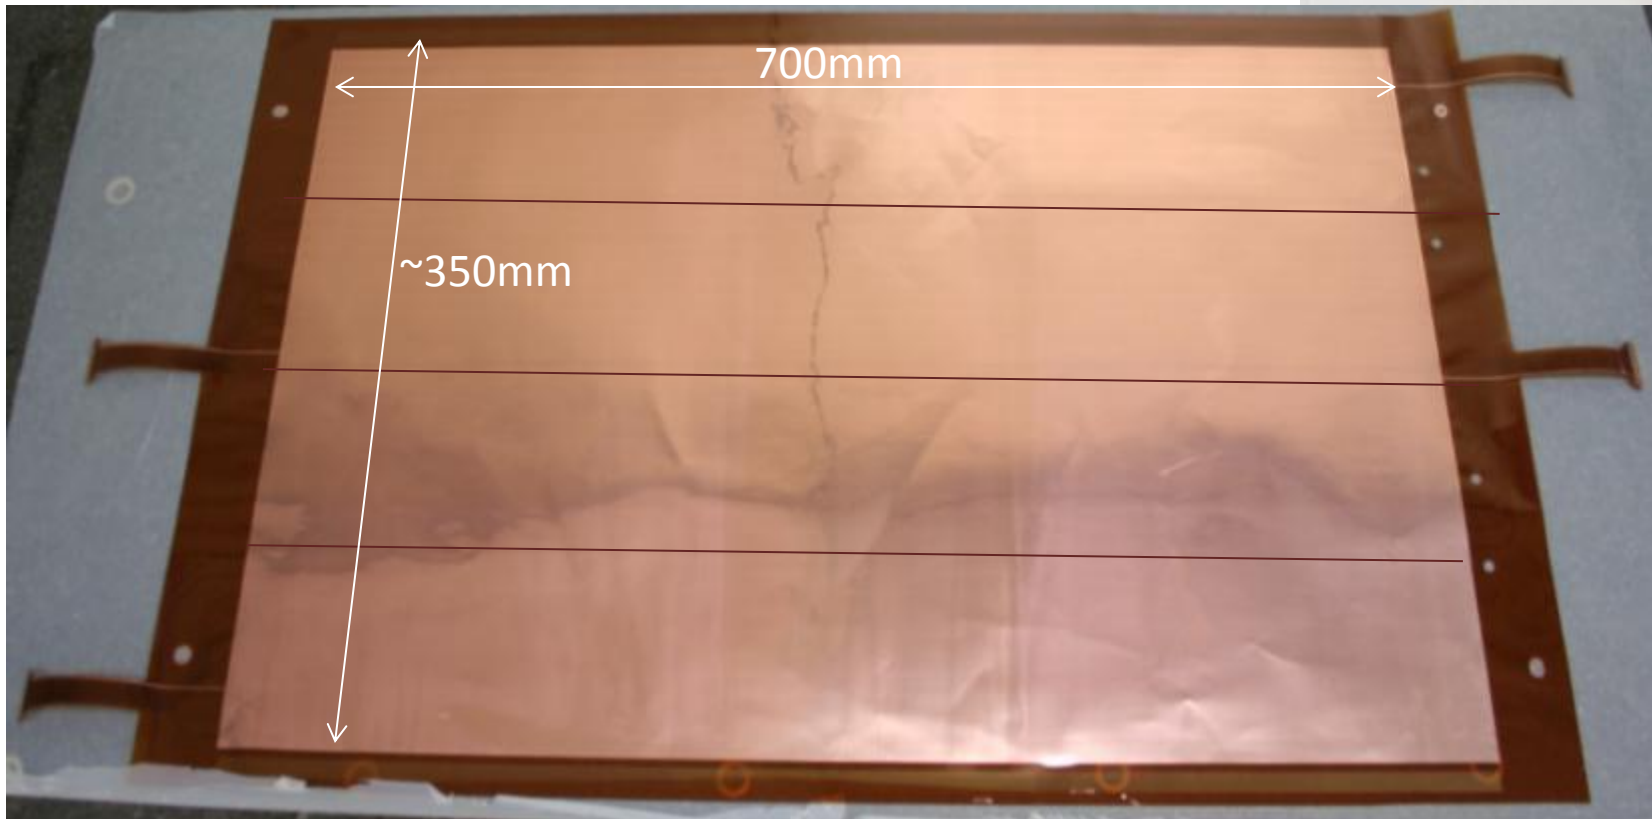
N.4 macro-sectors on the bottom side

N.40 micro-sectors (80 cm<sup>2</sup>) on the top side

All the HV connections are brought to the bottom side through vias, filled with conductive silver glue.

Detail of the HV connection with the 10+1 vias

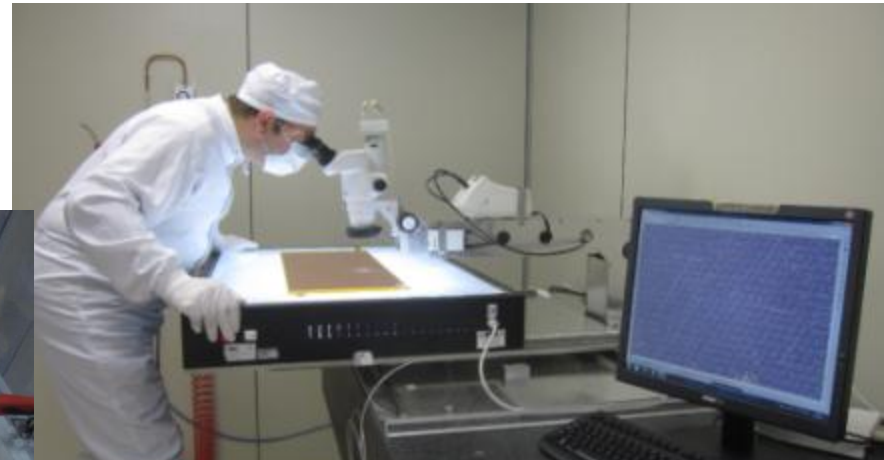
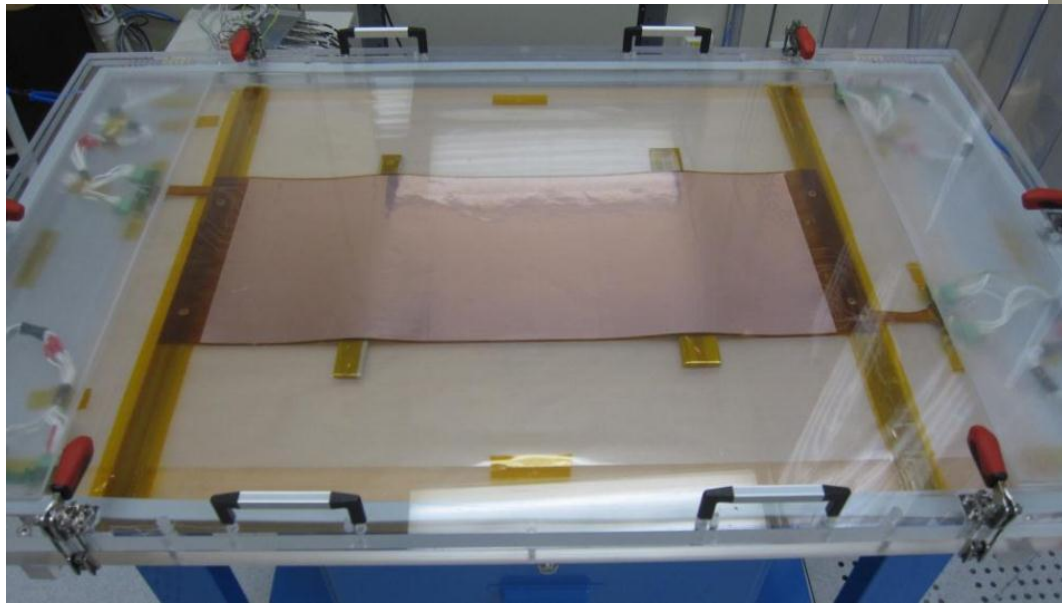
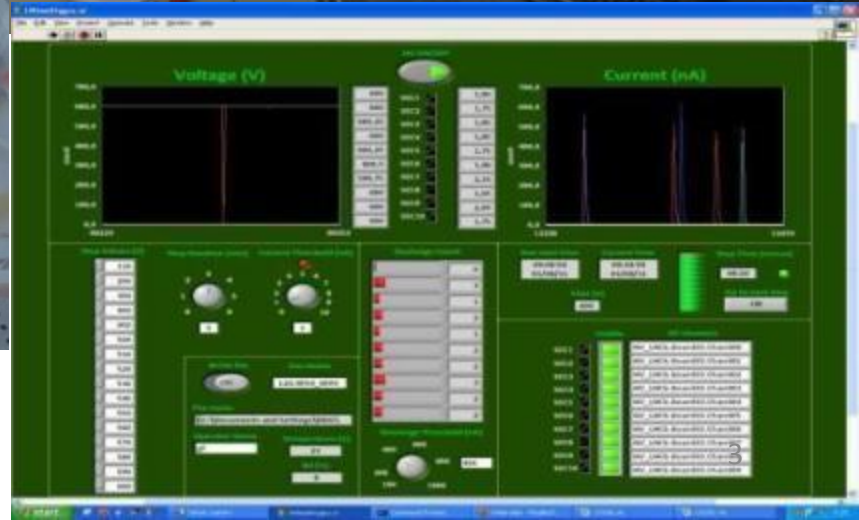
The quality of GEMs is checked with HV in a N<sub>2</sub> flushed box, for humidity reduction (<10% RH).

During the test each sector of the GEM foil is supplied up to 600 V. Discharge rate and leakage current are monitored.

HV connections are also checked to have  $R < 2 \text{ Ohm}$

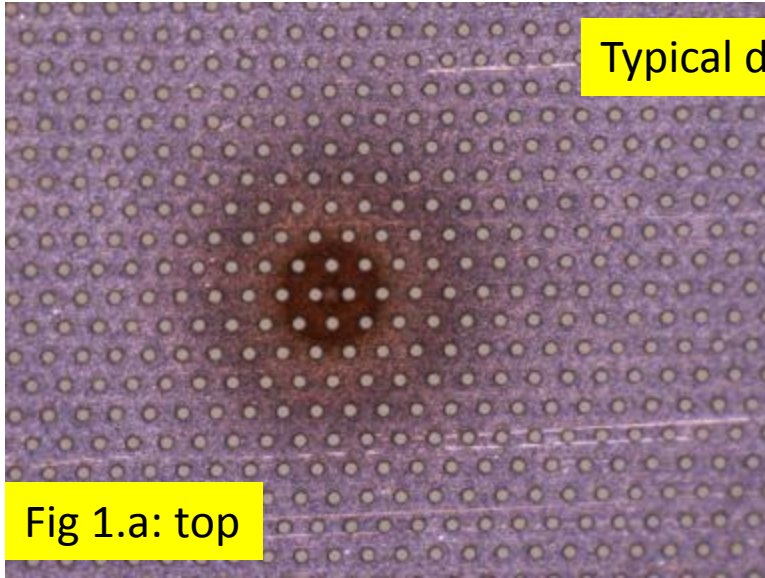
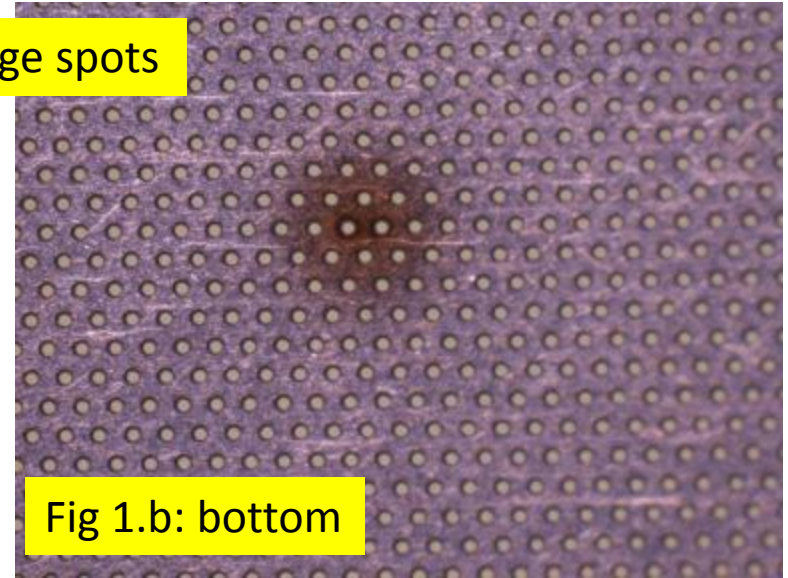
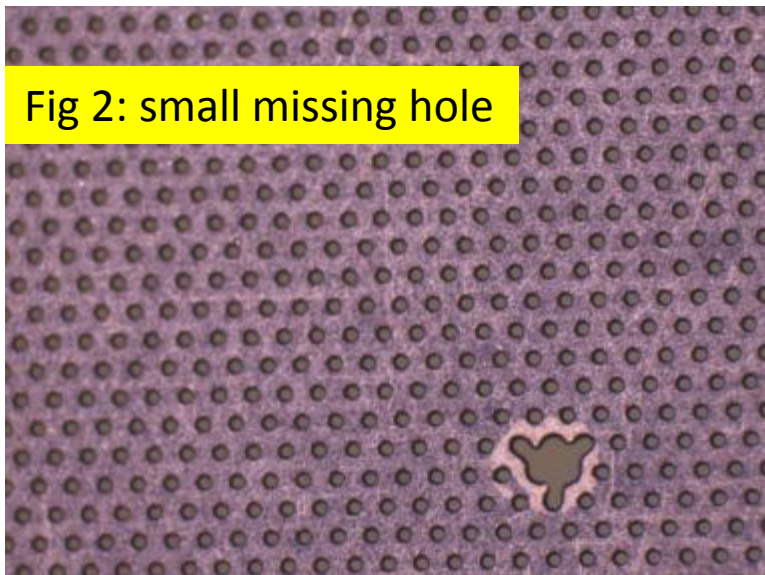
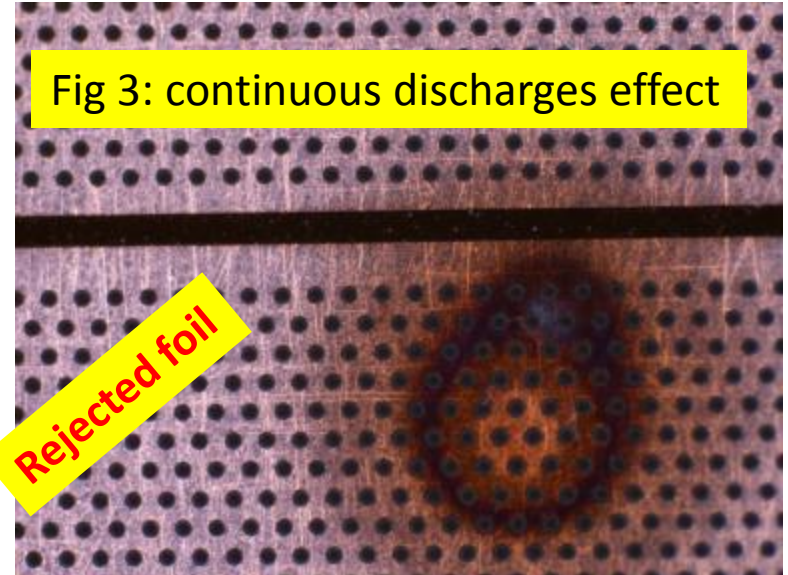
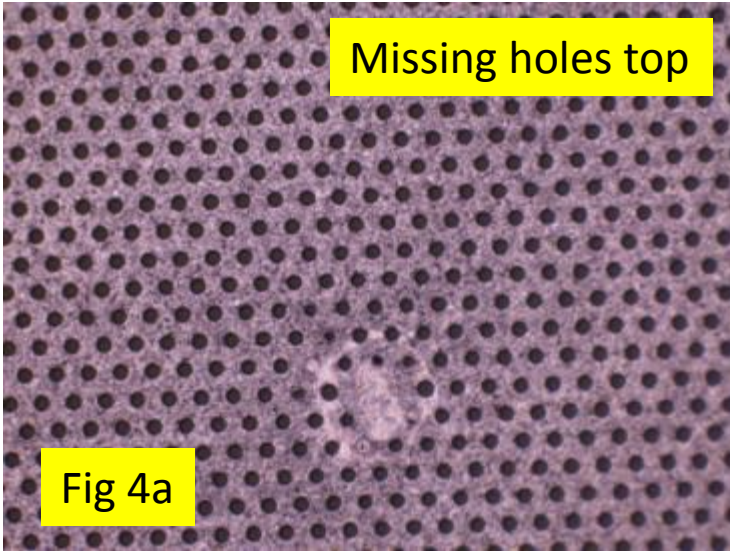
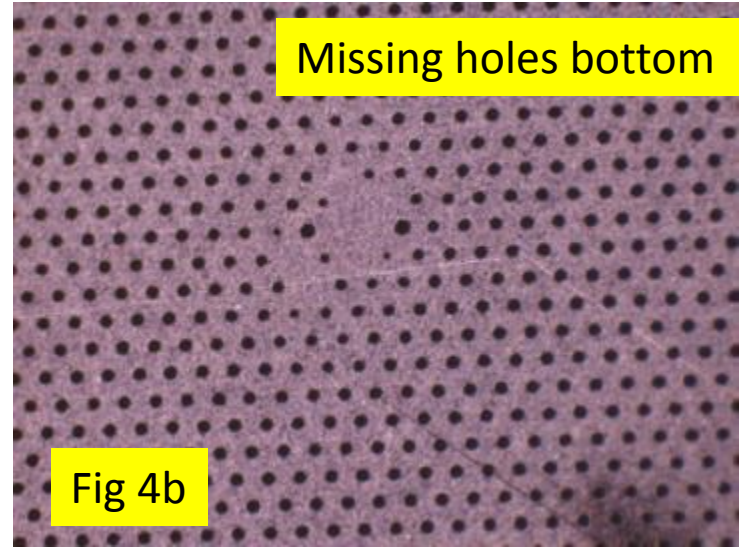
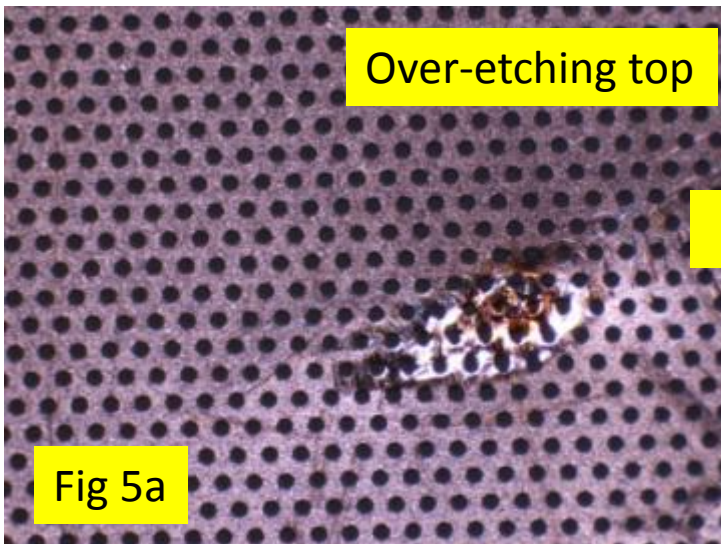
Rejected foil

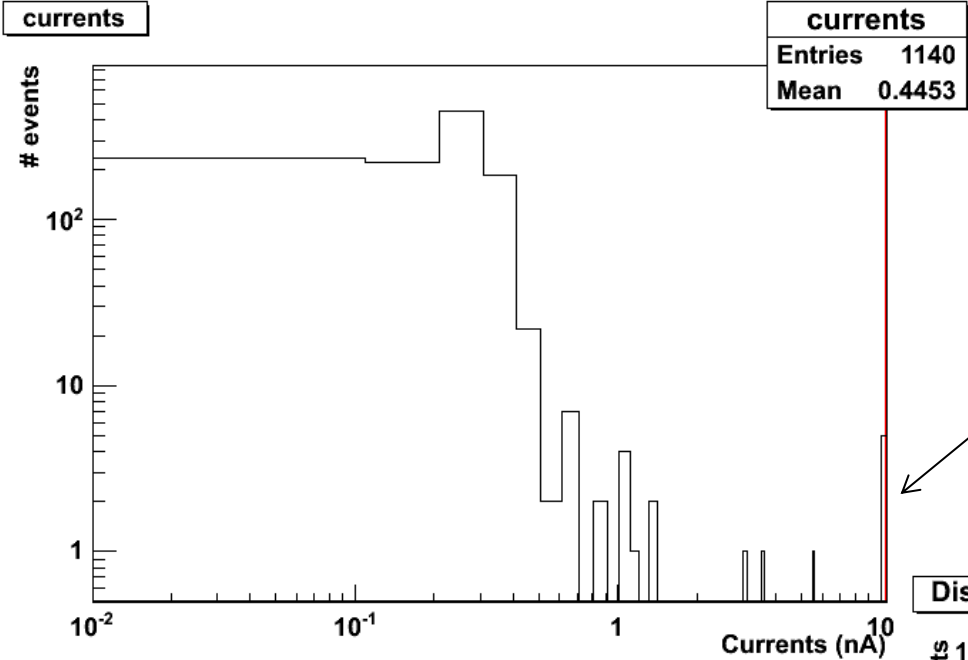
Layers 1,2,3

Discharges counted in 1 hour period
