Crab Cavity Tests

R. Calaga, HiLumi Meeting, Nov 13, 2013

Summary:

All 3 prototype cavities built by Niowave Inc. in bulk NiobiumSurface treatment and first tests completed1 very good result, 2 moderate results and retreating to recover performance

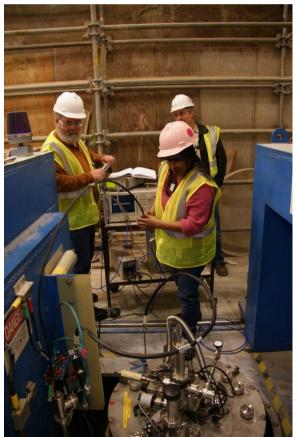
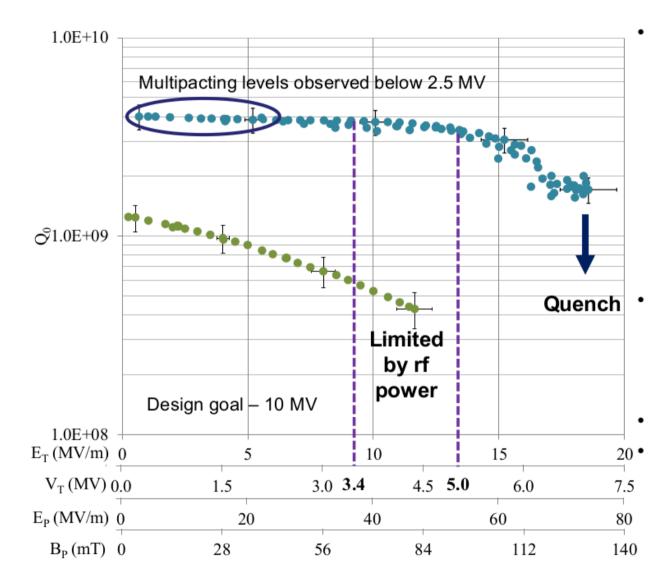
ODU RF-Dipole

Achieved fields: $V_{T} = 7.0 \text{ MV }!!$ $E_{p}=75\text{MV/m}, B_{p}=131\text{mT}$ Achieved $Q_{0} = 4.0 \times 10^{9} (35n\Omega)$

Low field multipacting easily processed did not reoccur

The slight higher residual resistance either due to acid contamination or stainless steel flanges

Future tests pending funding, perhaps use Nb coated SS flanges

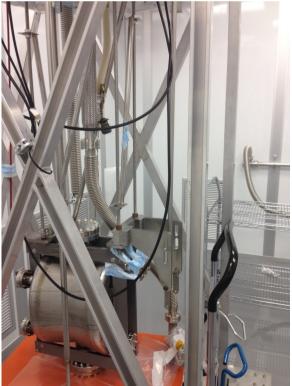
DQW 1^{st} Test

1st test with poor results due to improper HPR

Q is low, ~3×10⁸ (independent on the temp, expected 8.5×10⁹)

No Q-disease or not due to SS flanges

CW mode 0.96 MV (thermal load), pulsed mode reached 1.34 MV (200 W amplifier)

2nd Treatment at Argonne
Light BCP -40 μm
2 rounds of HPR due to contamination
Next test on Nov 19, 2013
