# Vacuum incident on MKB - Implication on HV performance and tests foreseen

MPP meeting

Viliam Senaj, 25/10/2013

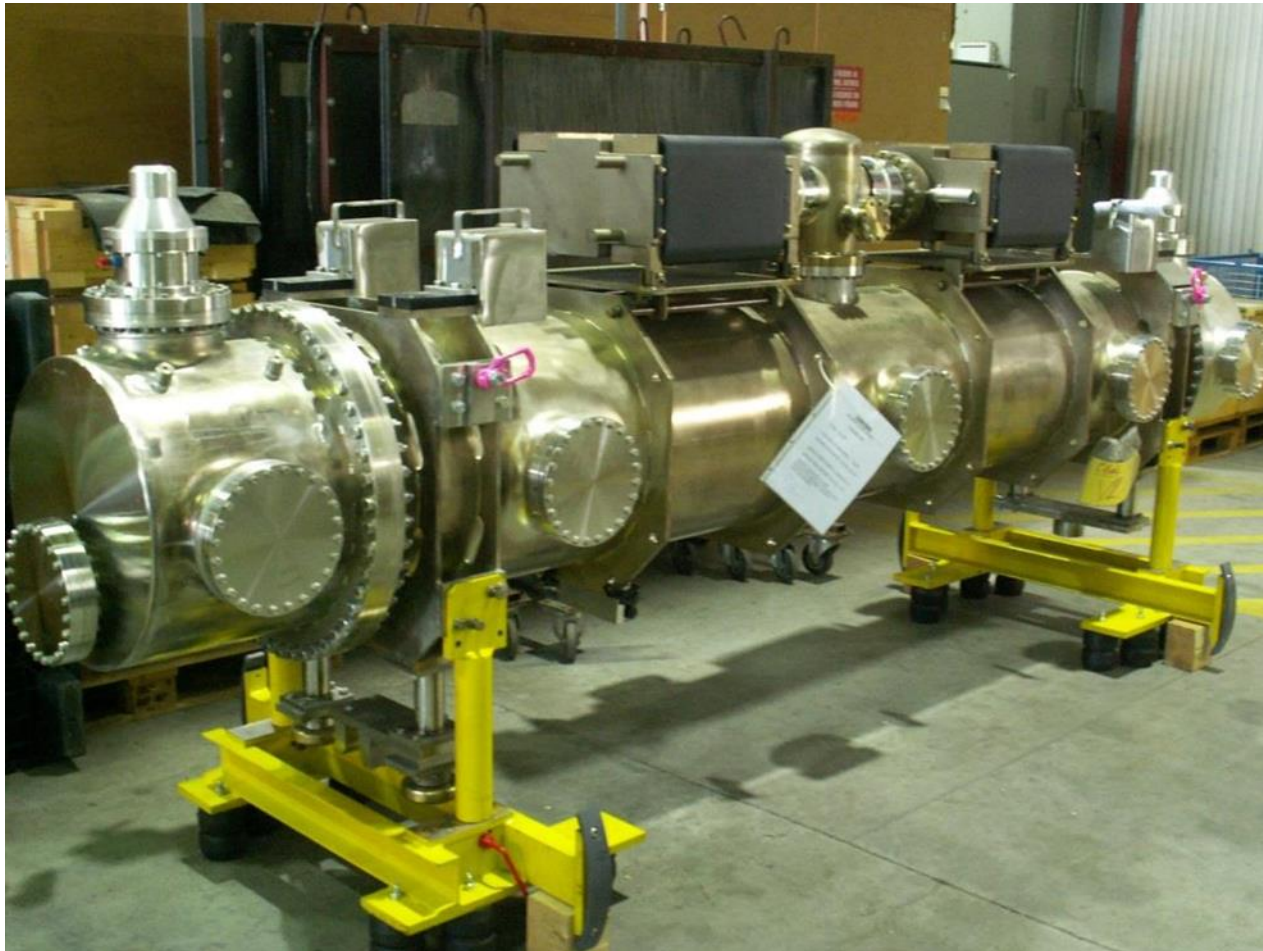
# MKB tank view

- Common tank for 2 magnets (MKBH or MKBV)
- Pumping by 2 sputtering pumps in the middle plus turbo pump
- Up to 29 kV and 24 kA per magnet

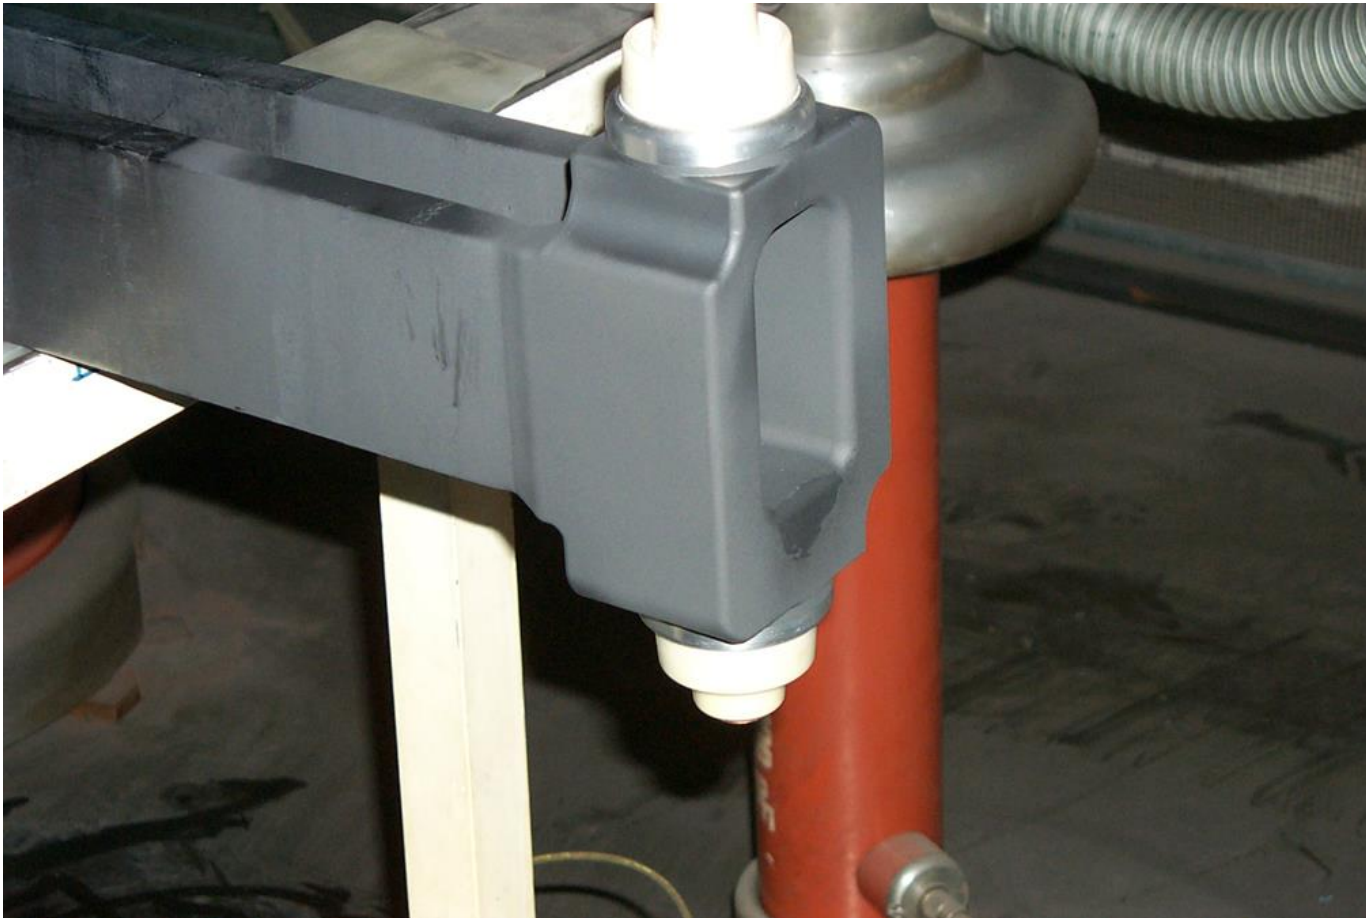
# MKB coil construction

- Copper coil in short circuit. Coil insulated and surface painted by a conductive painting and grounded
- Parts with risk – coil contact (HV side), connecting plates spacer and tank feedthrough
