LS1 Status Report

LS1@LHCC

Frédéric Bordry

25th September 2013

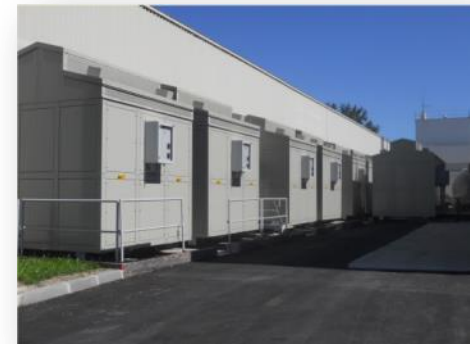
All new transformers in place

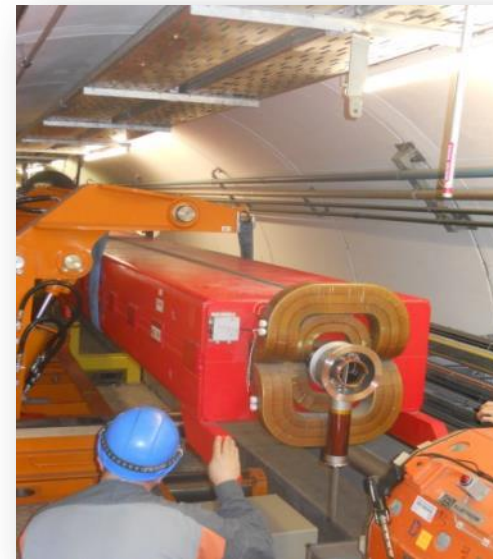
SPS magnet exchange

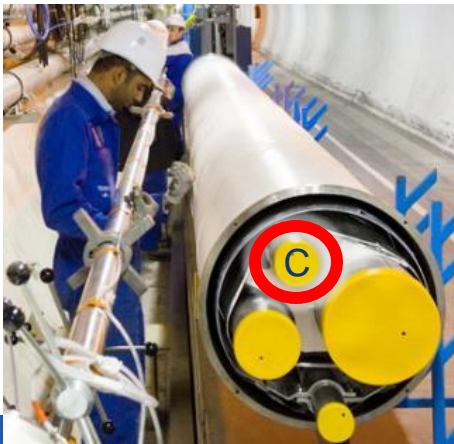
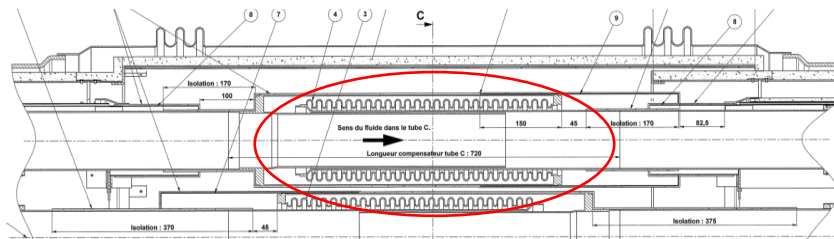
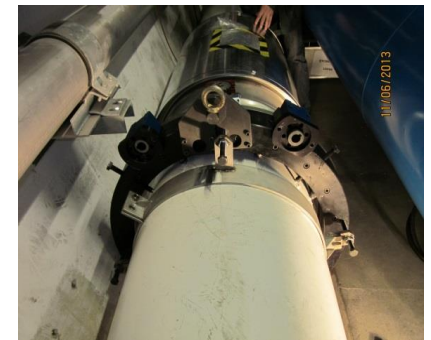
QRL opening sec. 45

The failure mode (QRL as typical)

A "virtual" leak
(not seen during global leak test)

Filling of the inter-ply space with time (3-4 years of operation)

Pressure increase of the inter-ply space during warm-up → compensator collapsing !
Maxi pressure with conservative assumption: isochoric transformation and space initially at line conditions (P, T)

- CM: 1500 bar
 - Line C: 1200 bar
 - Line E & F: 120 bar
 - Line D: 20 bar
 - Line B: 1 bar
- ← Difficult to survive !!

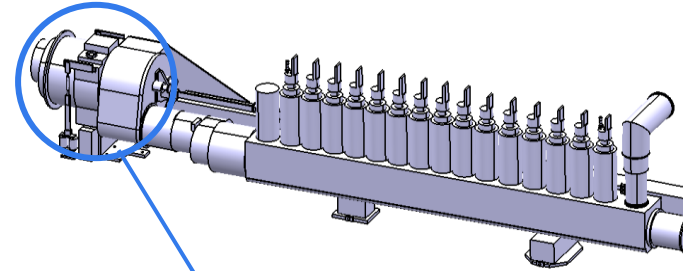
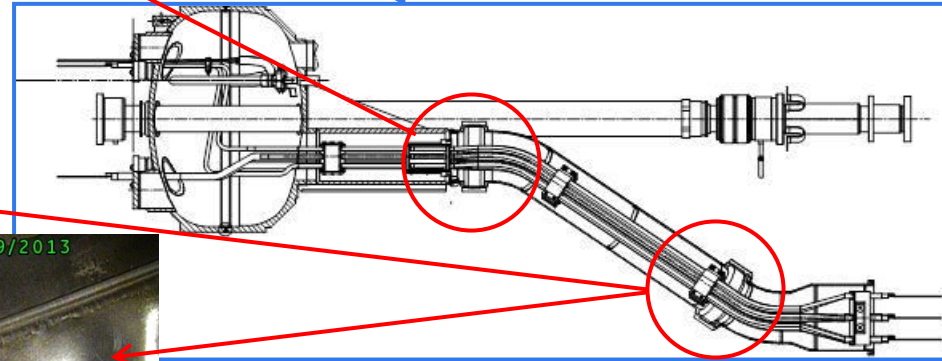
The damaged compensator (DFBA)

DN120 multi-ply gimbal bellows
(2 plies of 0.2 mm); Identical failure process identified

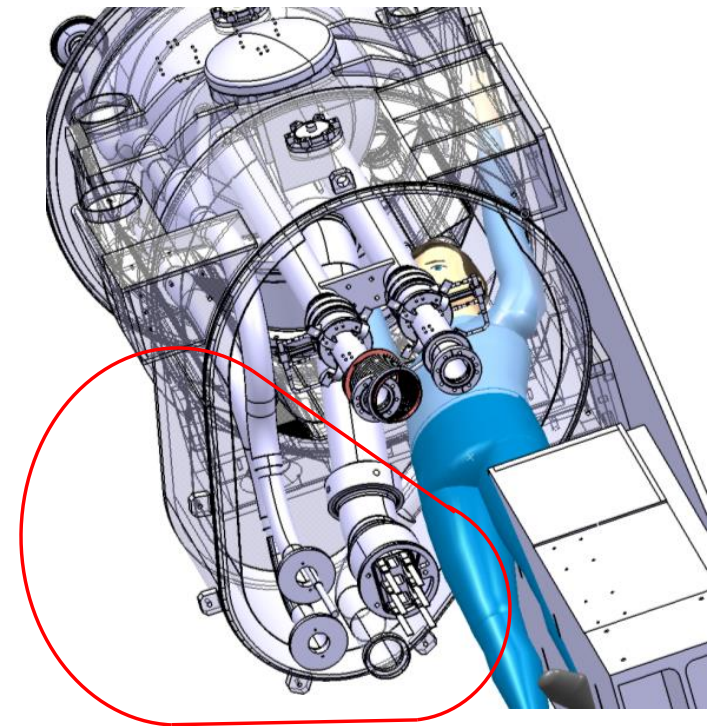
Questions/issues:

- Very limited space to cut/weld the door
- Cutting and welding of beam pipes to be done in very difficult position
- Leak tests of beam pipes?
- Extreme very difficult work positions
- Safety to be assessed

In situ access by cutting the end door: possible solution

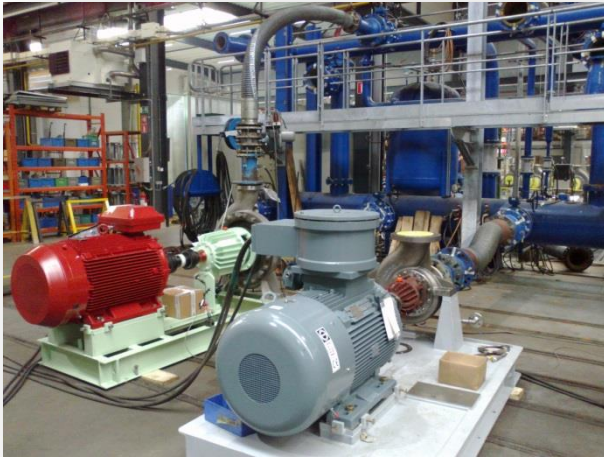
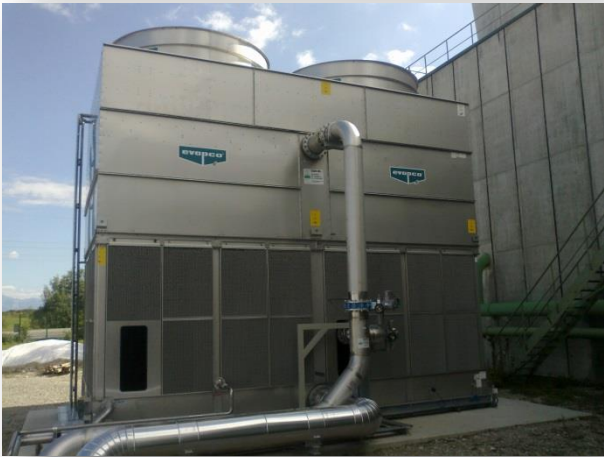
Maintenance and Consolidation of the Cooling and Ventilation System

Ongoing as planned

- ▶ Extensive Maintenance of cooling towers, the demineralised water production station, water cooling stations and machinery. The SPS water loop will restart operation this week.
- ▶ Consolidation & Upgrade
 - ▶ New redundant pumps on the demineralised water loop of the LHC
 - ▶ PS Ventilation System
 - ▶ CCC ventilation System
 - ▶ New cooling towers for the LHC to allow operation of the cryogenics during maintenance

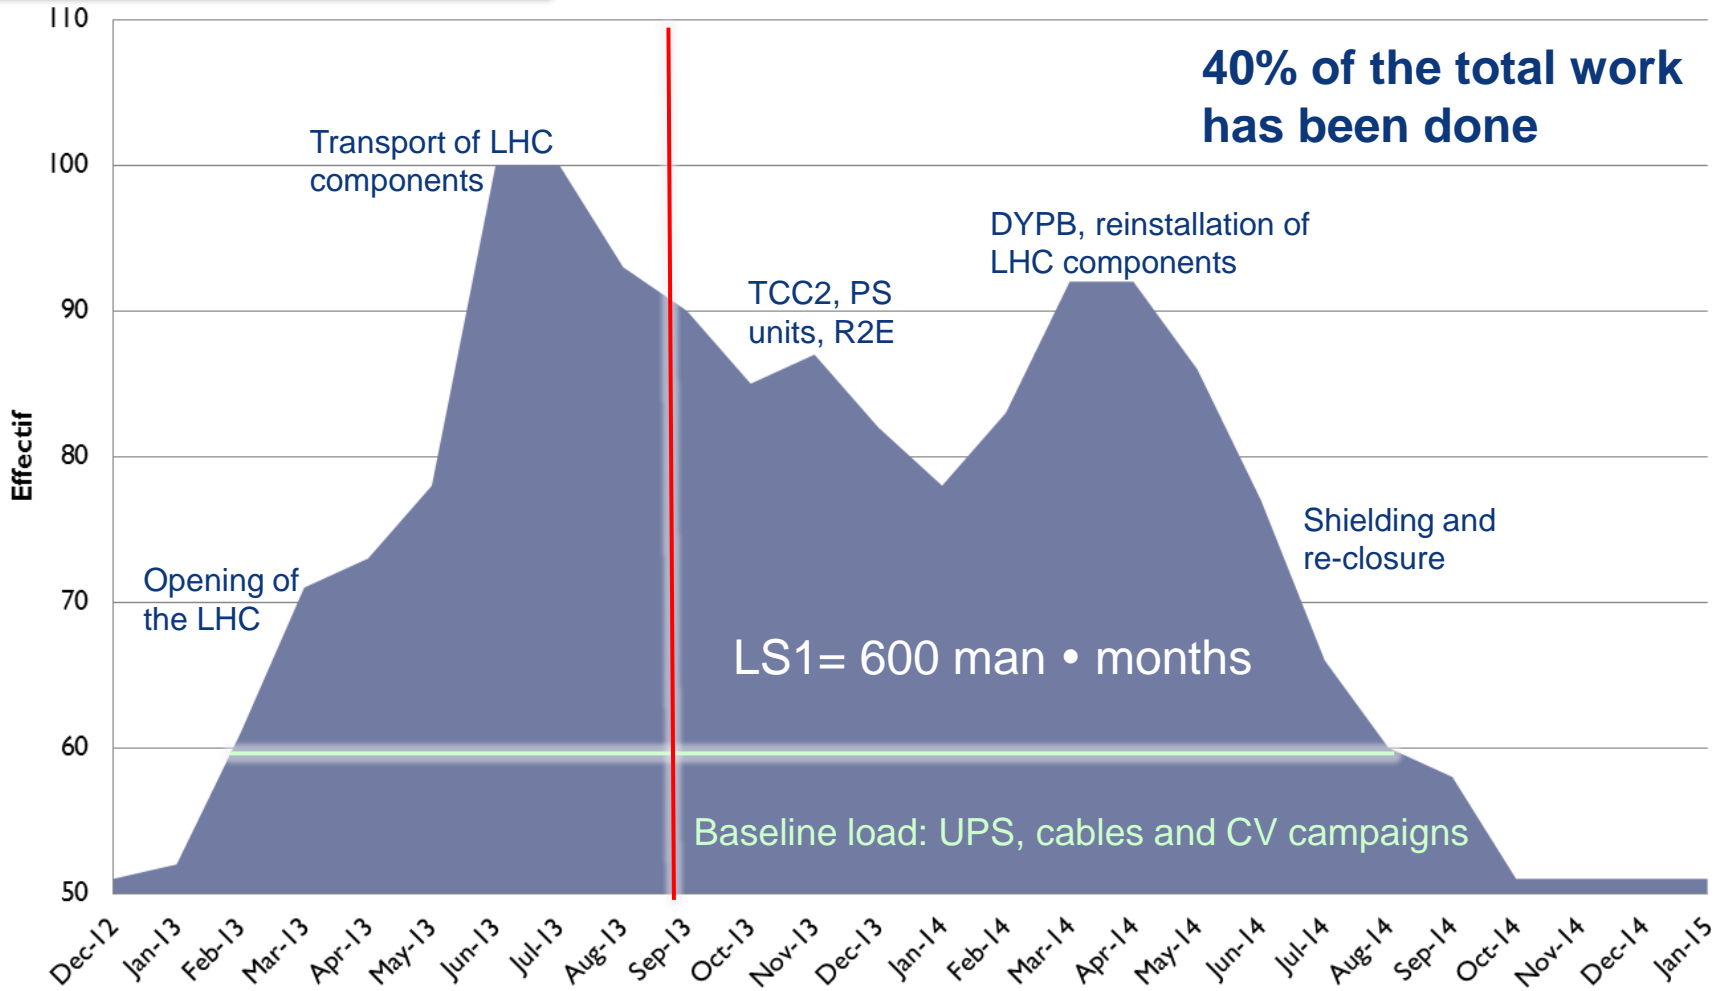
Handling & Transport

18 magnets were removed and the new ones are in place

- ▶ Replacement of magnets (15 dipoles + 3 quadrupoles)
- ▶ Removal and re-installation of shielding
- ▶ Removal and re-installation of components (racks, crates, collimators)
- ▶ Transport of cables
