RF Related Issues Encountered during over 15years of Operation of SPring-8

Shigeki Sasaki,
SPring-8/JASRI

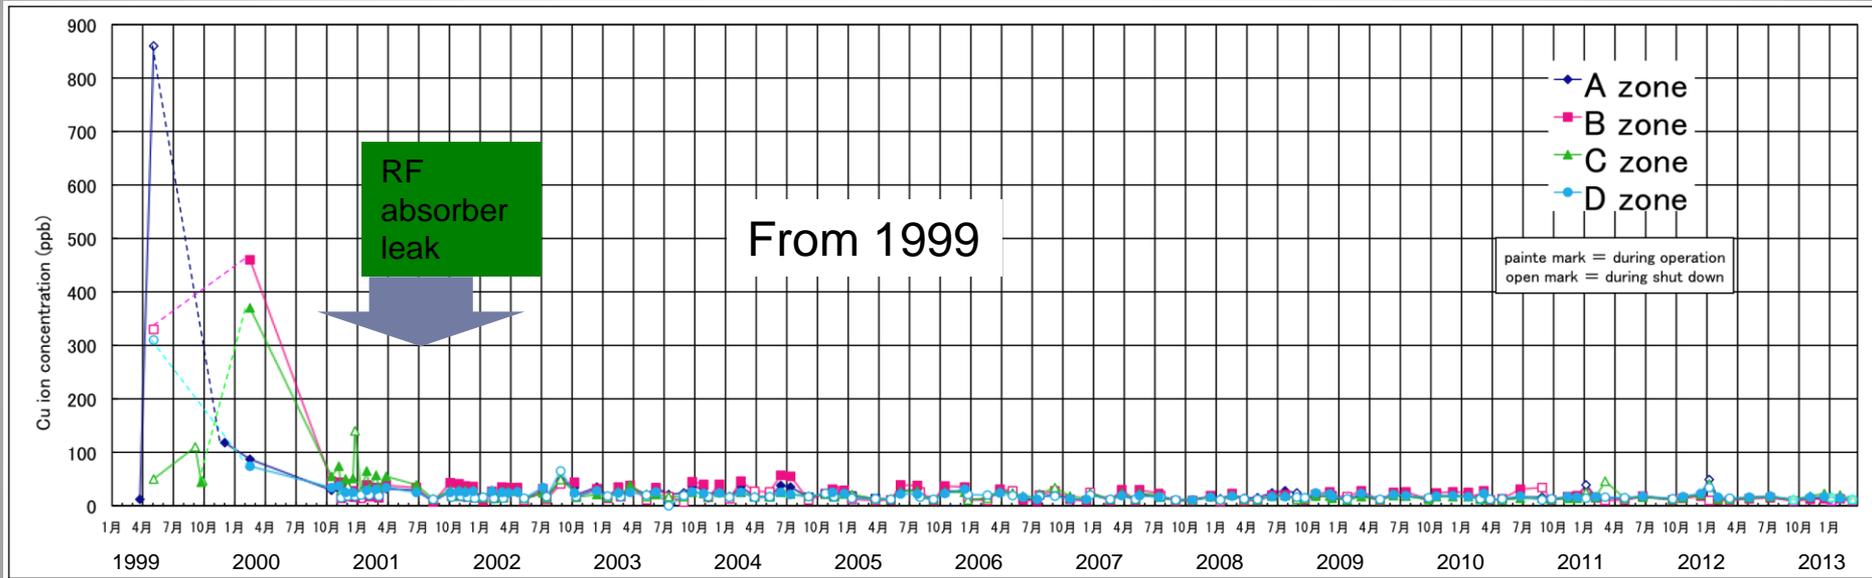
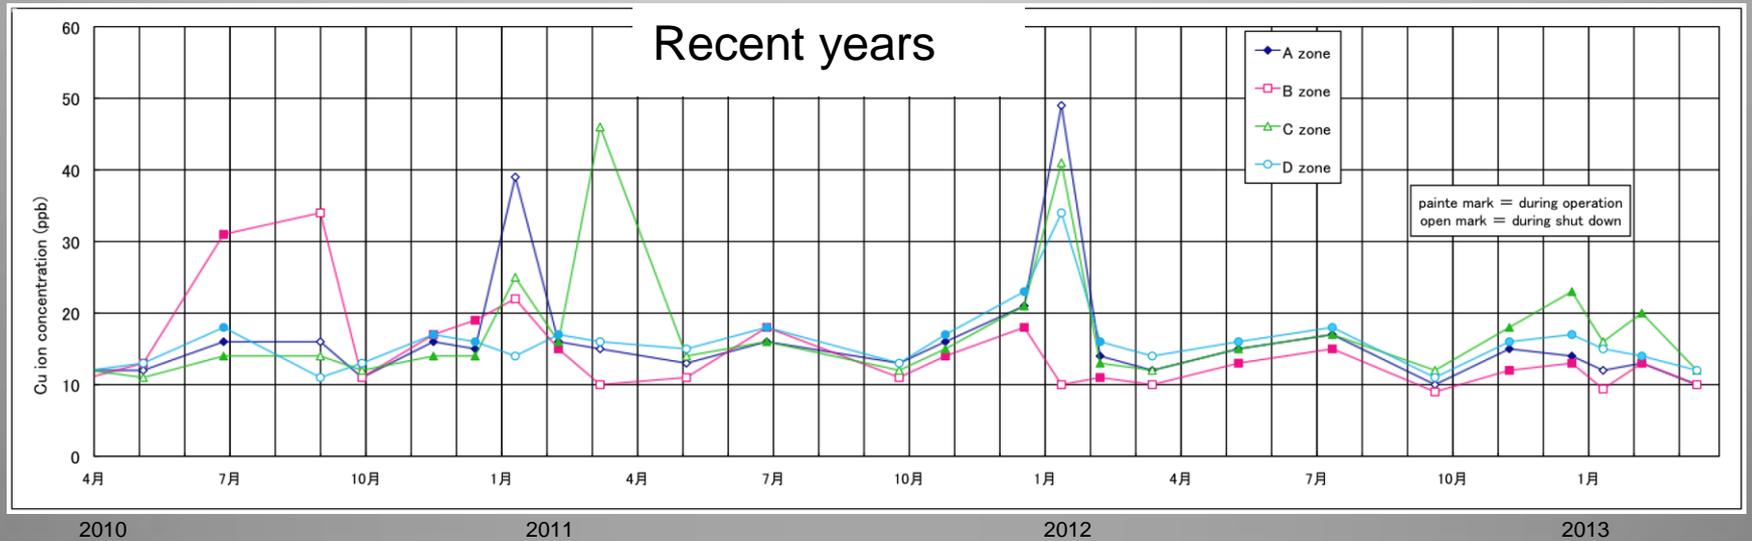
copper ion concentration in the cooling water

SR lights pass the cooling channel and the chemical reactions with copper and the oxygen occurred, and the copper was eluted
Absorber wall thinned and finally the water leaked through holes
