MICE Target Mechanism CM38 – Napa Valley

P J Smith on behalf of the MICE target team

Target Mechanism

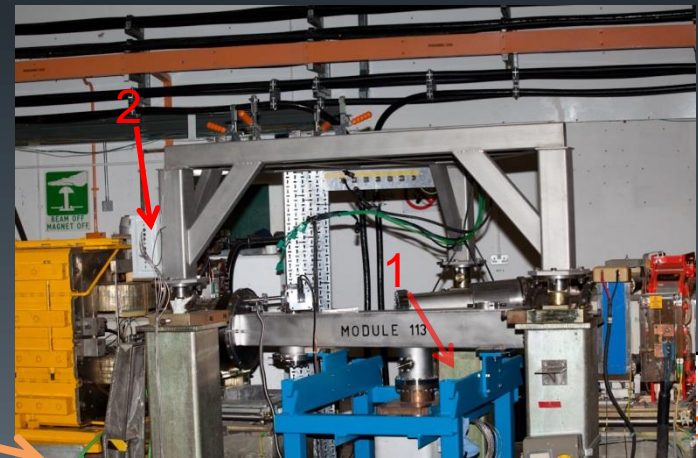
Patch cables were deliberately added to the end of the route as those lengths of cable were perceived to be at higher risk from both radiation and mechanical damage. (1→2)

Excess fibres stored underneath the dipole behind the target. This is not what it was planned to look like!

But it raises the question over whether any damage is being done to the excess of fibre that is currently being stored underneath the ISIS beamline. Some indication of higher activation in SP7 area but data on this is intermittent.

- 1) The excess of fibres at the end of the 07' install are vulnerable and are at risk of damage – both mechanical and radiation.
- 2) We only have one known good spare channel for the target system.

- 1) A critical case for re-installing the fibres as per the original plan – the plan deviated significantly in the synch.
- 2) That there should be twice as many fibres laid as are required to give a significant number of spare channels in case of accidental damage to the fibres .
