Elettra Booster Power Converters Refurbishment

"A Year-Long Challenge"

R. Visintini

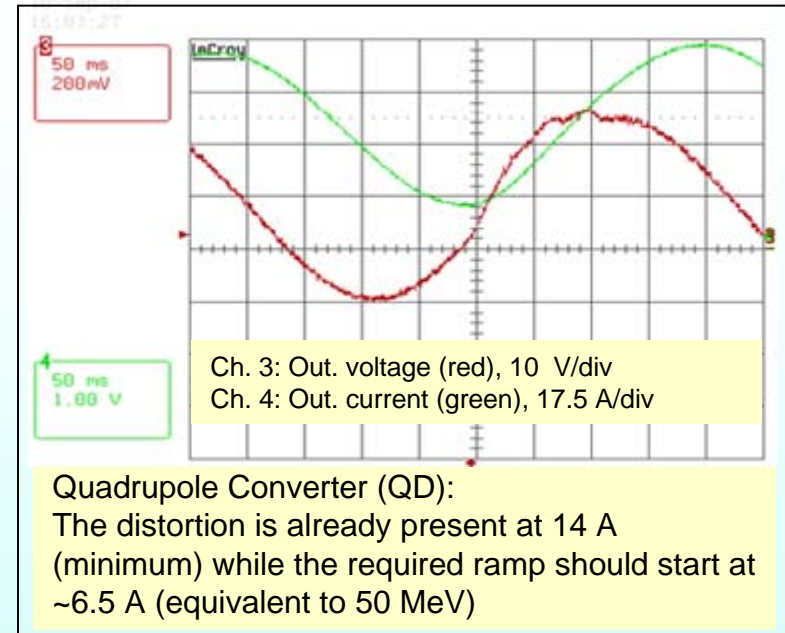
"Every Solution brings new problems"

- Shipping damages repair and pre-start up tests on resistive load in July. Tests on actual loads in August.
- Main hardware troubles:
 - Output voltage and current distortion when ramping (hw modification: 2Q → 4Q);
 - High ripple content in the output current (also after improving the filtering);
 - EM noise and its consequences on operating the PCs (increasing with the peak power)
 - Not optimal charging of the DC-Link
 - Overheating of the output filter chokes
 - Sextupole converters heavily damaged during stability tests in DC.
- Factory tests could not be repeated
- The quadrupole converters could be operated together at nominal values (3 Hz, "2.5 GeV" currents)
- Dipoles operated at "2.0 GeV" current, "single 3 Hz Pulse per second" mode

- Advice, suggestions and help from colleagues of other Laboratories (PSI, DLS, DESY, ALS, SLAC)
- Internal team for addressing the problems in parallel to Kempower
- Power Converters Refurbishment Program from Kempower

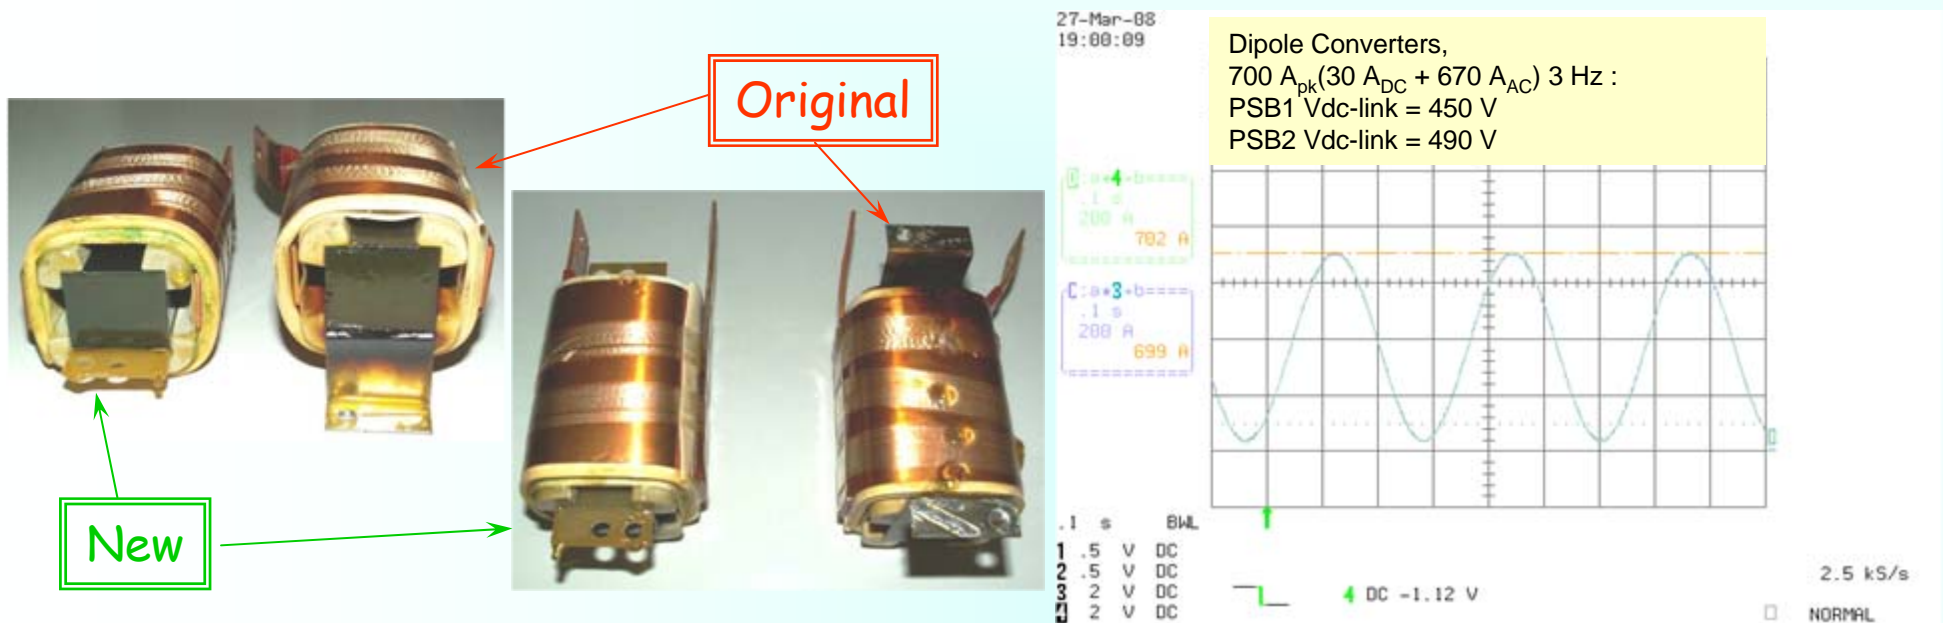
Some Results after the 1st Refurbishing Step

- Started in the Holy Week and during the "Easter Shutdown"
- The scheduled actions were completed by Kempower's people according to the time schedule
- **Replaced the output filter chokes: overheating issue is SOLVED**
- **All output modules are in place and also the Dipole Converters CAN operate at 3 Hz up to the "2.5 GeV peak current".**
- Added EMI shielding to the control crates but still problems deriving from induced/picked up EM noise.

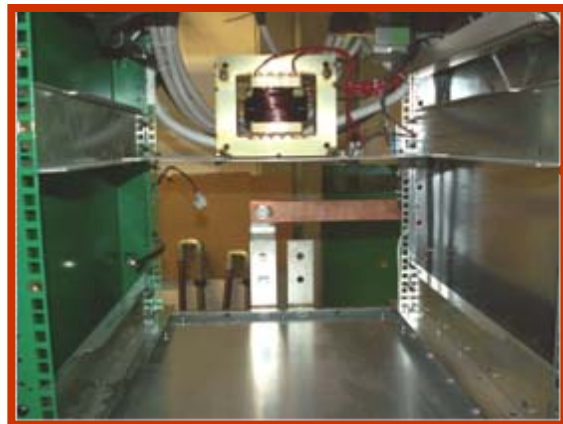
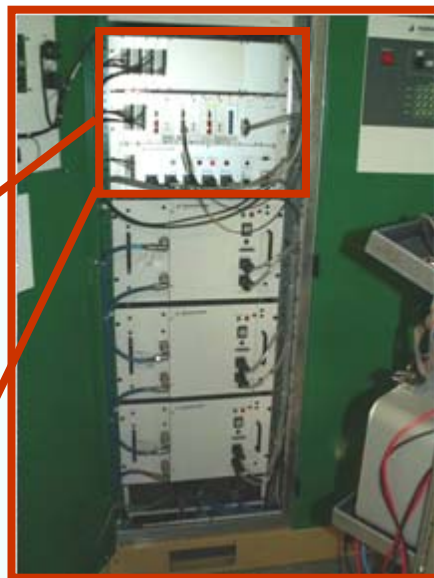
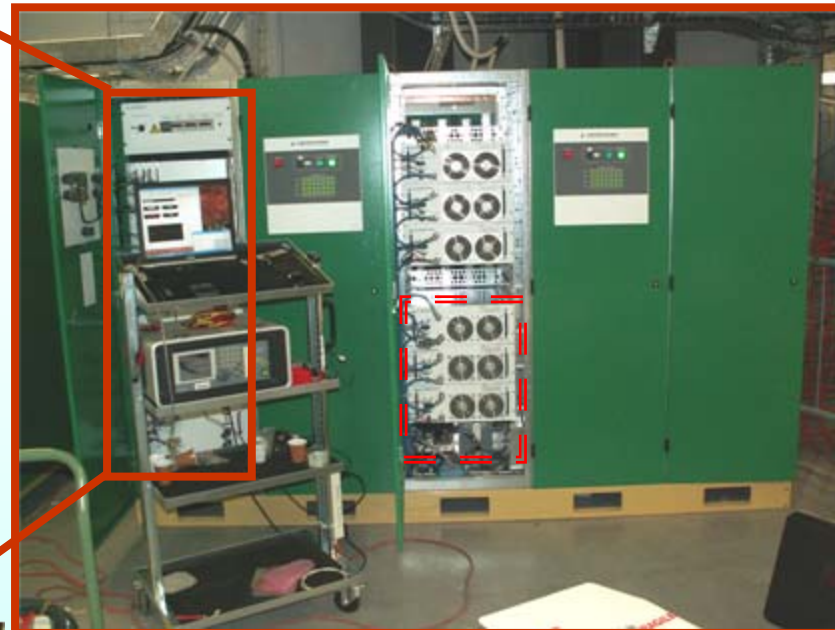
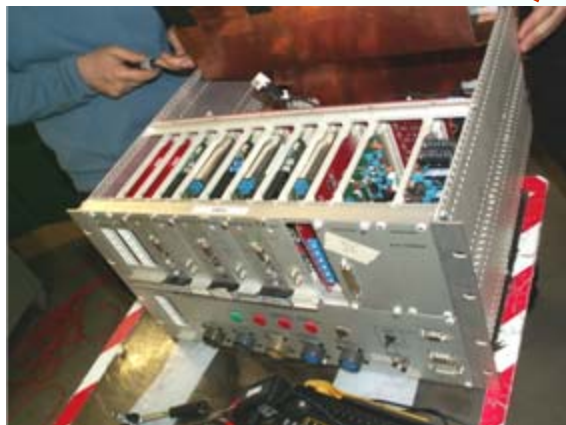
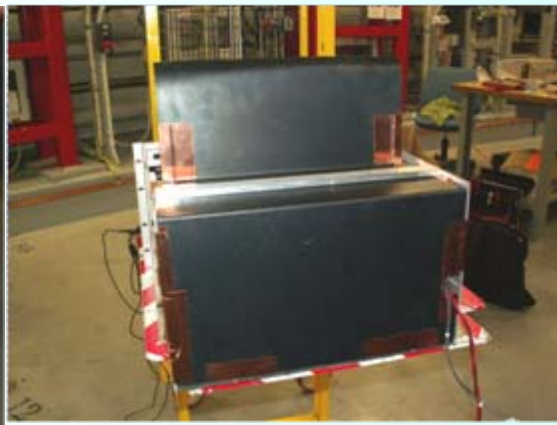
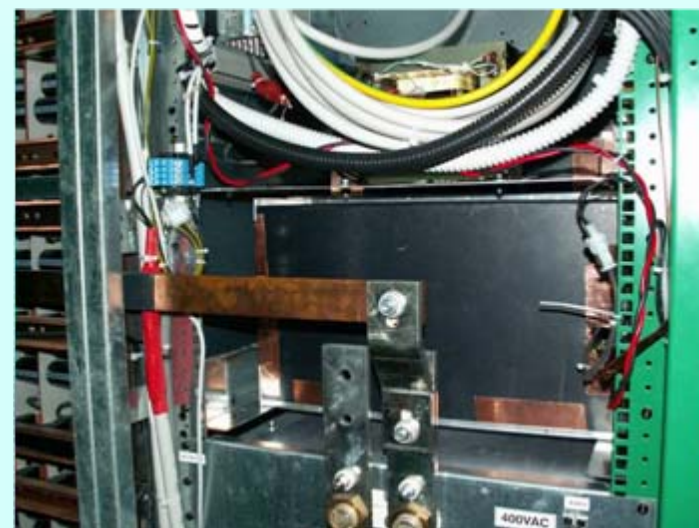
Status - Dipole Cabinets Snapshots

Temporary EMI Shield on the "Common Control Crate"
