LEAK DETECTION AND REPAIR IN THE ACCELERATOR COLUMN

LEAK DETECTION AND REPAIR OF VACUUM IN THE ACCELERATOR COLUMN

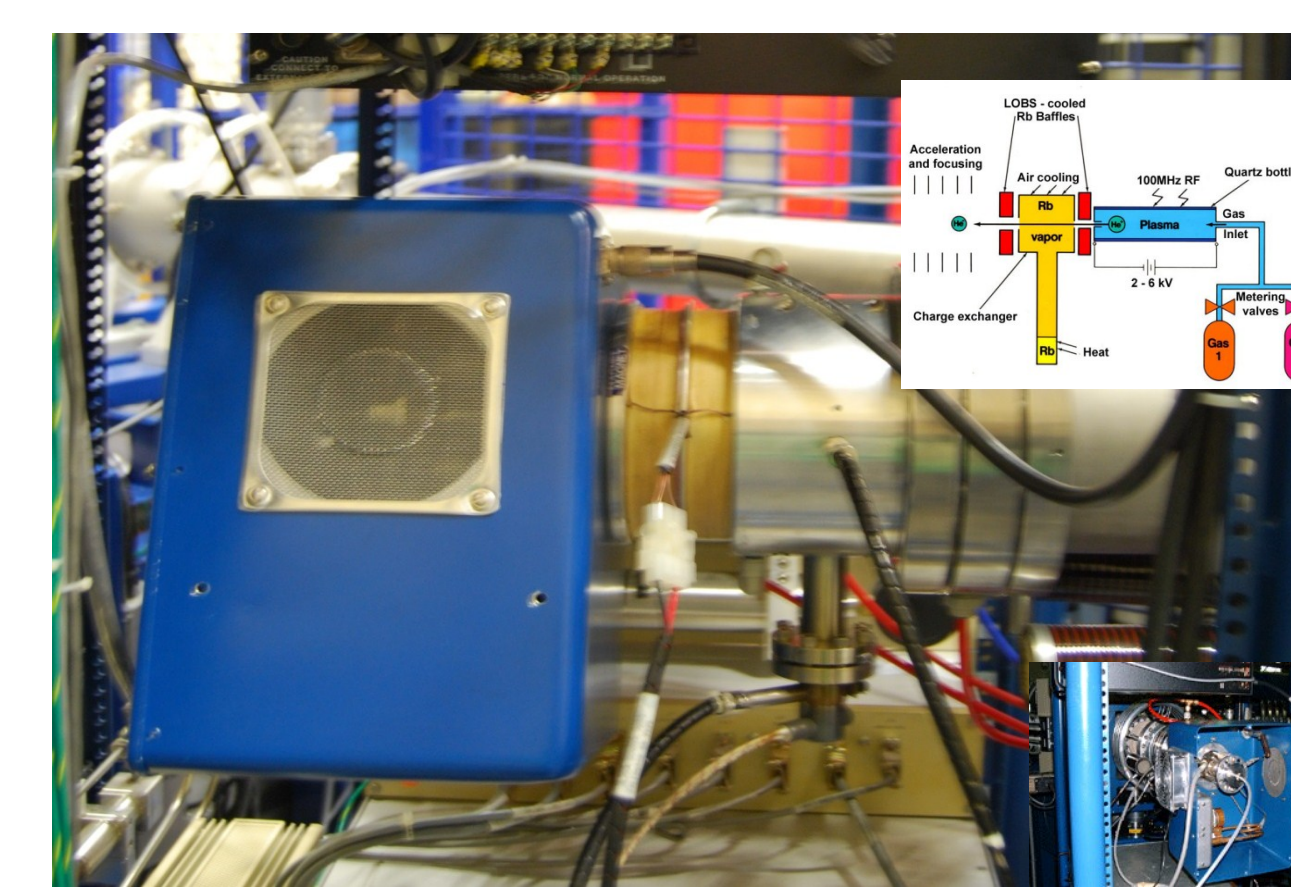
A leak located in the high-pressure tank is one of the most feared problems for a tandem Pelletron accelerator. This type of situation usually requires disassembly of the accelerator followed by an extensive leak detection effort. The accelerator can be down for many weeks or months before operations can restart. In early July 2013, this situation occurred with the 3 MV model 9SDH-2 Pelletron accelerator located at the CNA.

The vacuum started deteriorating inside the tube after a spark. It was found out that residual gas inside tube was SF₆. The pressure of SF₆ tank was decreasing, the maximum voltage was 2.3MV

Hunting of leak: Leak detection just after the tank opening. A leak detector was connected to the low energy terminal. The procedure employed was same as conventional leak detection. Accelerator tubes were sprayed with helium. The leak was very small, the leak wasn't detected.

The leak was detected in second tube of low energy column.

Tube replacement is a very hard job and requires many fore preparations. So the damaged tube was replaced with a new accelerator tube.

During the same installation time alignment of the machine was taken care. Again leak checking was done and the tube was baked properly. The tank was closed again and was conditioned for about four days. today the terminal can reach its maximum voltage stably(3MV).
