# CDF silicon cooling: problems and recovery

- I will not talk..
- The CDF silicon detector cooling system
  - The leak
    - Investigation
    - Repair
- Status

*Ignacio Redondo*

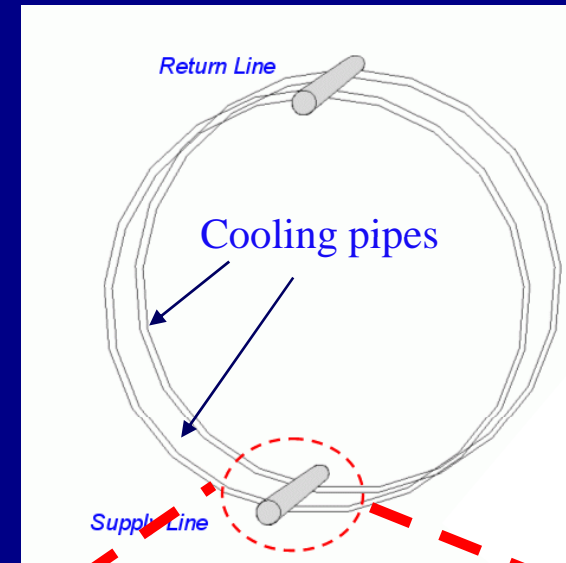
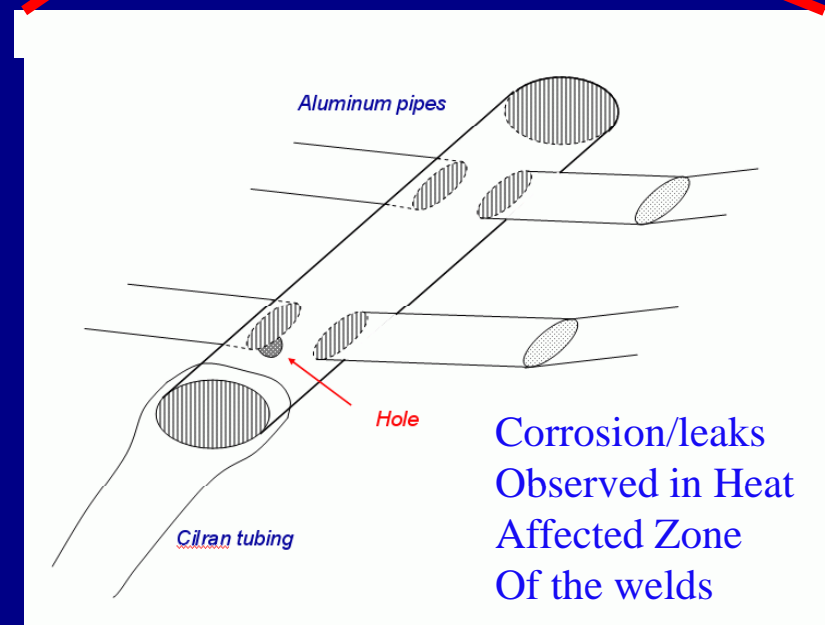
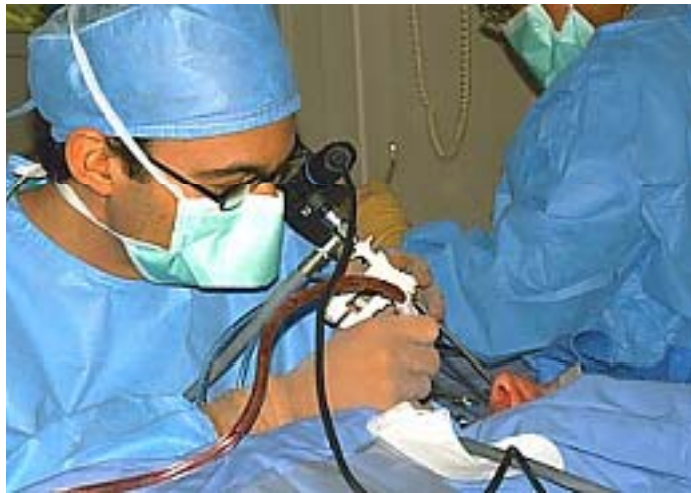
Portcard ring

- Al vulnerable to corrosion below pH 2 because Alumina becomes soluble
- Corrosion resistance is alloy-dependent:
  - Heat affected zone in 6061-Al welds (ISL portcard rings) most sensitive
  - 1100-Al test sample (pipes cooling the sensors) shows no corrosion or mass loss

- Manifold - AL 6061-T6, 0.7 mm wall, 127 mm long tube 6 mm ID
- Cooling Rings - AL 5052, 5 mm wall, oval tubes (21 sided)
- Welded - either 5356 or 4043 filler
- Inner surface area: 0.12m<sup>2</sup>
- Fed by Cilran (Silicon) tubing from COT face
- Impossible to access from outside, isolated by volume full of cables, ~60cm in z.

Repair

- **Keep the silicon cold and dry:**
  - Plastic barrier encloses wire chamber bore, 600cft volume.
  - Desicant based air drier will provide 300cft/min to the volume.
  - Dewpoint always below –10 C.
- **Cover holes with epoxy DP-190 from the inside of the pipe using borescopes and catheters.**
- Repairs performed over a month with 4 people shifts lead by FNAL specialist (“*head surgeon*”) Ken Schultz.
  - Vacuum tests show that the Al lines are as tight as the stainless steel ones (SVX portcards)
  - **Cooling running stable for a year**
