LHC insulation vacuum system: consolidation activities and leaks followup during the first LHC long shutdown

Jaime Perez Espinos on behalf of all contributors to LHC insulation vacuum (TE/VSC, AL4030 and ICIT)

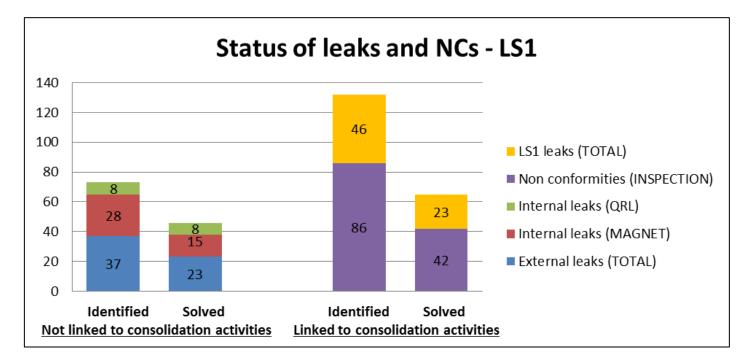
Status of leaks

Leak tests linked to consolidation activities have been done for **6** out 8 sectors Inspection procedures linked to consolidation activities have been done for **7** out of 8 sectors
