LHC's injector chain:

# Vacuum activities during LS1

Jose A. Ferreira Somoza on behalf of TE-VSC-IVM  
team

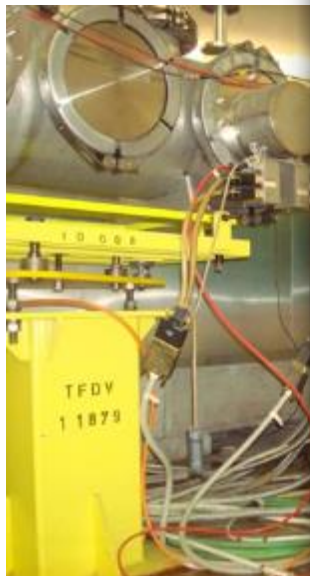
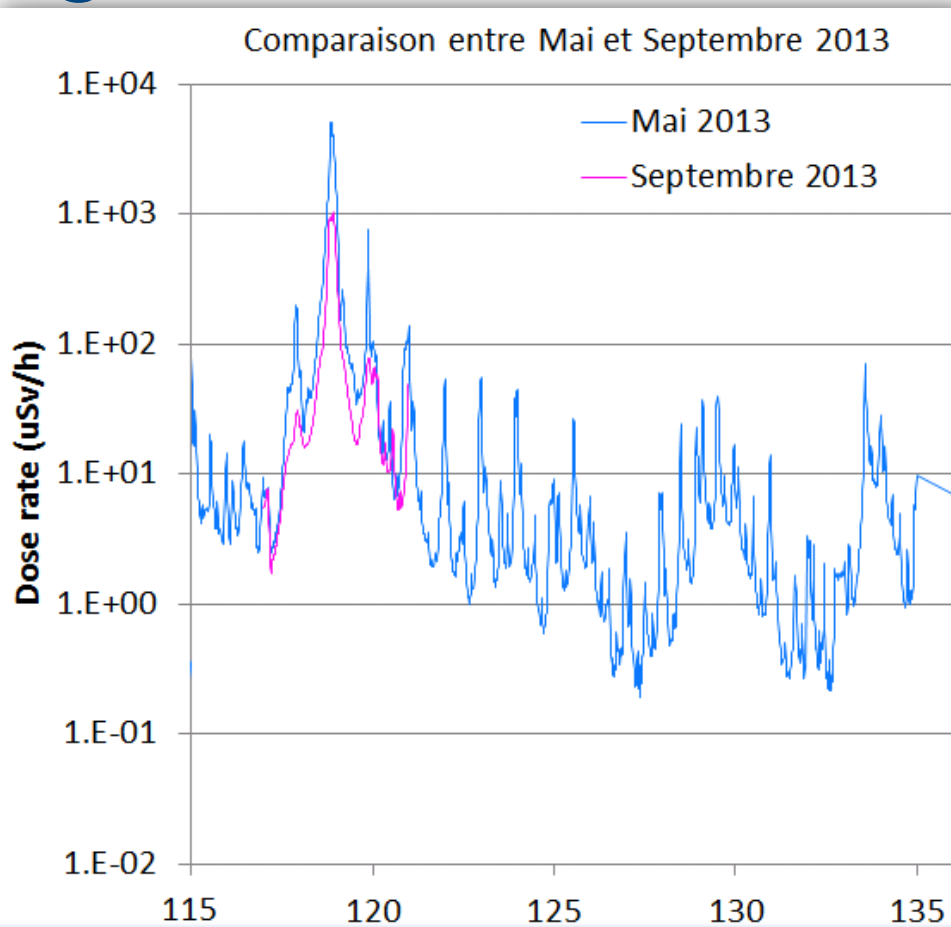
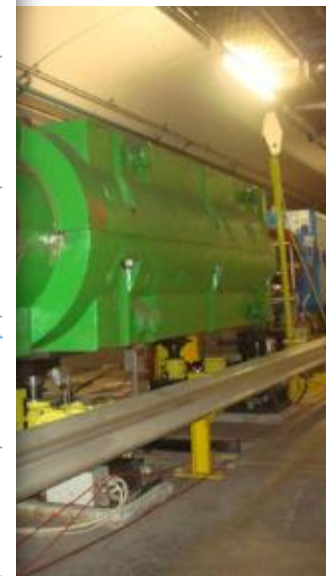
# Recabling LSS1 of SPS

4 mSv/h

Peak dose rate reduction factor  $\approx 5$  (initial estimation  $\approx 2$ )

Average dose rate reduction factor in LSS1+  $\approx 3.2$

- Recabling LSS1 (SPS). 120 m of beam line dismantled (reduction of ambient dose) in summer 2013. Reinstallation spring 2014.
- Vacuum consolidation north area of SPS

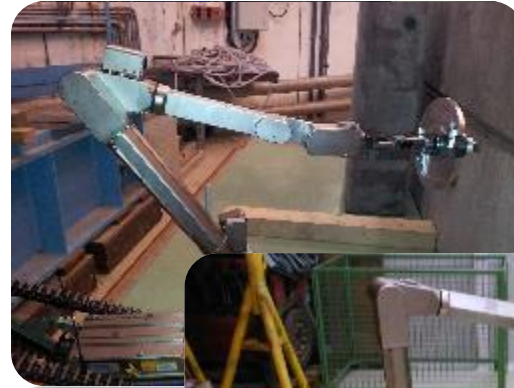
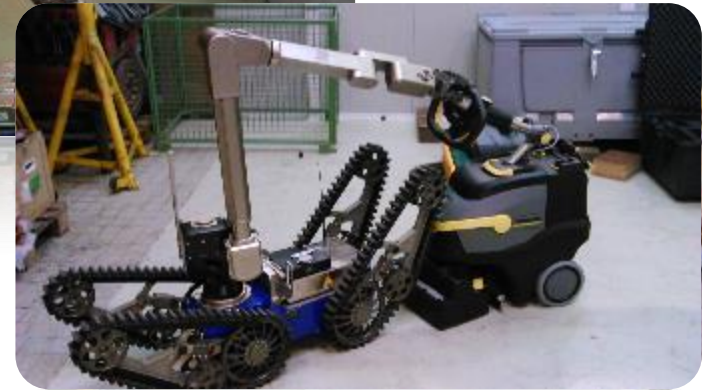
>60% reduction of the collective dose

- Inspection
- Leak detection
- Removal of clamps
- Cleaning
- Install 1 flange (12 mSv/h)
