OTHER NON-SOLVED NC ACROSS THE LHC RING AND POTENTIAL IMPACT ON PERFORMANCES

V. Baglin, CERN, Geneva, Switzerland

Abstract

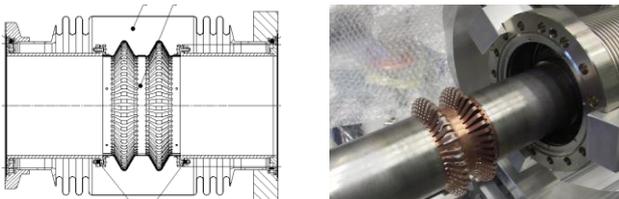
It is worth mentioning also that new concepts of RF bridge are presently under development and ready to be vacuum and impedance qualified. As shown in Figure 4, this type of RF bridge do not have any sliding contact in such a way the electrical continuity is always guaranteed at a price of a relaxation in impedance tolerance. This RF bridge could be used in the future in high radiation areas of the LHC. However, it must be stressed that one limitation of such a system is the demanding alignment accuracy which is not always compatible with the field limitations. More dedicated studies are needed to validate this proposal.

Figure 4: A possible new type of RF bridge for high radiation areas (courtesy J. Perez Espino TE/VSC).

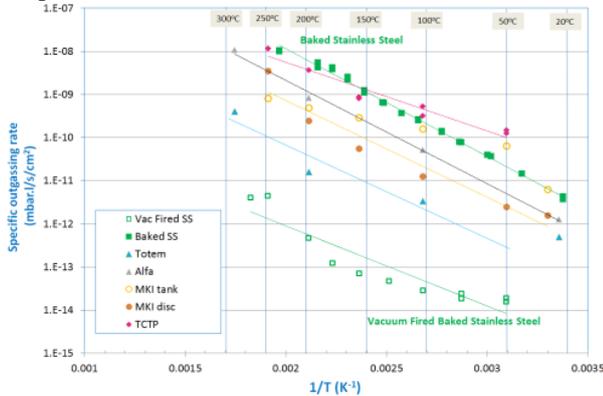
Figure 6 shows the specific outgassing rate of standard ferrites used at CERN and compared to baked stainless

steel and vacuum fired stainless steel. These data were obtained followed a degassing treatment of the ferrite at 400 or 1000 °C. The specific outgassing rate is inversely exponentially dependent with the inverse of the temperature.

Figure 6: Specific outgassing rate of ferrites compared to baked stainless steel and vacuum fired stainless steel (courtesy G. Cattenoz TE/VSC).

Therefore, as shown in Table 1, increasing the ferrite temperature from RT to 50 °C will multiply its outgassing rate by 5. Increasing further the temperature, the ferrite outgassing rate can be multiplied by several orders of magnitude increasing significantly locally the vacuum pressure. Long term operation will then saturates the NEG coating and induce radiation to the electronic. Finally, the equipment will need to be repaired during LS2.
