FOCUS COIL STATUS

FC 1 @ CM39

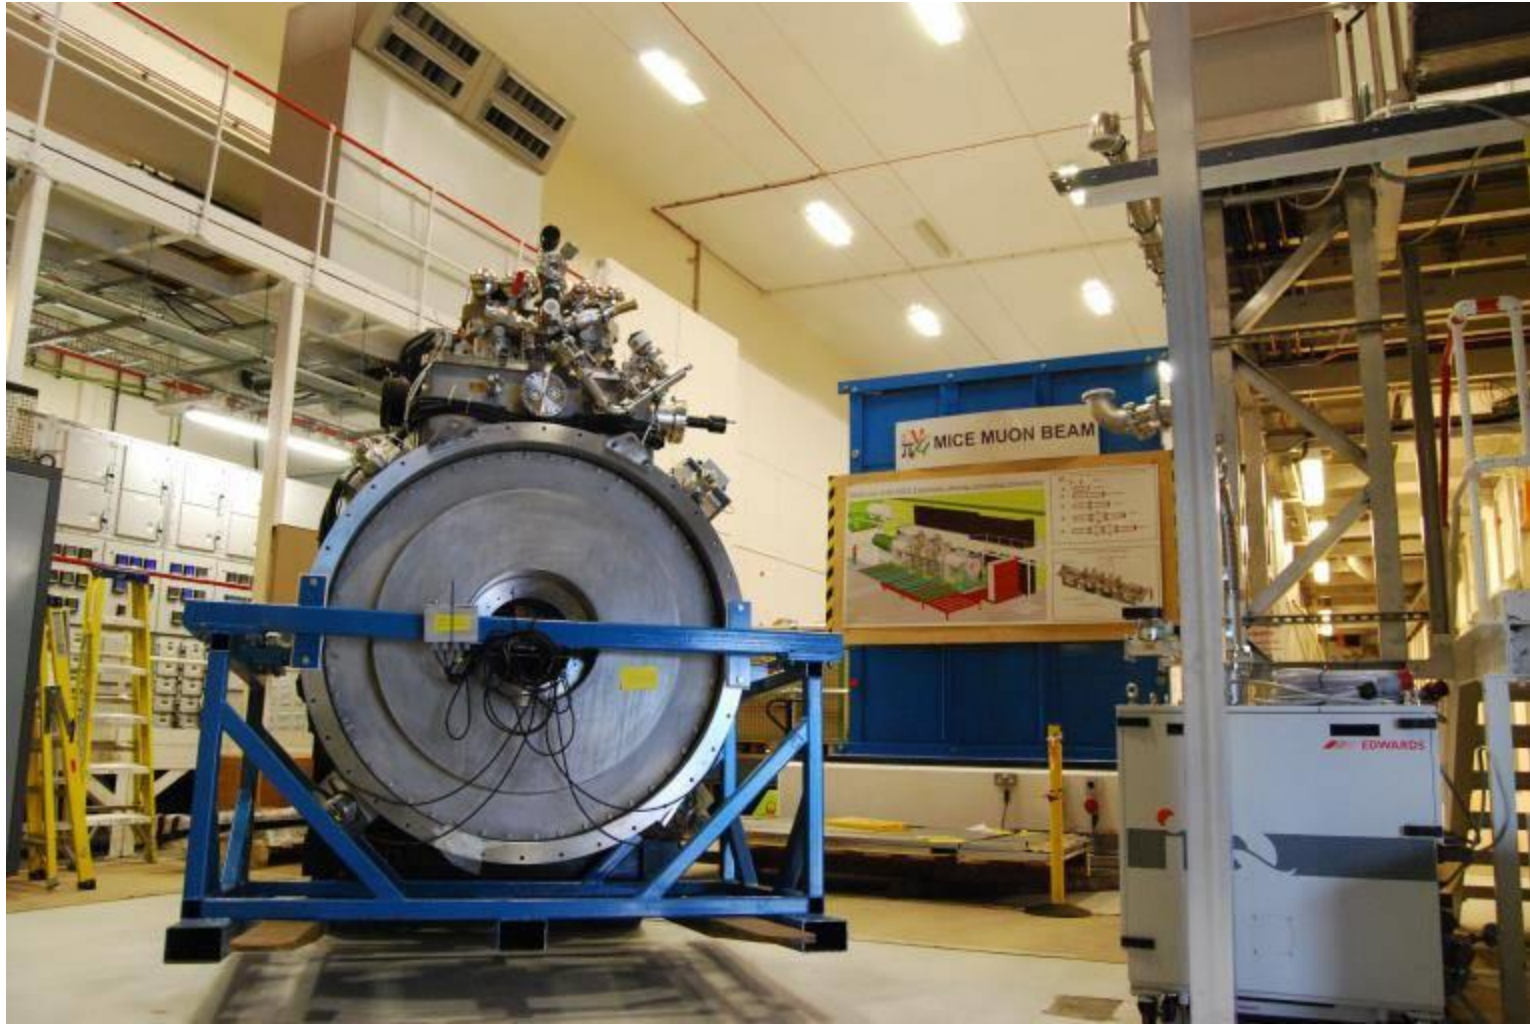
FC 1 NOW IN HALL

Moved to Hall 19 June

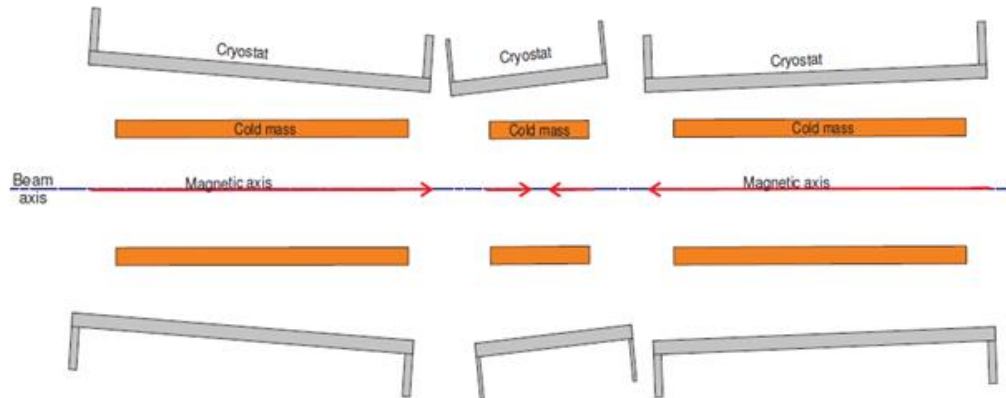
FINDING THE MAGNETIC AXIS

Need to know position of *magnetic axis* to 0.25 – 0.5 mm to align axes of modules to beam axis

‘Magnetic axis’ means perpendicular components of $B = 0$
